# What's in the Report

# Results – Property Condition Report

5679 Hollister Avenue Goleta, Ca

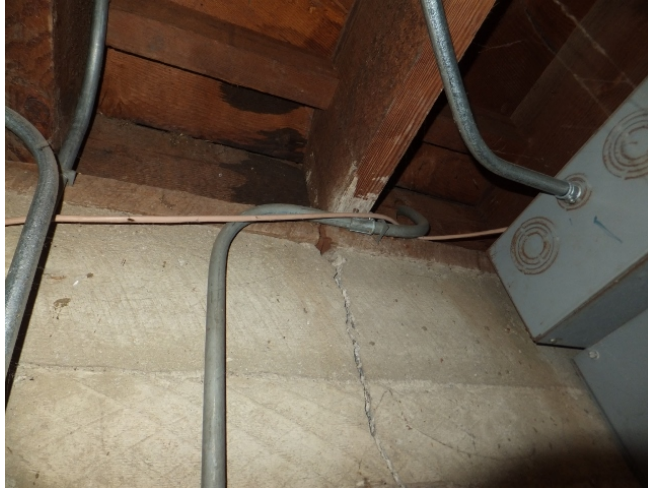
Basement wall foundation and sill plate with vertical split is widest at the top and narrower at the floor

There is a large vertical crack in the north basement wall near the northeast corner of the basement.

- The crack in the basement wall should be repaired by epoxy adhesive injection and monitored for further settlement cracking.

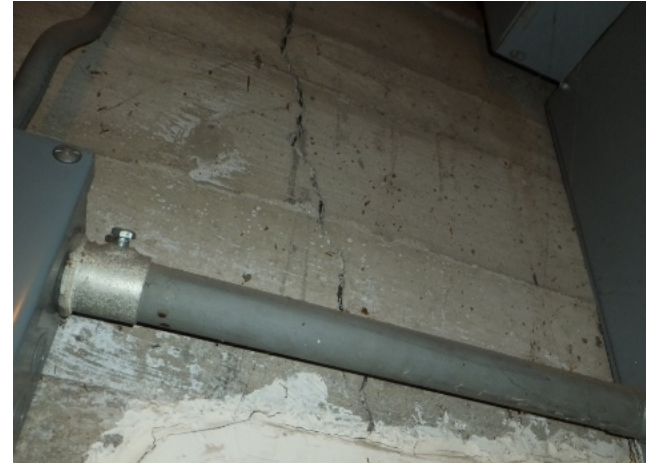
Vertical crack in basement foundation wall, Main Building A.

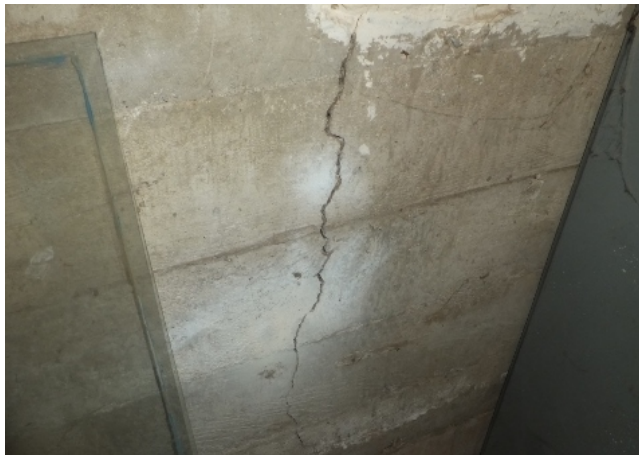
Vertical crack in basement foundation wall, Main Building A

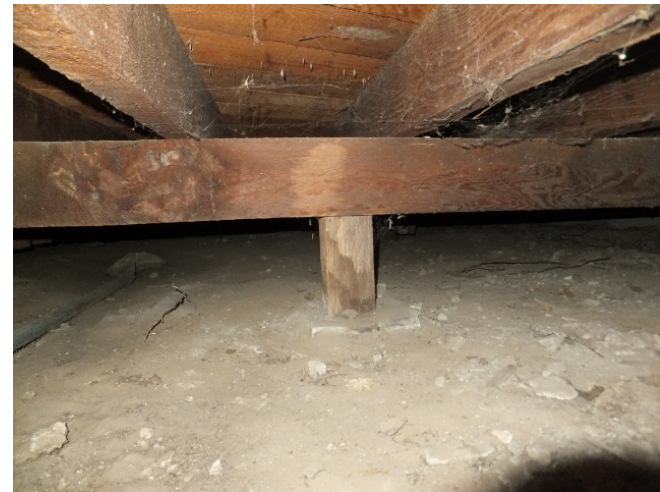
Main Building A substructure pier and floor framing.

The building has a raised wood floor with a substructure crawl space. The piers that are visible from the interior two access openings have dirt over the concrete pads, in contact with the wood blocks and piers.

- The dirt covering the subarea piers should be lowered and removed or redistributed to separate the top of the pier and the wood post from the exposed dirt.

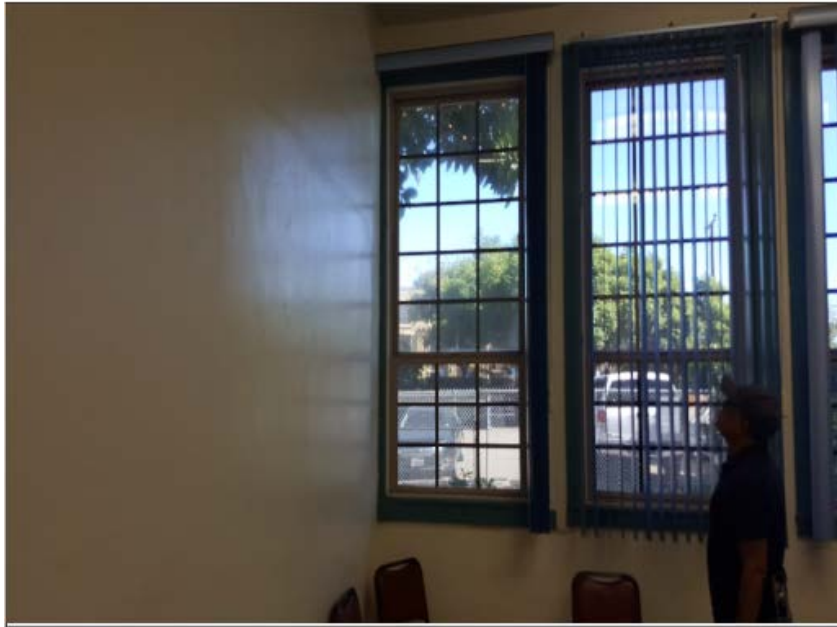
Residential-grade windows with failed jamb opening system at Community Center

5.3	Repair inoperable windows mechanisms at east classrooms of the Community Center building	1	LS	\$5,000	\$5,000		\$ 5,000
-----	------------------------------------------------------------------------------------------	---	----	---------	---------	--	----------

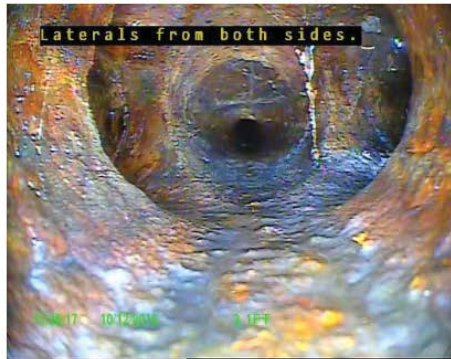
"Y" intersection at 2.10 ft.

6.2	Replace sewer line between the Community Center office restroom cleanout and the men's restroom. Cost includes further investigation and possible pump station	1	LS	\$30,000	\$30,000	\$ 30,000
-----	----------------------------------------------------------------------------------------------------------------------------------------------------------------	---	----	----------	----------	-----------

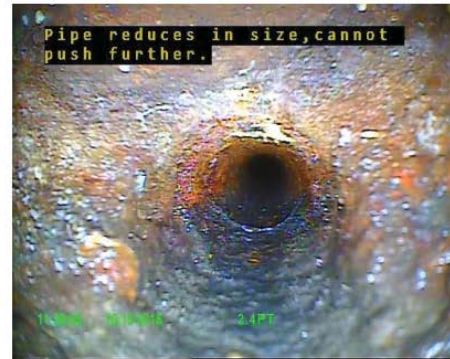
Line reduces in size unable to push further past 2.40 ft.

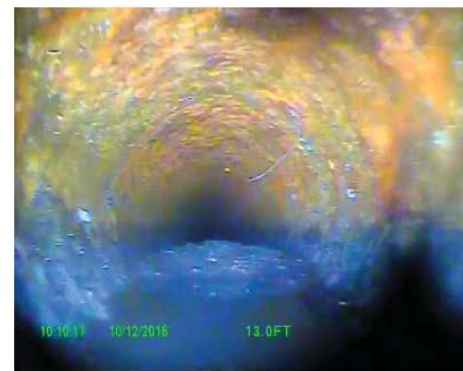
Debris at 13.00 at bottom of line.

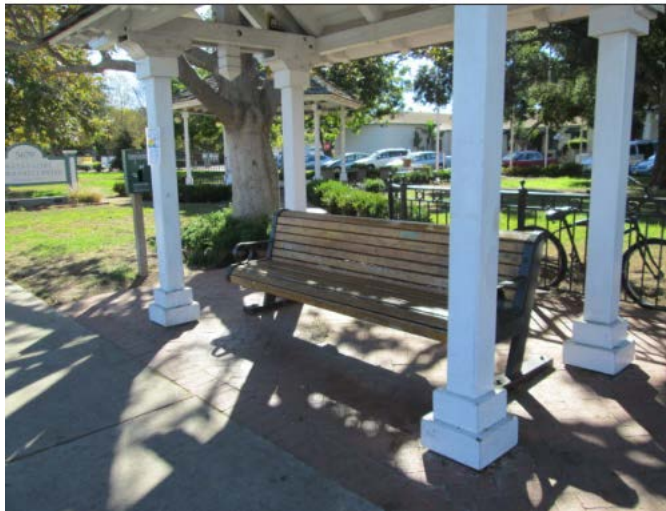
Bus Shelter along Hollister Avenue.

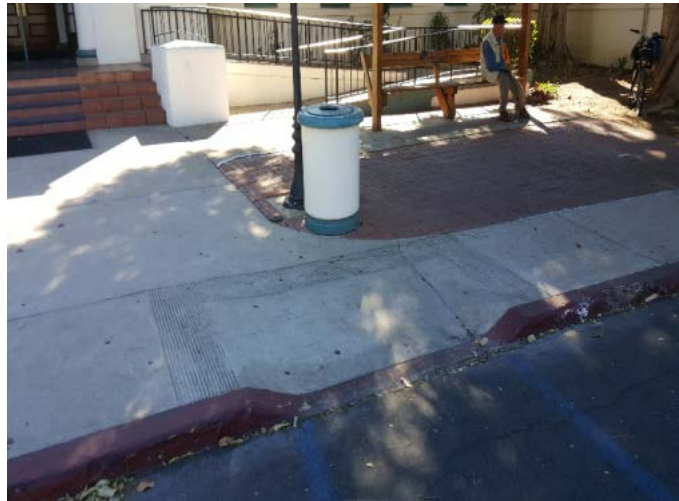
Non-compliant curb cut at sidewalk from accessible route.

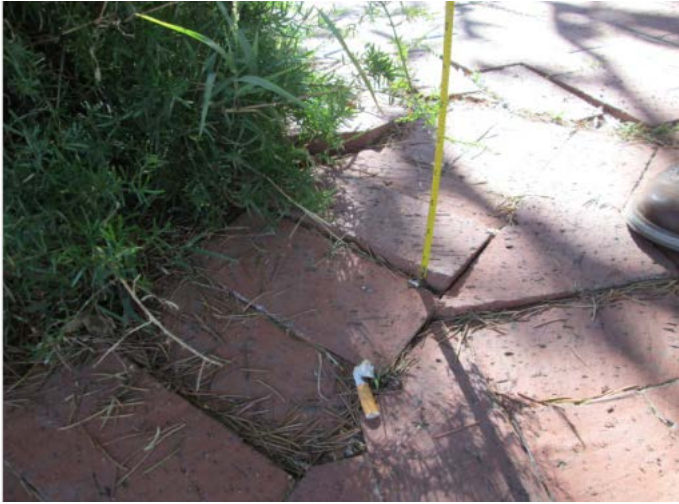
Uneven pavers at accessible route from Hollister Avenue .

9.0	Reset uneven brick pavers at walkway from bus shelter at Hollister Avenue	1	LS	\$1,000	\$1,000		\$ 1,000
9.0	Provide accessible concrete ramp with handrails to top level at gazebo	1	LS	\$2,500	\$2,500		\$ 2,500

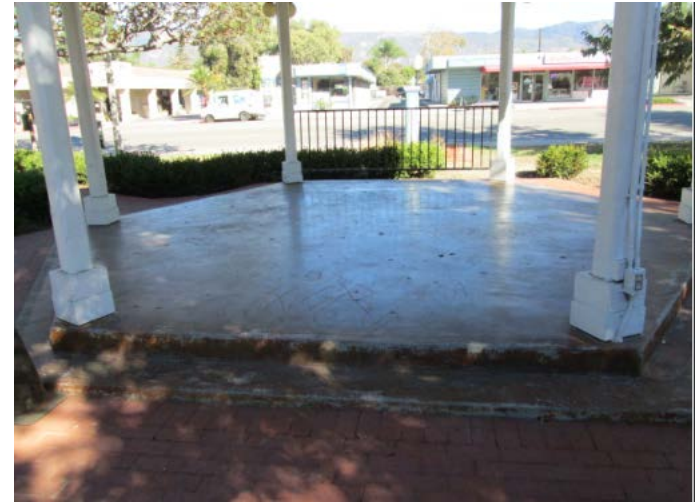
Accessible ramp required to top level of gazebo .

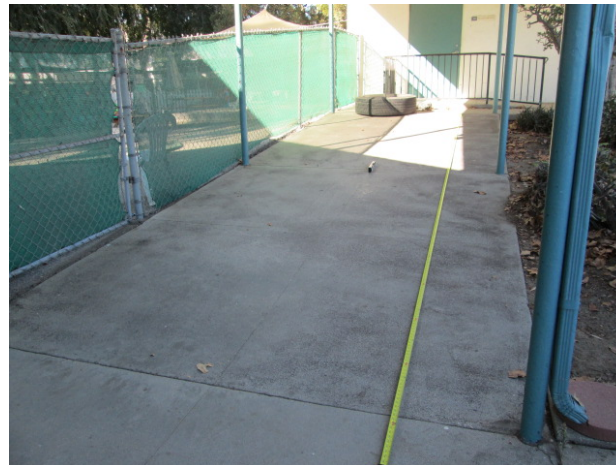
Modify walkway between Building B & C4.

9.0	Modify existing sloped walkway to provide compliant access between Classroom Buildings B and C4	1	LS	\$5,000	\$5,000		\$ 5,000
9.0	Provide compliant handrails at main entrance and accessible ramp to the Community Center	1	LS	\$15,000	\$15,000		\$ 15,000

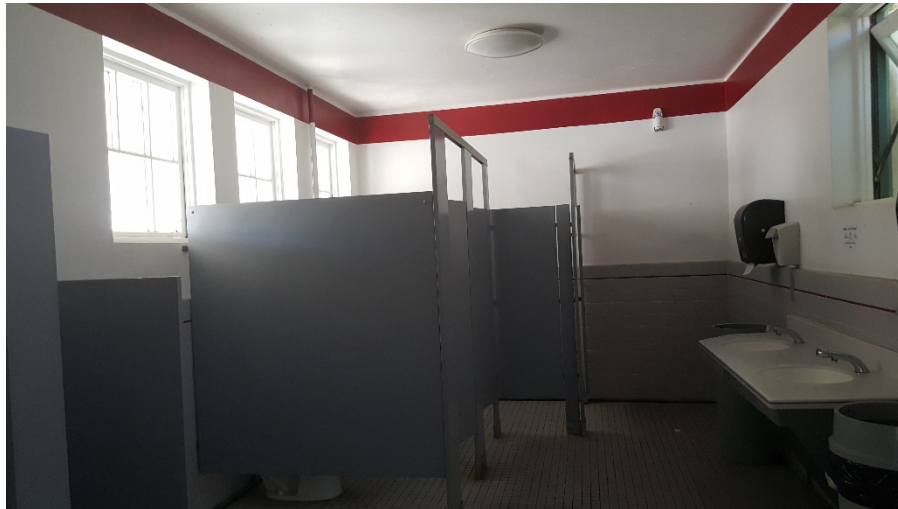
Modify existing community center restrooms.

9.0	Provide cane detection at the drinking fountain at the Community Center	1	LS	\$1,000	\$1,000		\$ 1,000
9.0	Modify existing public restrooms of the Community Center building	2	EA	\$25,000	\$50,000		\$ 50,000
<b>TOTAL</b>					\$ 170,500		\$ 170,500

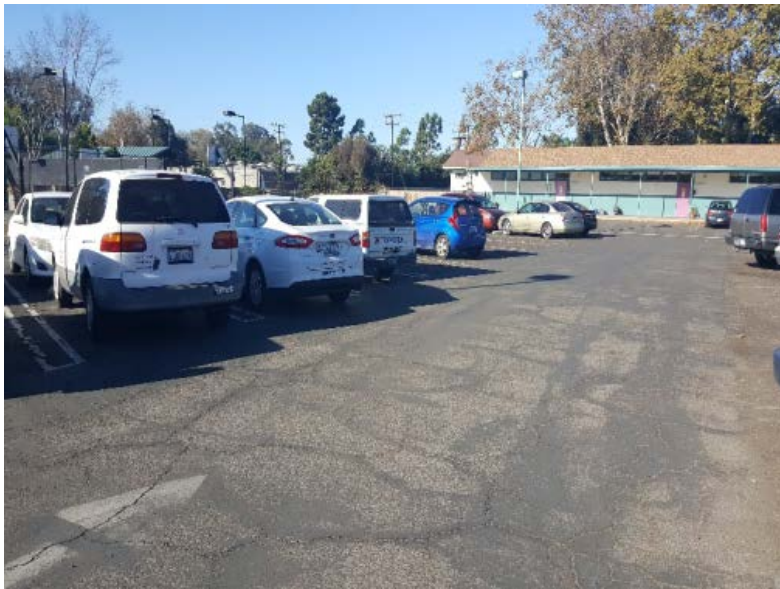
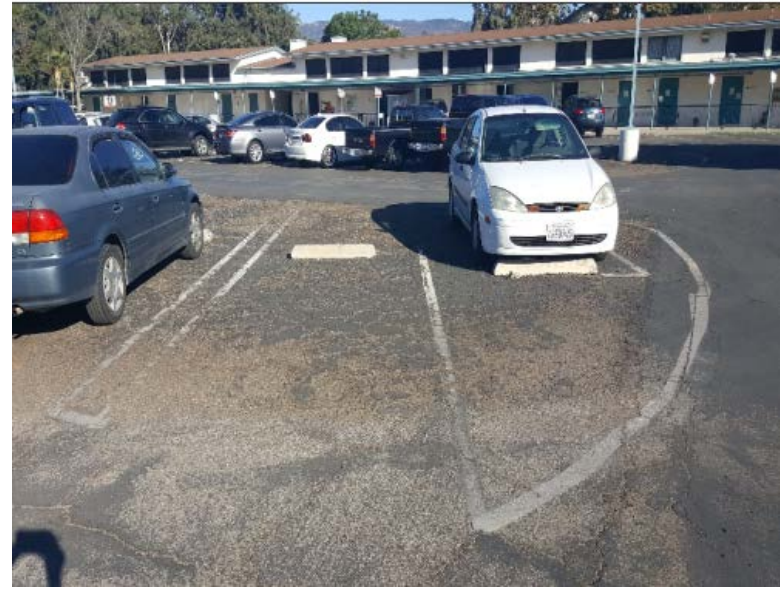
South Parking Paving and Deterioration.

3.6	Asphalt seal coat & parking stall striping	5	4	1	102,000	SF	\$0.15	\$15,300					\$ 15,300					\$ 30,600
3.6	Mill, grind and place asphalt overlay throughout parking areas	25	24	1	102,000	SF	\$2.75	\$ 280,500										\$ 280,500

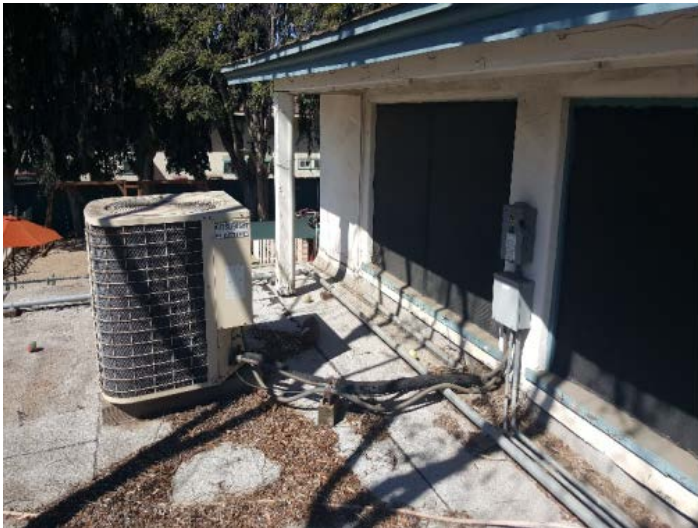
Condenser unit for Building B appear inoperative.

6.1	Split-system condenser, replace	20	19	1	3	Ton	\$1,200	\$ 3,600										\$ 3,600
6.1	Split-system furnace-fan coil, Replace	25	24	1	3	Ton	\$800	\$ 2,400										\$ 2,400

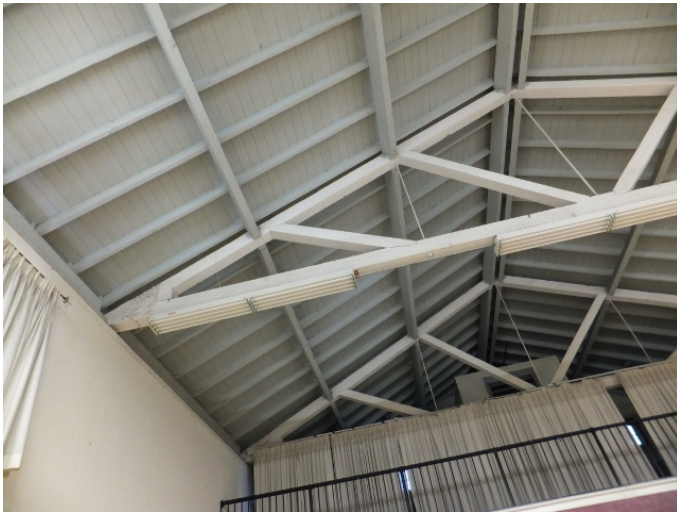
The Auditorium roof appears to not have adequate wall to roof anchorage. The framing conditions provide a weak connection between the heavy concrete walls and the roof diaphragm assembly, which is intended to transfer the lateral forces to the sides of the building.

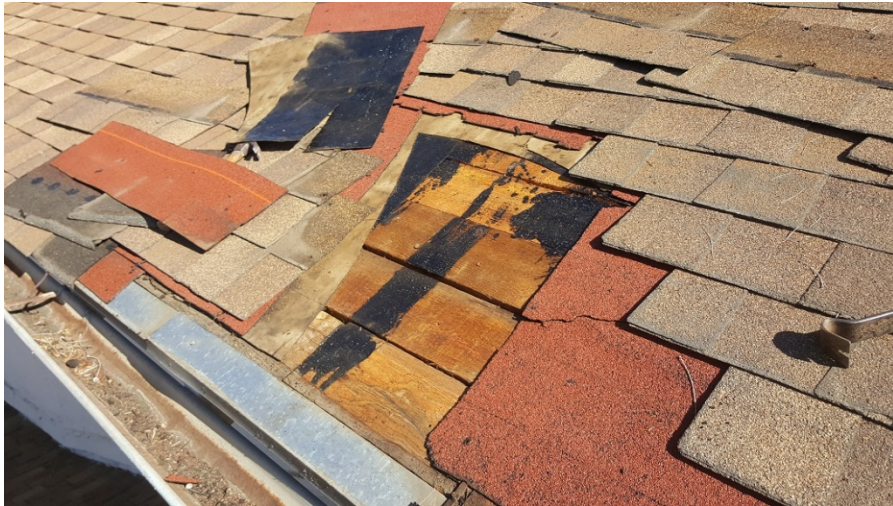
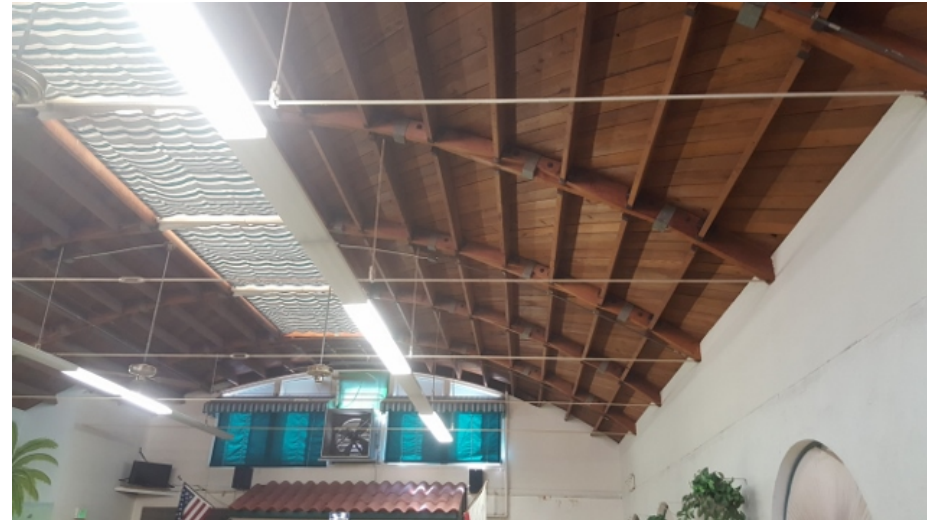
The roof sheathing is diagonal 1x8 sheathing over the 2x6 tongue and groove sheathing that is visible from below. This sheathing is not adequate for the seismic loads generated by the heavy concrete walls.
