Agenda Item E.2
DISCUSSION/ACTION ITEM
Meeting Date: May 2, 2017

SUBJECT: Goleta Community Center Special Studies Update

HAZARDOUS MATERIALS SURVEY REPORT

5679, 5681, & 5689 HOLLISTER AVENUE
GOLETA, CALIFORNIA 93117

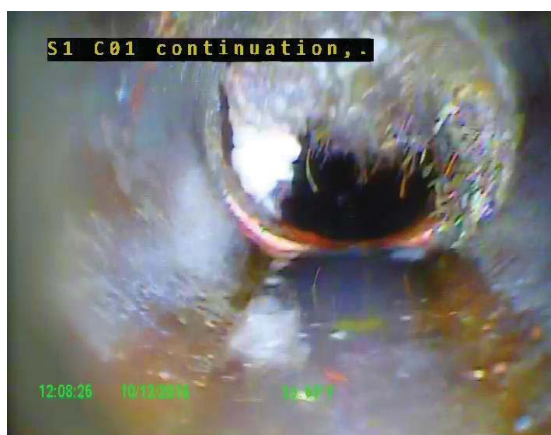
Root intrusion at 39.80 ft.

Recommendation: Replace several pipes and clean-outs throughout the onsite sewer collection system.

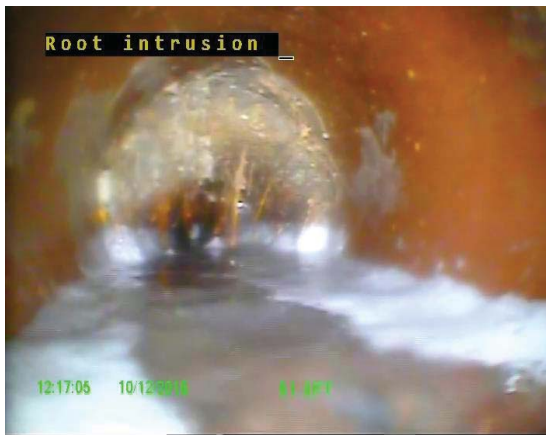
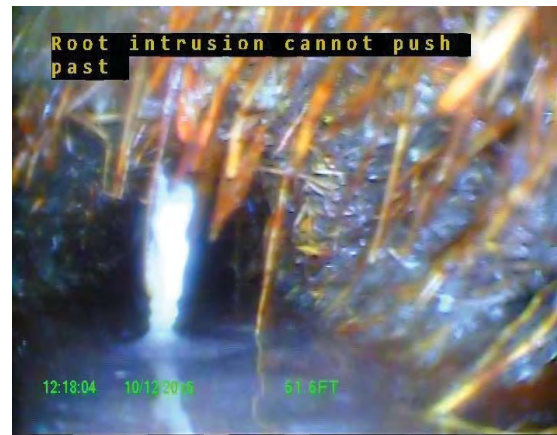
Unable to push past 50.40 ft. due to blockage with debris. Heavy root intrusion at 51.30 ft.

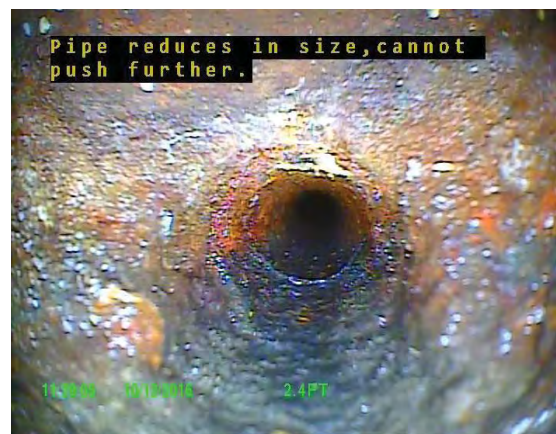
Line reduces in size unable to push further past 2.40 ft.

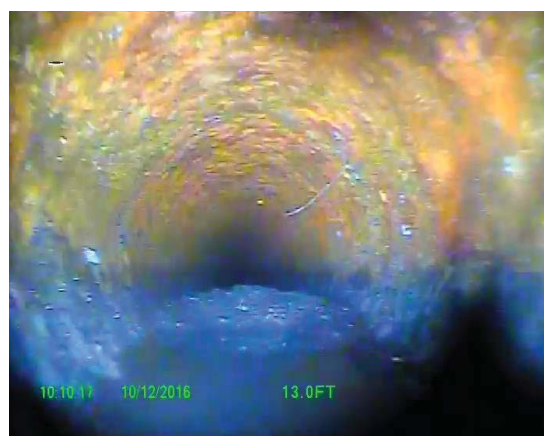
Debris at 13.00 at bottom of line.

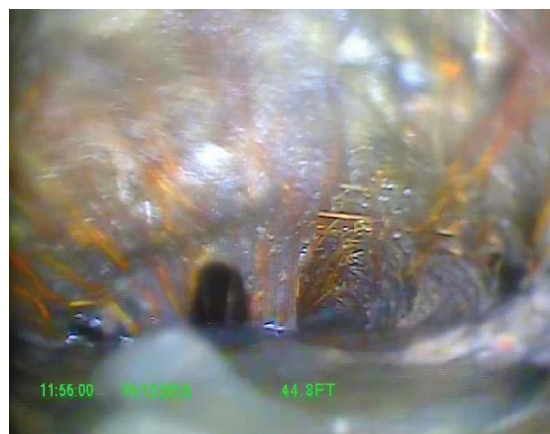
Debris at bottom of line at 38.30 ft.

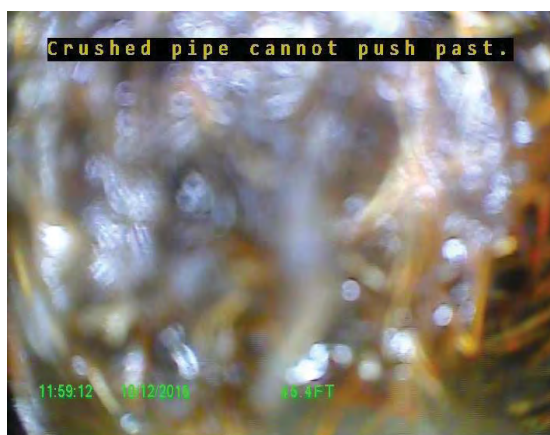
Unable to push past 45.40 ft.

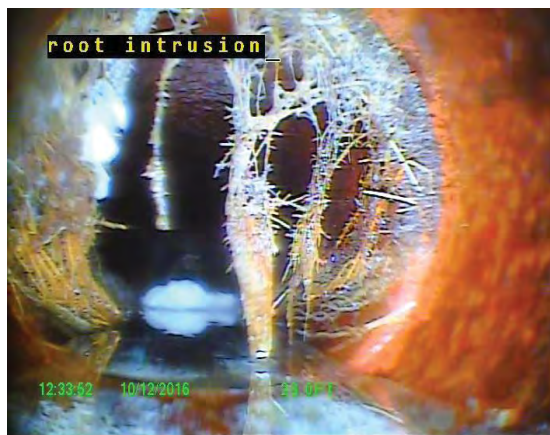
Root intrusion at 23.00 ft.

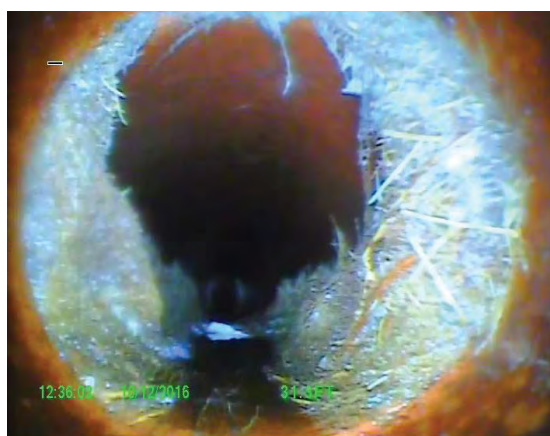
Root intrusion at 31.30 ft.

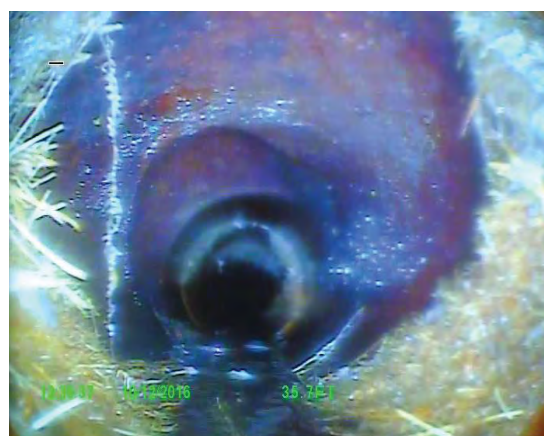
Root intrusion at 35.70 ft.

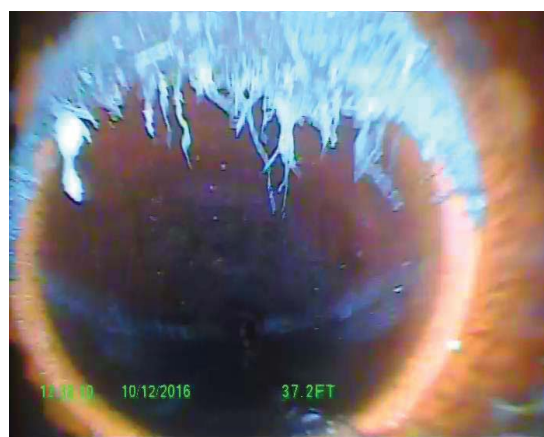
Root intrusion at 37.20 ft.

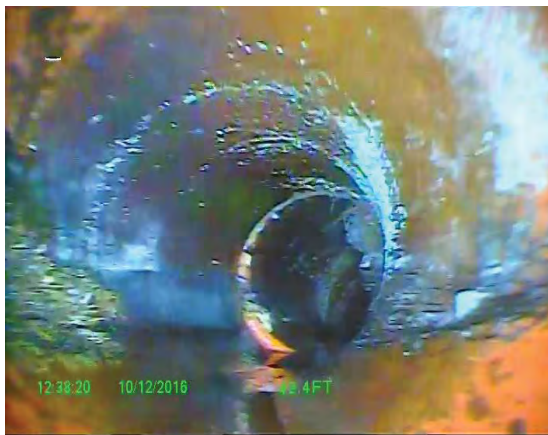
Line turns right at 42.40 ft. with root intrusion.

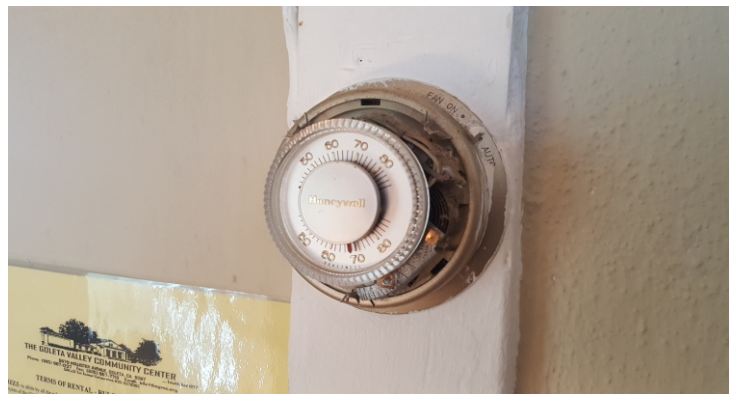
8. View of the mercury thermostats.

Recommendation: The identified hazardous materials should be properly removed and segregated prior to renovation/demolition activities. Proper packaging and disposal should be conducted in compliance with federal, state, and local regulations.

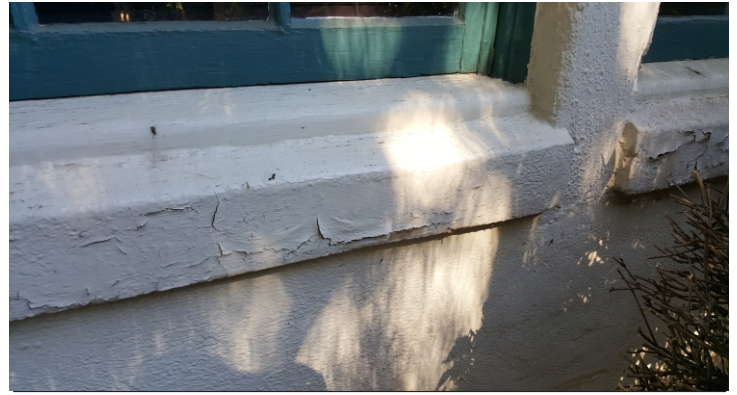
Most of the LBP was found to be intact; however, a few samples were classified as poor (courtyard window sill) or fair (exterior windows). Additional LBP was found on exterior walls and doors overhangs and windows of the Headstart building. All of these areas were deemed intact. LBP was also found in the Rainbow School building (Building Three) on exterior overhangs and on the walls of two of the restrooms. These areas were also deemed to be intact.

10. View of the concrete window sills.

Recommendation: Surfaces deemed to be poor are considered to be a hazard and should be corrected. Fair surfaces should be repaired, but are not yet considered to be a hazard. If not repaired, they should be monitored frequently. Intact surfaces should be managed under an Operations and Maintenance Plan which includes periodic inspections for condition changes in the paint

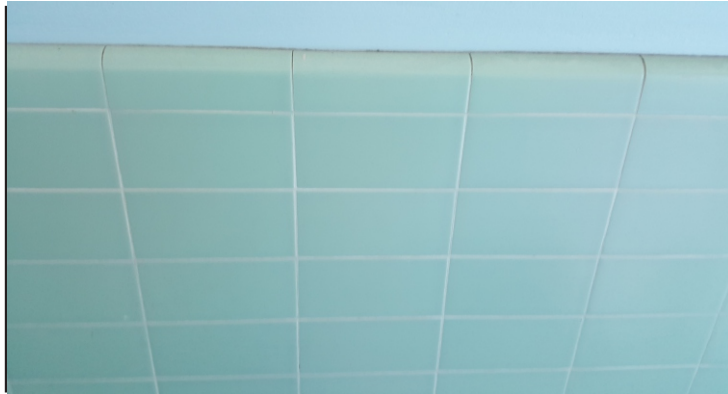
11. View of the lead containing ceramic tiles.

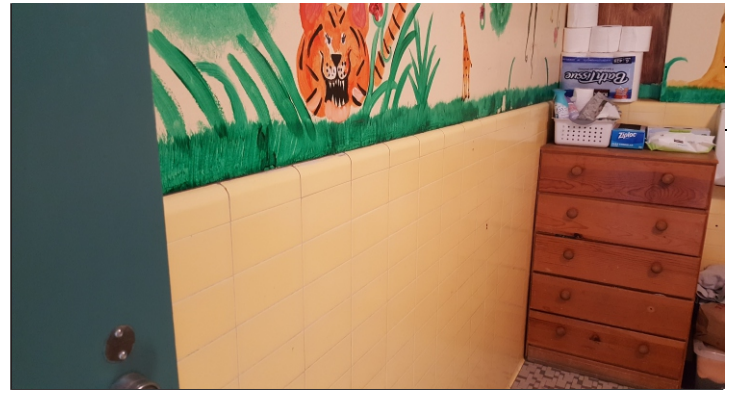
12. View of the lead containing ceramic tiles.
