PROPERTY CONDITION REPORT

Goleta Community Center
5679, 5681 & 5689 Hollister Avenue
Goleta, California 93117

December 30, 2016
Partner Project Number: 16-170535.1

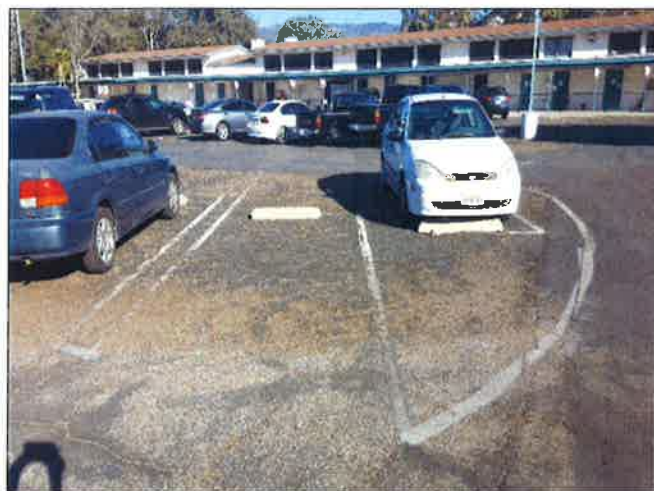
20. South parking deterioration

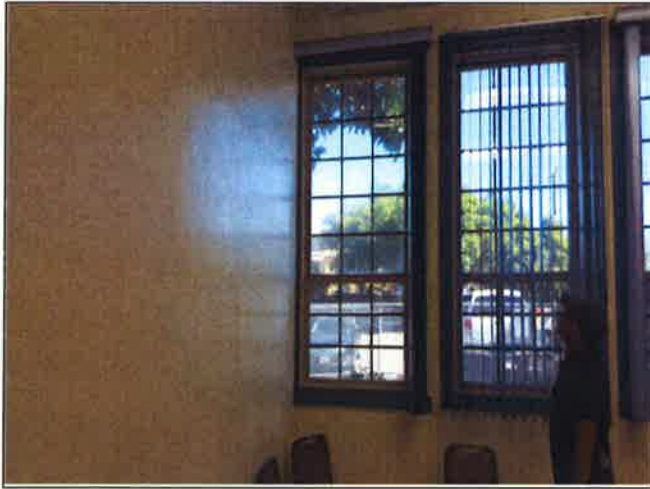
91. Residential-grade windows with failed jamb opening system at Community Center

5.3	Repair inoperable windows mechanisms at east classrooms of the Community Center building	1	LS	\$5,000	\$5,000		\$ 5,000
MECHANICAL AND ELECTRICAL SYSTEMS

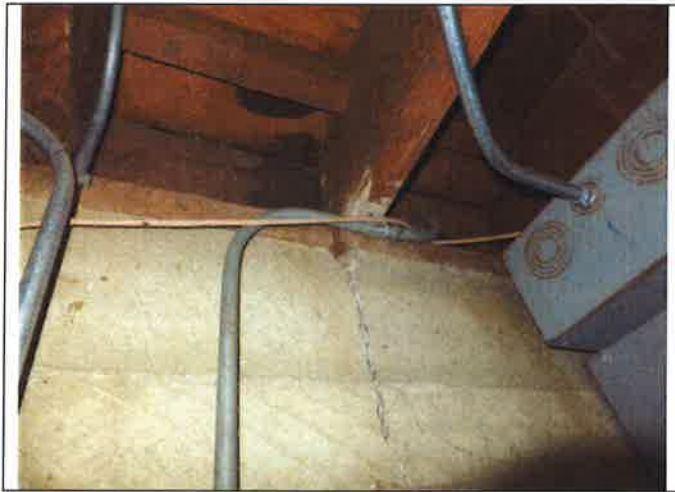
9. Basement wall foundation and sill plate with vertical split is widest at the top and narrower at the floor

4.0	Repair crack in the basement foundation wall of the Community Center Building with epoxy injection	1	LS	\$2,000	\$2,000		\$ 2,000
4.0	Clear soil away from pier footings in crawl space of the Community Center Building	1	LS	\$1,000	\$1,000		\$ 1,000
EXTERIOR ENVELOPE

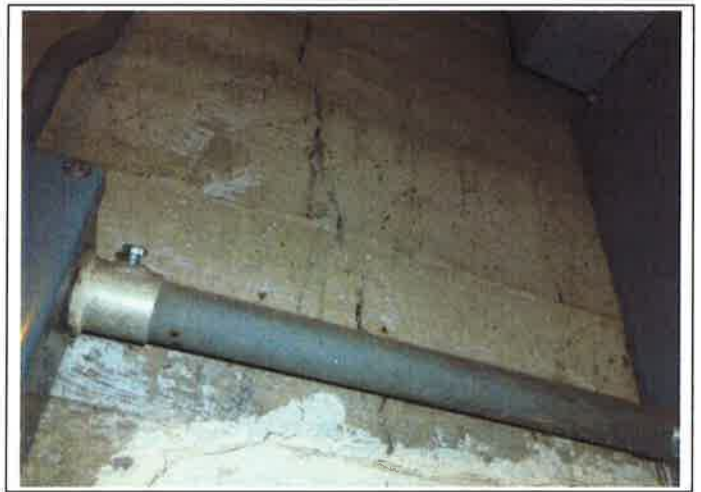
10. Vertical crack in basement foundation wall, Main Building A

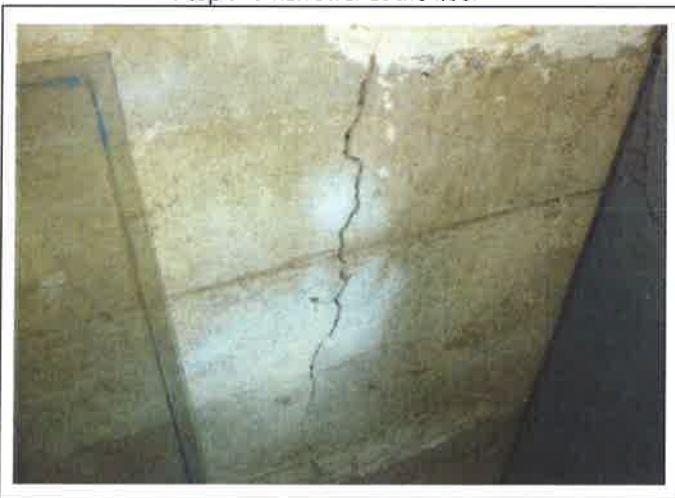
11. Vertical crack in basement foundation wall, Main Building A

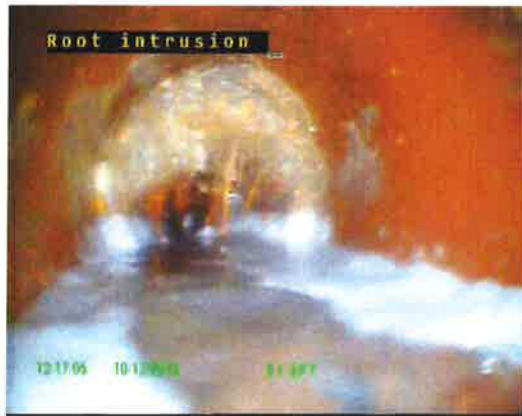
Unable to push past 50.40 ft. due to blockage with debris. Heavy root intrusion at 51.30 ft.

6.2	Replace sewer line between the Community Center office restroom cleanout and the men's restroom. Cost includes further investigation and possible pump station	1	LS	\$30,000	\$30,000		\$ 30,000
INTERIOR ELEMENTS AND FINISHES

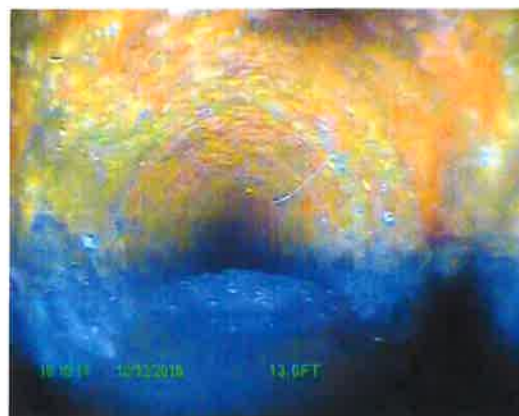
Debris at 13.00 at bottom of line.

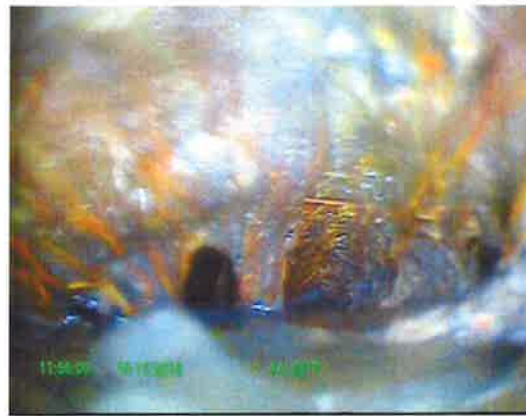
Debris at bottom of line at 38.30 ft.

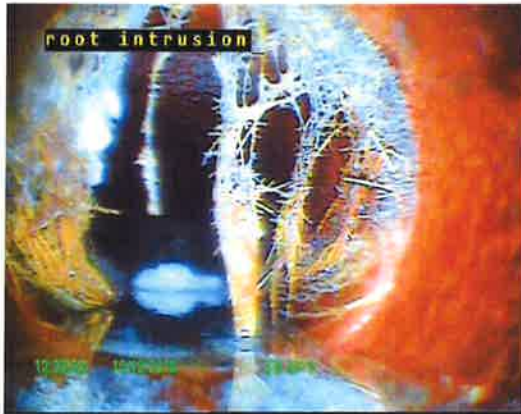
Root intrusion at 23.00 ft.

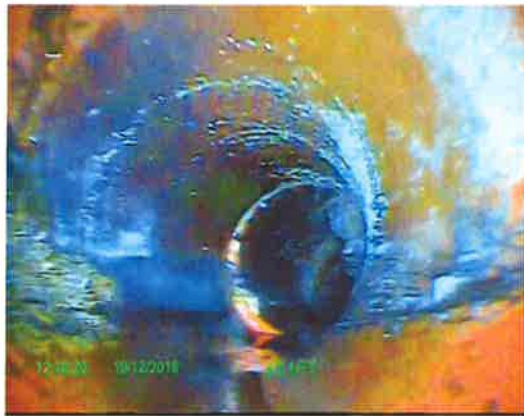
Line turns right at 42.40 ft. with root intrusion.
