# POTENTIAL IMPACT STUDY

## GOLETA COMMUNITY CENTER GOLETA, CALIFORNIA [16128]

PREPARED FOR:  
City of Goleta  
Neighborhood Services and Public Safety Department  
130 Cremona Drive, Suite B  
Goleta, CA 93117

FEBRUARY 2017

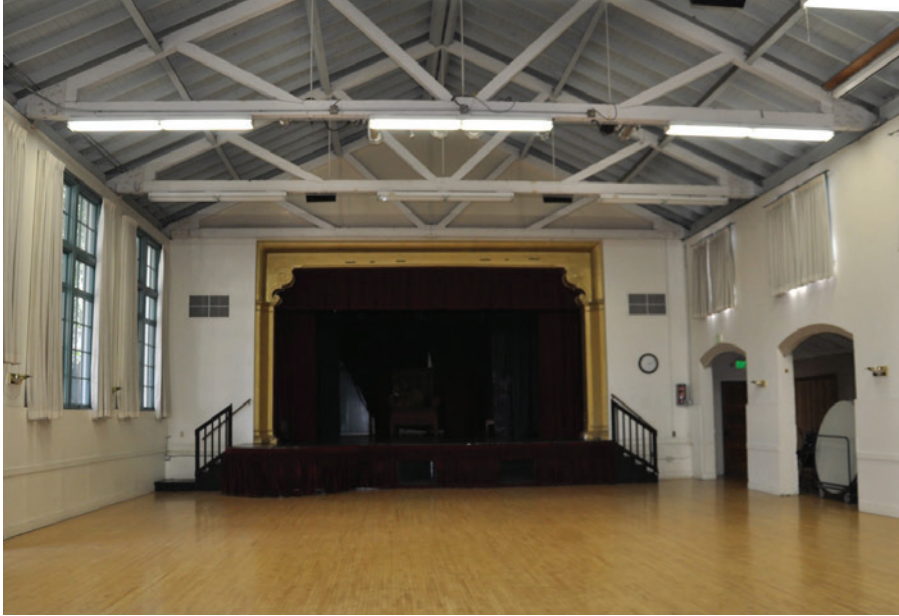
Figure 11. Auditorium, looking south. Note exposed ceiling and trusses and decorative stage surround.

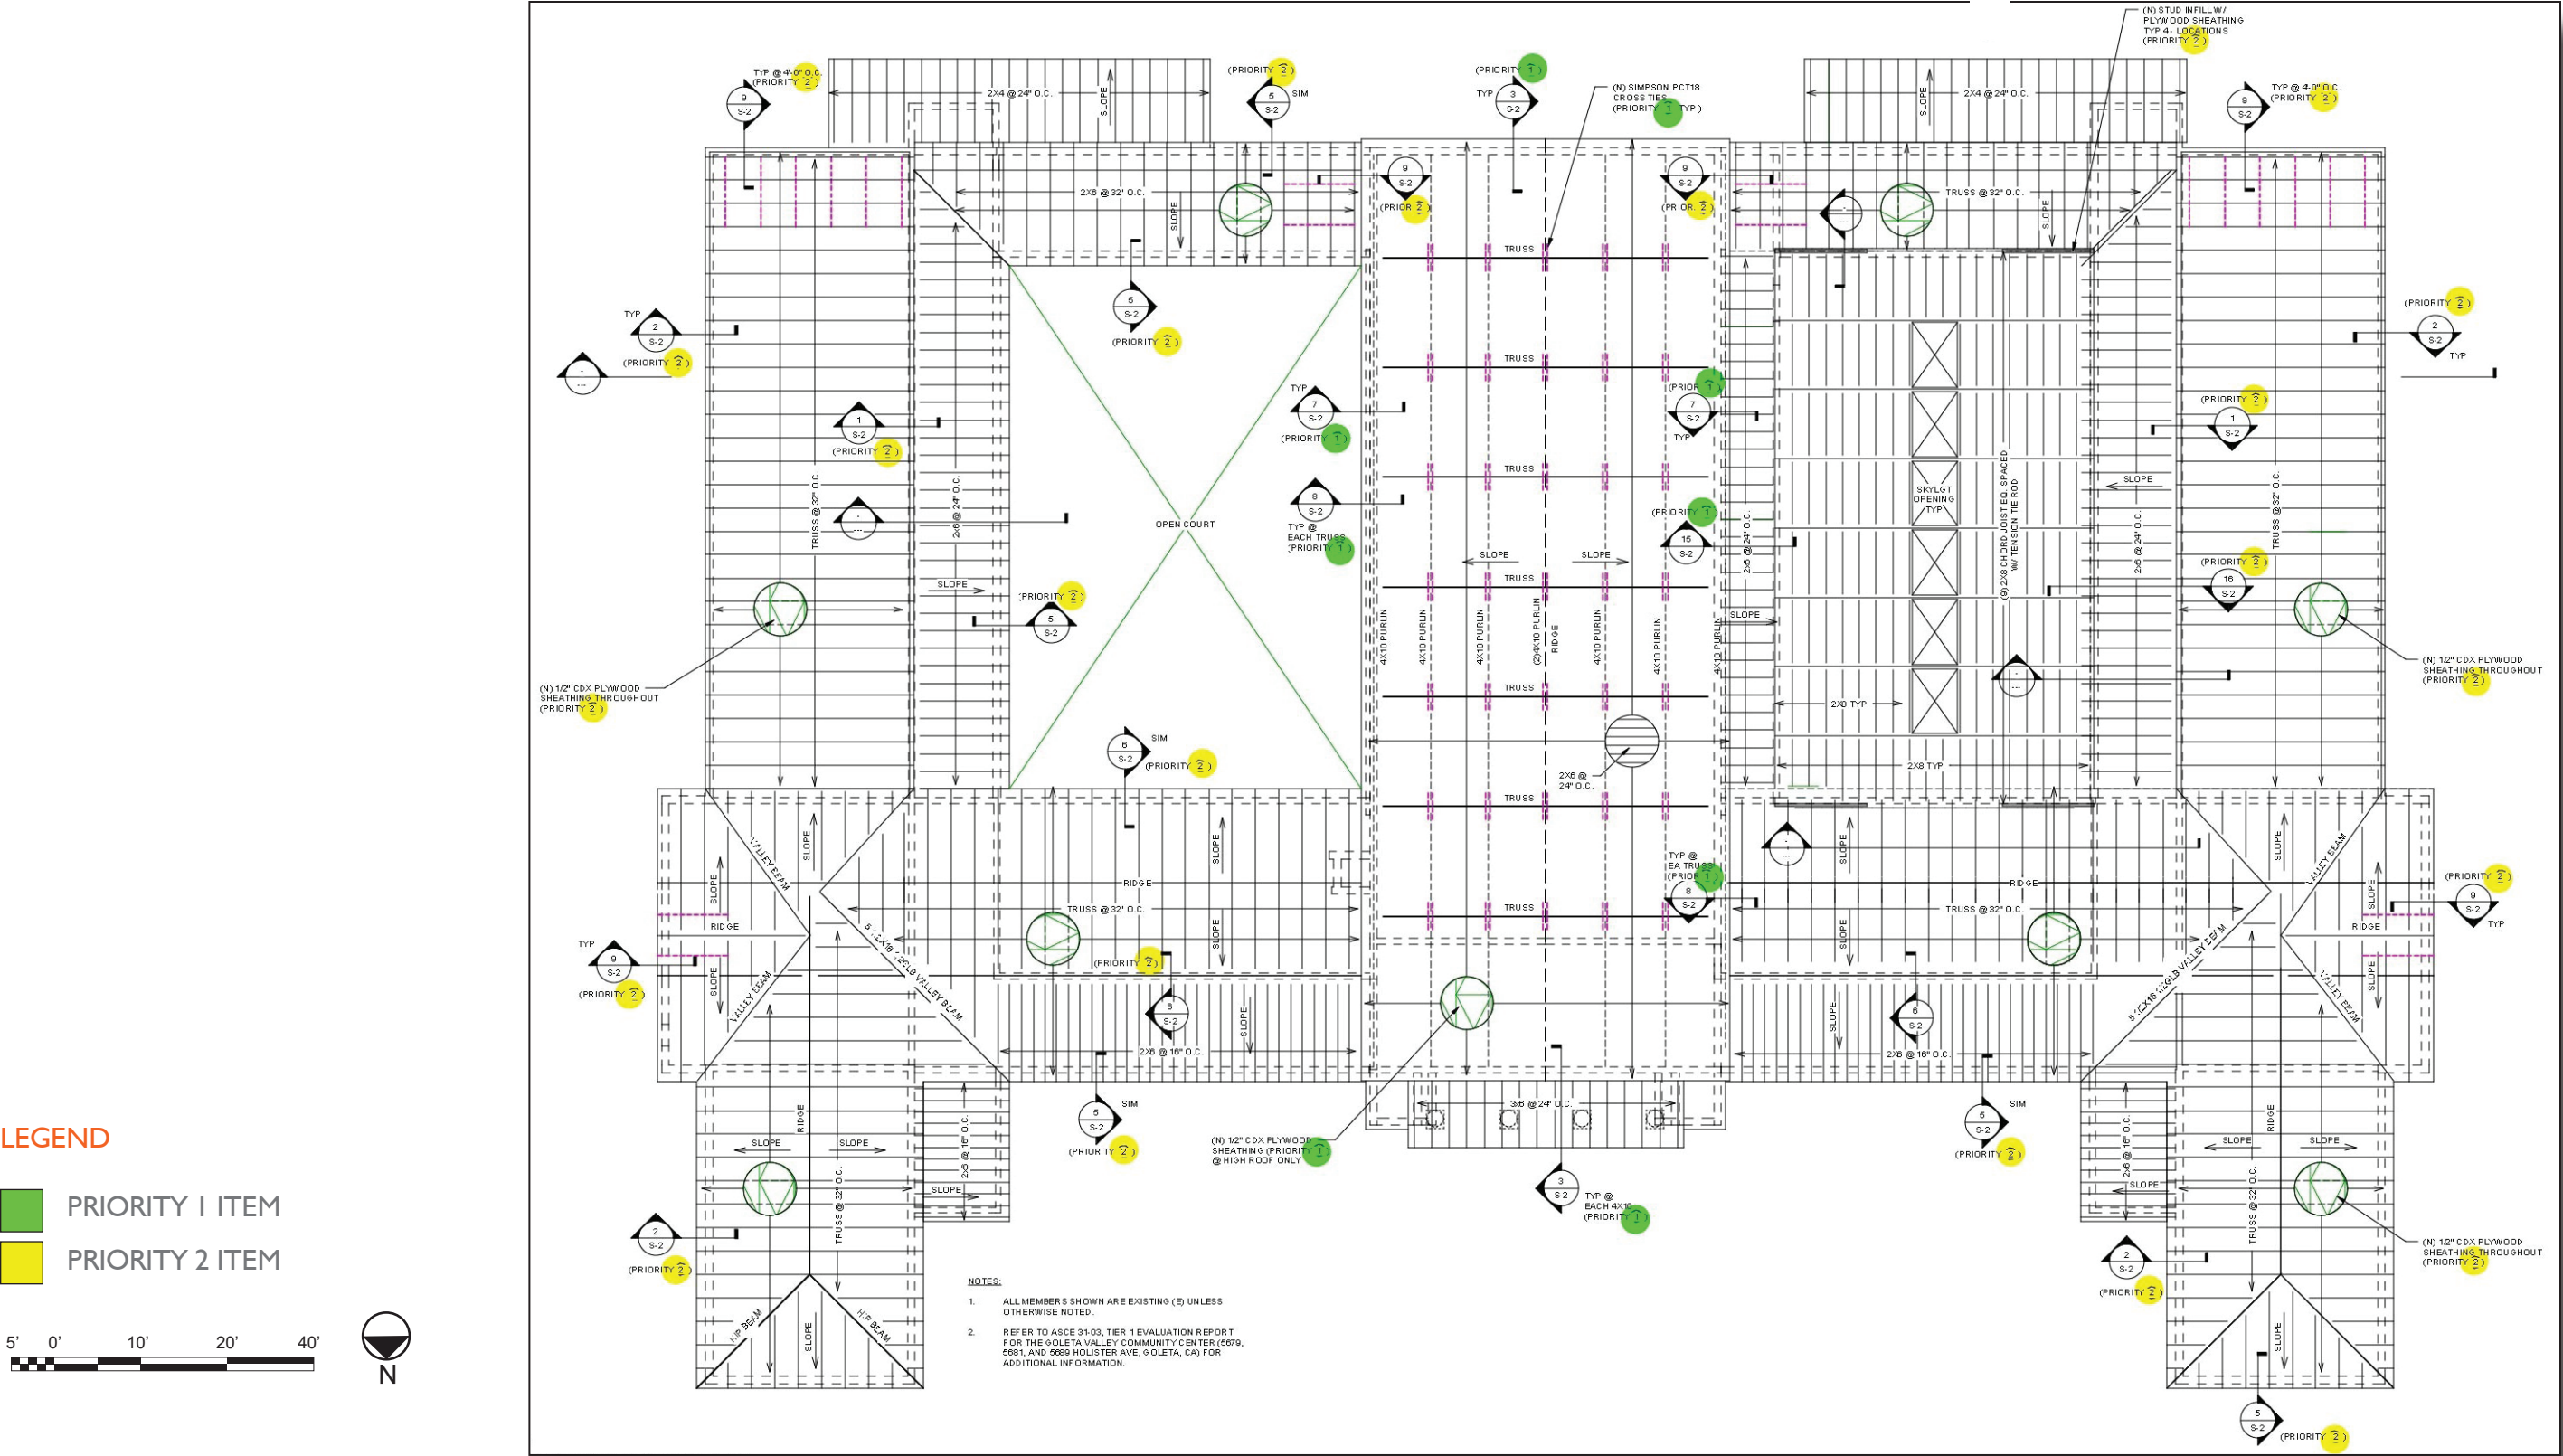
In April 2013, Crosby Group completed an ASCE 31-03 Tier 1 Seismic Evaluation. The Crosby Group report identified components that currently do not comply with ASCE 31-03 and categorized the deficiencies by priority (Figure 14). Priority 1 items are considered to be of greatest risk to life-safety and are limited to deficiencies in the Auditorium, including inadequate truss-to-wall connections; non-compliant roof diaphragms; and inadequate connection of roof diaphragms to walls. Priority 2 items include strengthening roof diaphragms at the remainder of the building and improving the connection between diaphragms and walls throughout the Main Building; these items are ad-

Figure 14. Seismic Assessment for Building A, Adapted from Crosby Group, ASCE 31-03 Tier 1 Evaluation Report, Goleta Valley Community Center, report (2013).

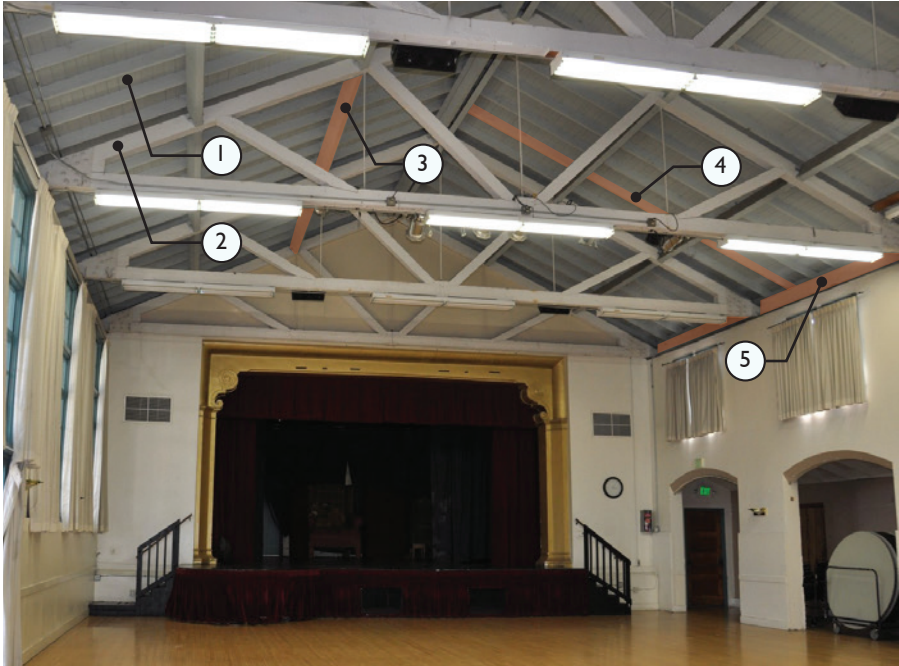
Figure 15. Auditorium, annotated with key framing elements.

- ① Exposed 2x6 Wood Tongue and Groove Sheathing
- ② 6x8 Truss Member, Typical
- ③ 4x10 Purlins, Typical
- ④ 2x6 Rafters, Typical
- ⑤ 4x beam on 2x sill at East and West Walls

- The new plywood should be added from the top or roof side to keep the Auditorium’s exposed ceiling visible. The plywood proposed is typically 1/2 inch thick and should not impact the visual quality of the gable roof form, exterior eaves or exposed wood rafters.
- Nailing of new plywood sheathing from the top should consider the spacing of existing structural members and engage the existing 2 inch x 6 inch rafters below.
- Coordinate the roof diaphragm with roof edge details, like drip edges and gutters, to minimize the thickness of the roof edge.

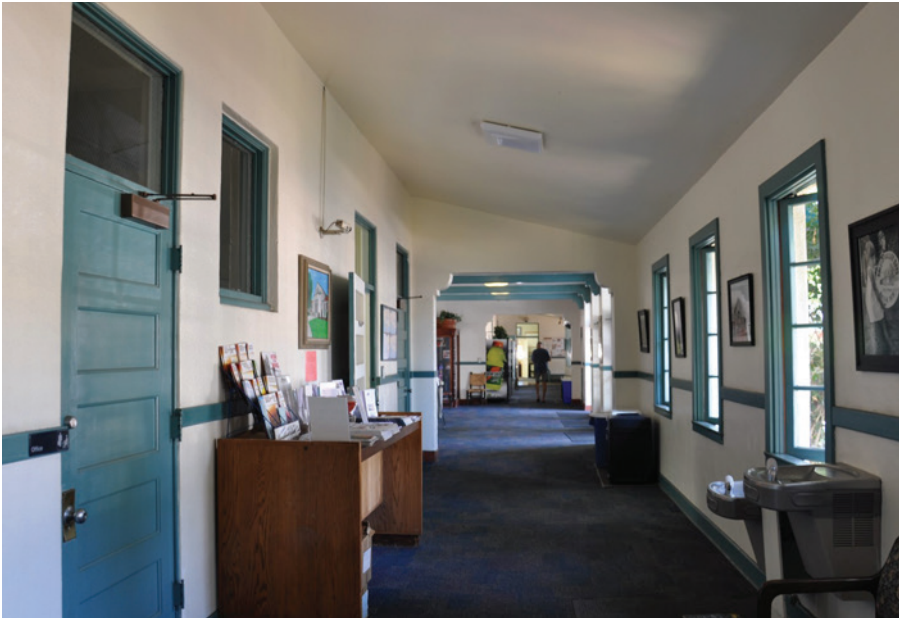
Figure 16. Wood paneled doors and corridors are character-defining features that can be adapted with ADA-compliant hardware.

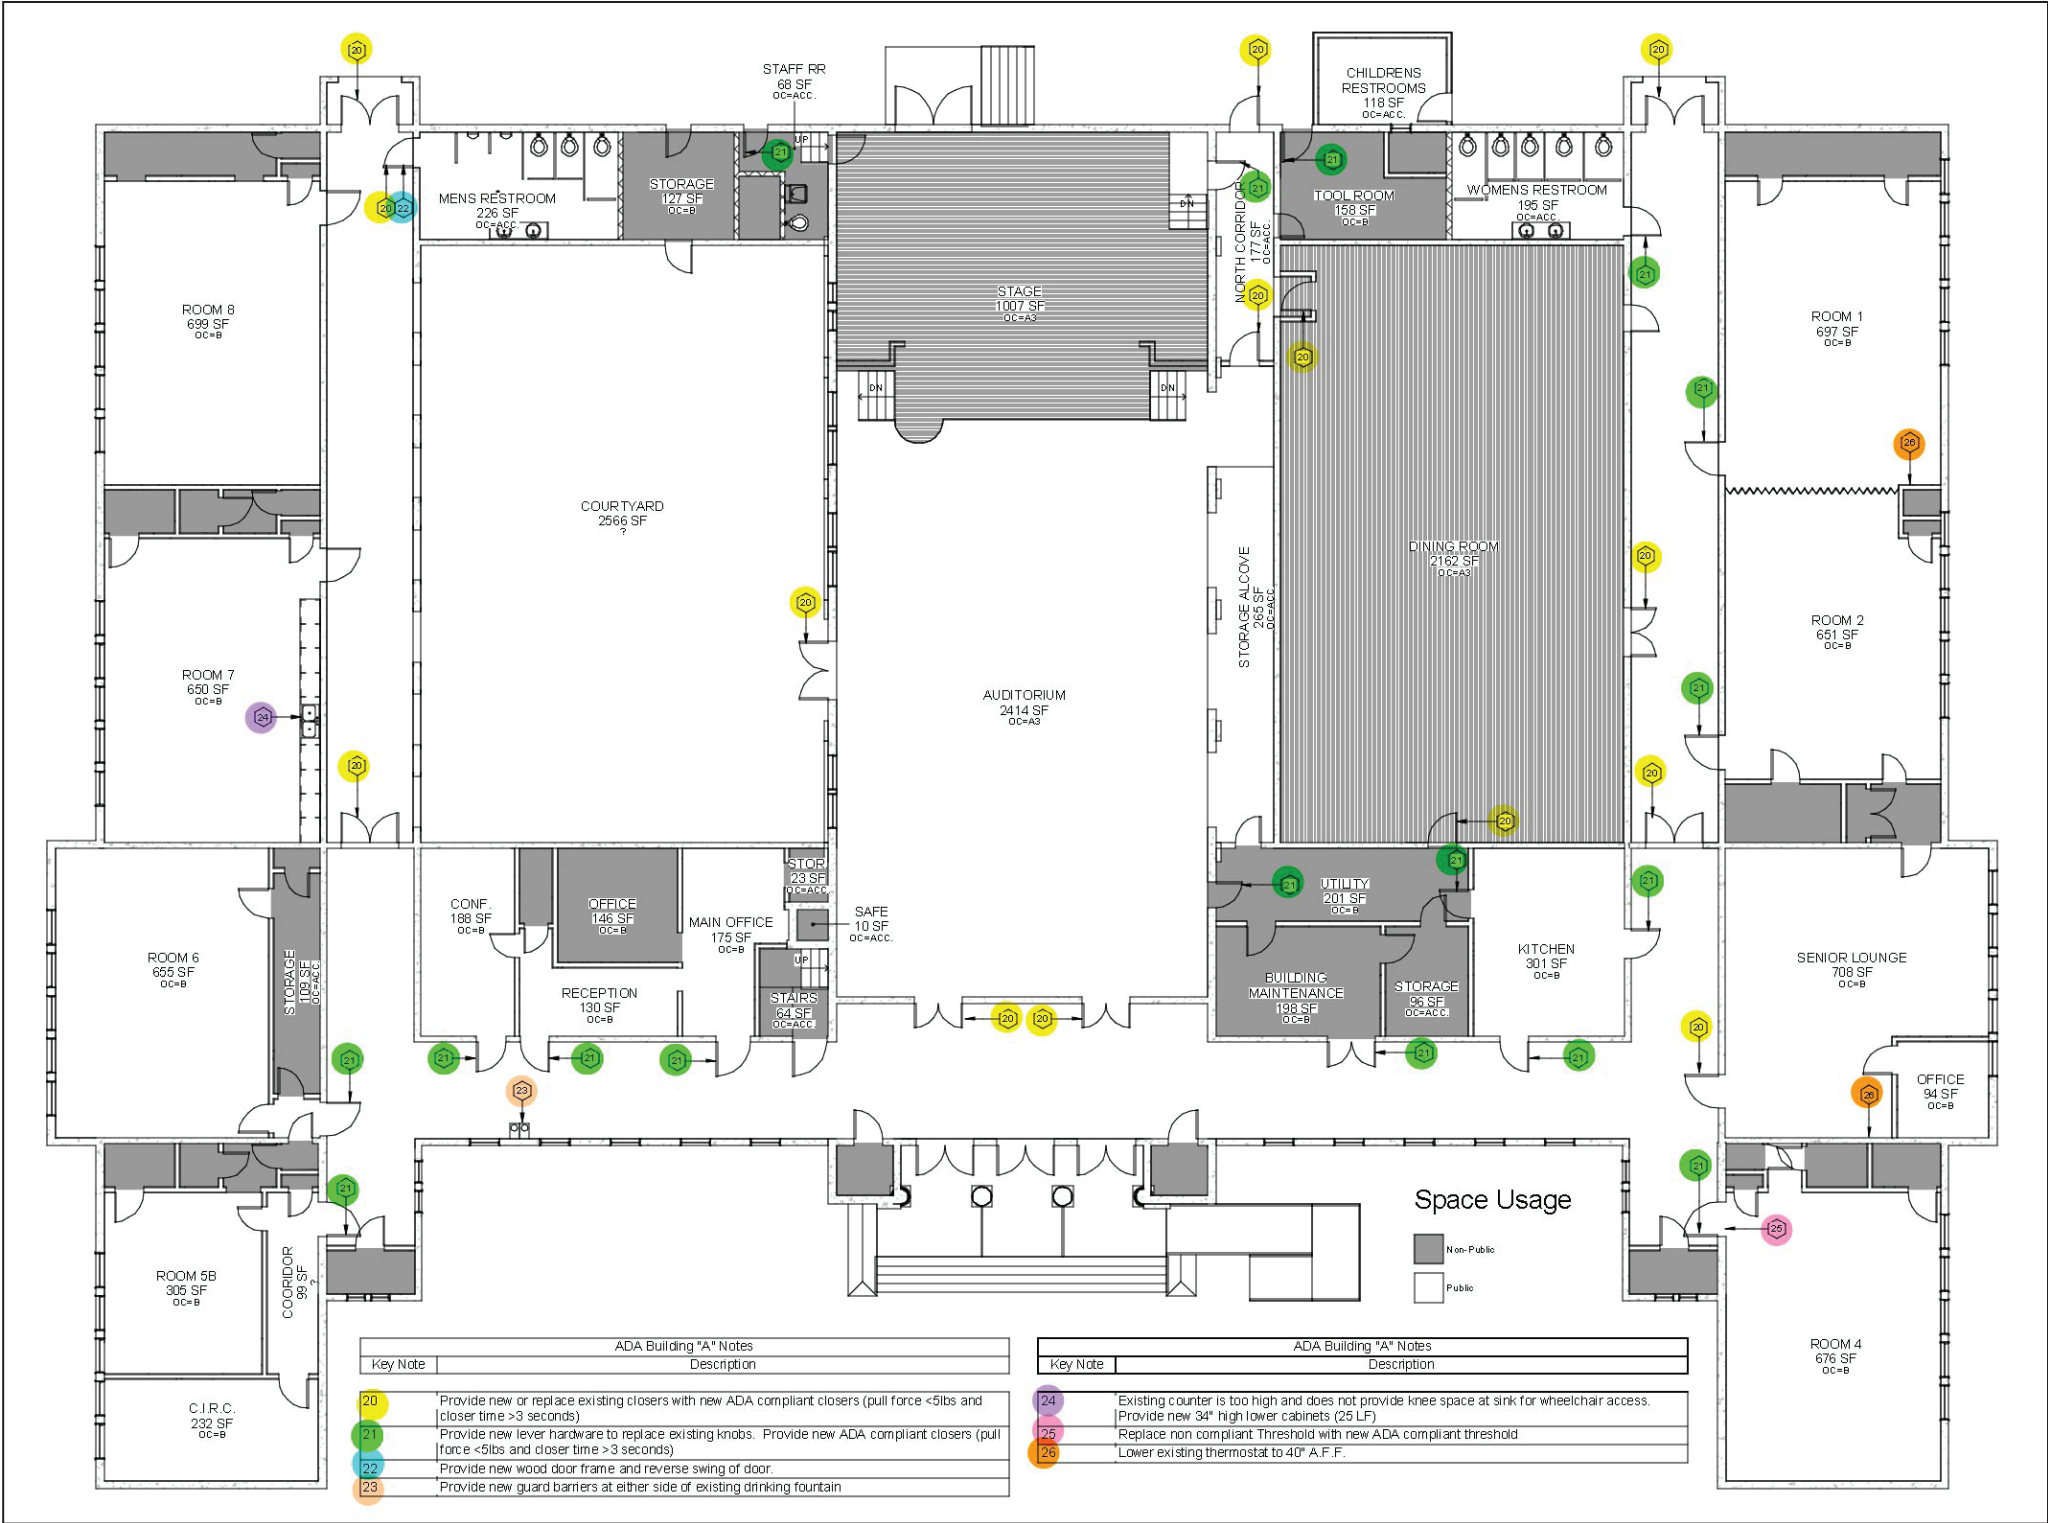
- 20: PROVIDE NEW DOOR CLOSER
- 21: NEW DOOR LEVER HARDWARE
- 22: NEW DOOR FRAME AND REVERSE SWING
- 23: PROVIDE GUARDS AT DRINKING FOUNTAIN
- 24: PROVIDE ADA-COMPLIANT COUNTER
- 25: PROVIDE NEW THRESHOLD
- 36: LOWER THERMOSTAT BOX

Figure 17. Accessibility Assessment for Building A, Adapted from Crosby Group, *Accessibility Assessment, Goleta Valley Community Center & The United Boys & Girls Club of Goleta*, report (2013).

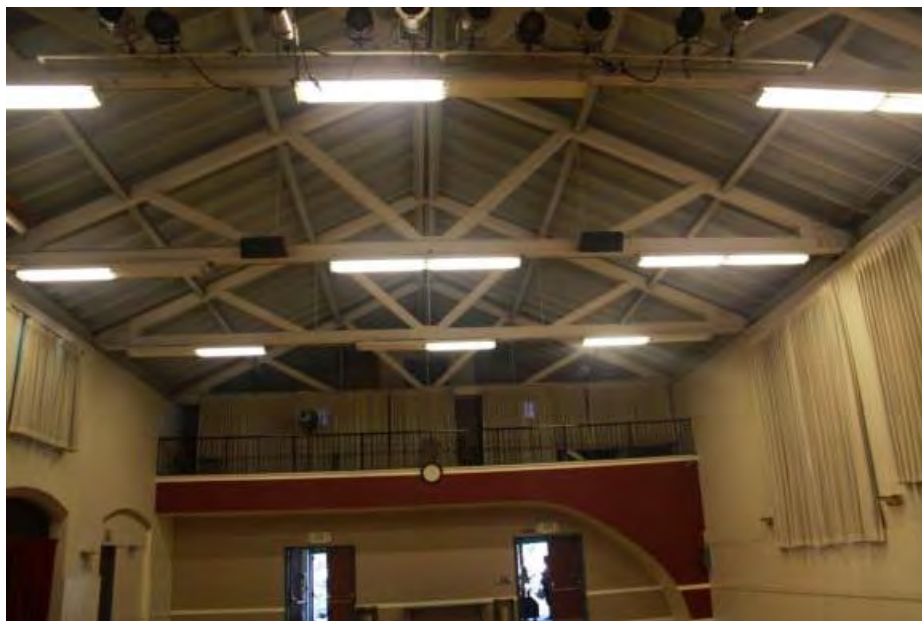
Figure 3 – Building A, Main Auditorium, Roof Truss

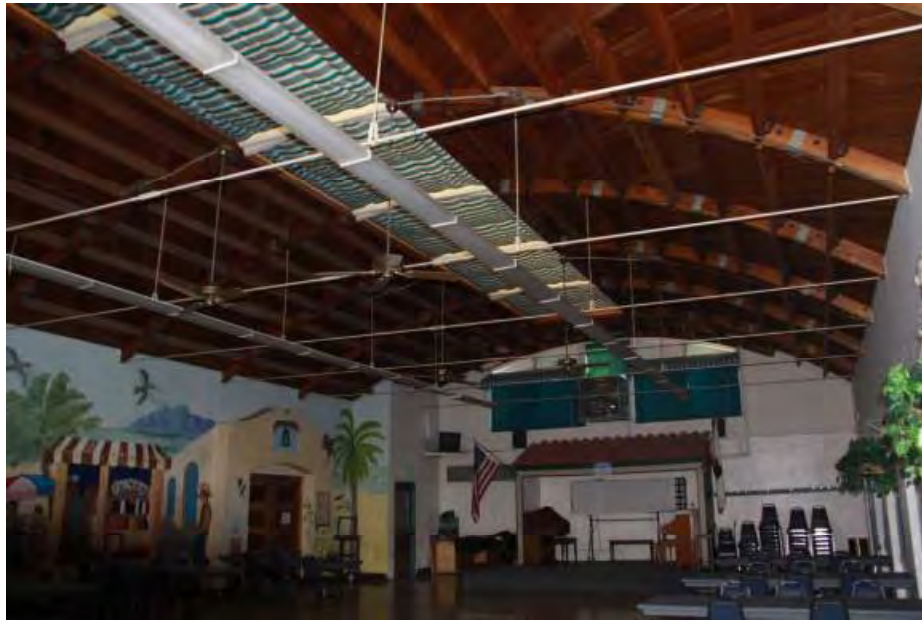
- The barrel vault roof and its cripple walls are not original to the building. They may have been constructed circa 1946, when the HRE Part 1 identified a roof to enclose the original patio. It is not considered a character-defining feature, so further discussion of the barrel-vault and cripple walls have been excluded from our analysis. If the City chooses to retain and repair the barrel-vault roof, the repairs should seek to minimize impacts to the Main Building’s concrete walls.

Figure 4 – Building A, Barrel Vaulted Roof Addition

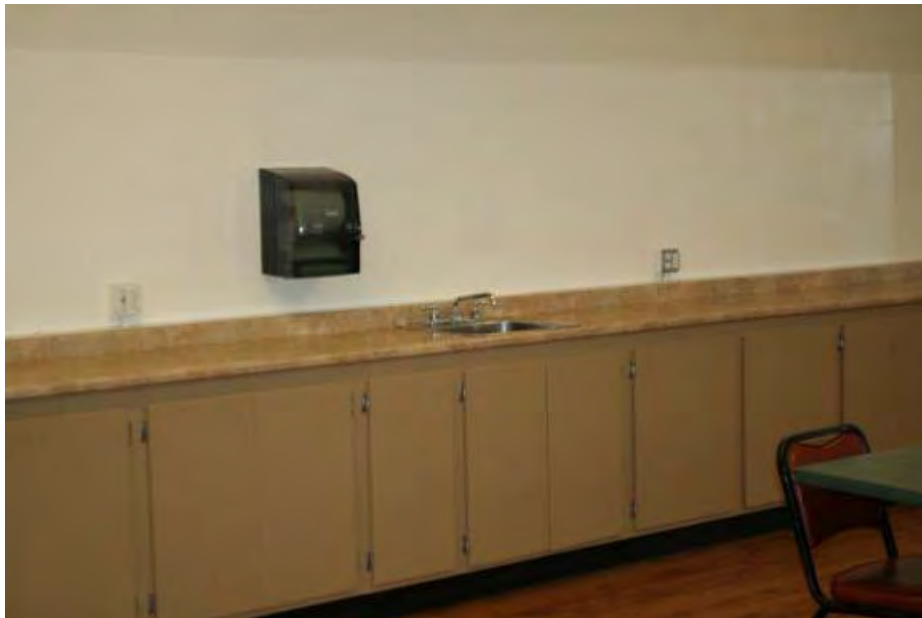
Figure 8 – Building A, non-compliant cabinet and sink
