# What's in the Report

# Results – Property Condition Report

5679 Hollister Avenue Goleta, Ca

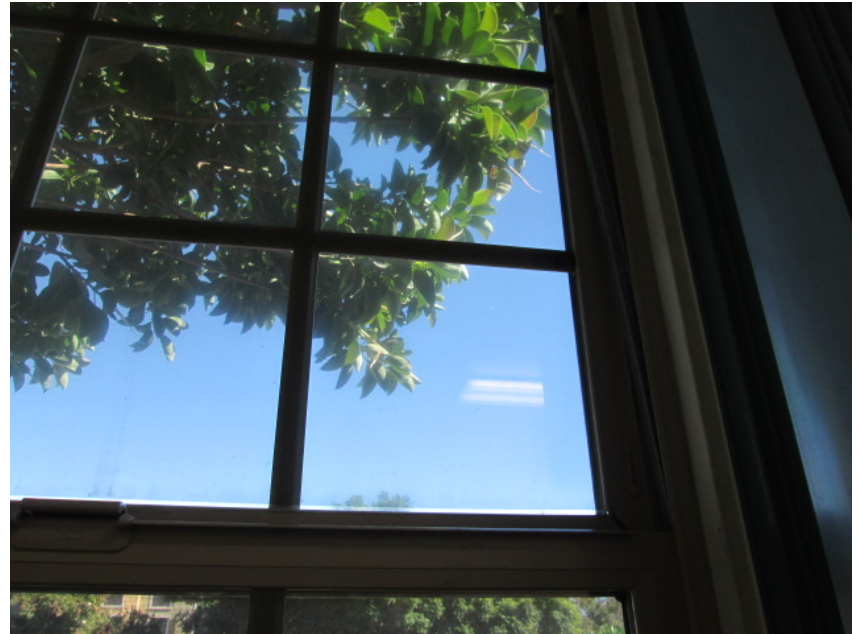
Residential-grade windows with failed jamb opening system at Community Center

5.3	Repair inoperable windows mechanisms at east classrooms of the Community Center building	1	LS	\$5,000	\$5,000		\$ 5,000
-----	------------------------------------------------------------------------------------------	---	----	---------	---------	--	----------

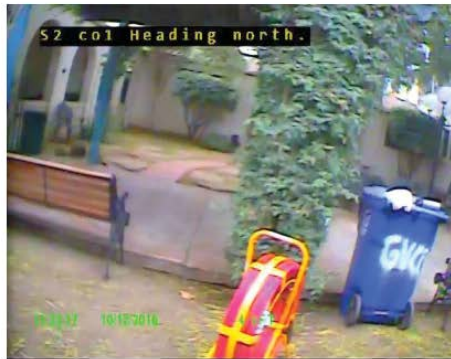
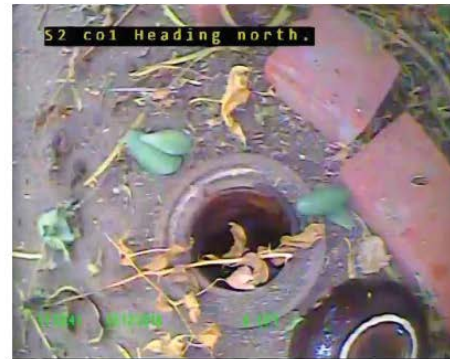
No.	Utility	Material	Total Video Length (ft)	Pipe Size (in) <sup>2</sup>	Line Condition
S2 CO1 North	Sewer	Steel	2.40	4	"Y" intersection at 2.10 ft. Line reduces in size unable to push further past 2.40 ft.

6.2	Replace sewer line between the Community Center office restroom cleanout and the men's restroom. Cost includes further investigation and possible pump station	1	LS	\$30,000	\$30,000	\$ 30,000
-----	----------------------------------------------------------------------------------------------------------------------------------------------------------------	---	----	----------	----------	-----------

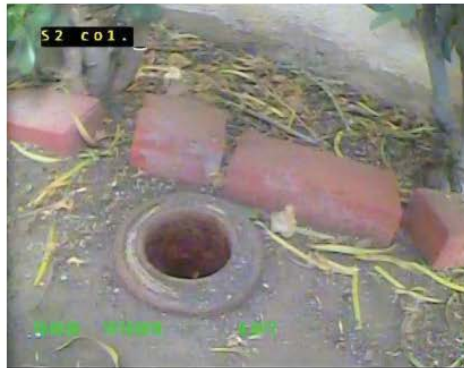
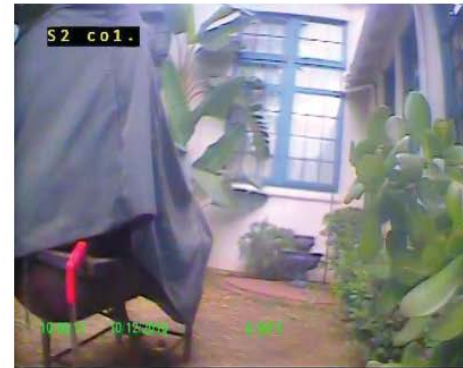
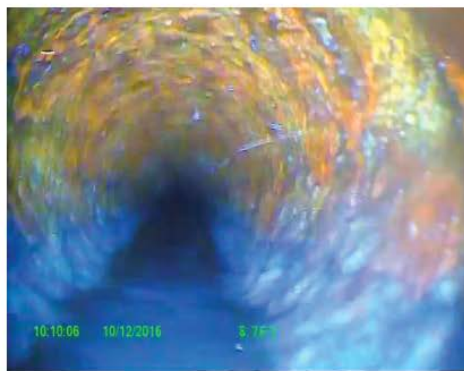
No.	Utility	Material	Total Video Length (ft)	Pipe Size (in) <sup>2</sup>	Line Condition
S2 CO1 South	Sewer	Steel	60.40	4	Debris at 13.00 at bottom of line. Camera under water at 40.50 ft. unable to investigate line condition. Unable to push past 60.40 ft. due to debris blockage.

Typical clear line condition

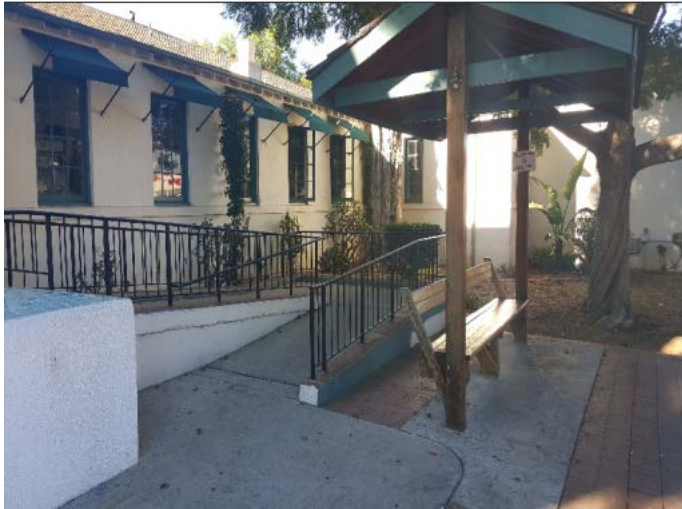
Loading area and ramp access to building.

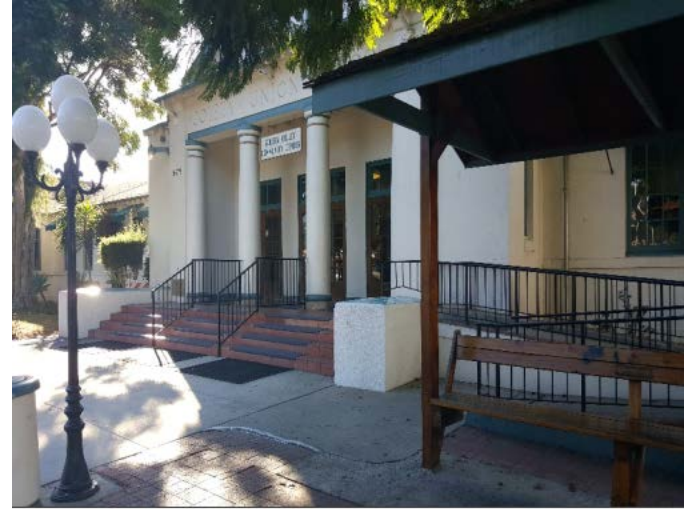
Stairs at main entrance area.

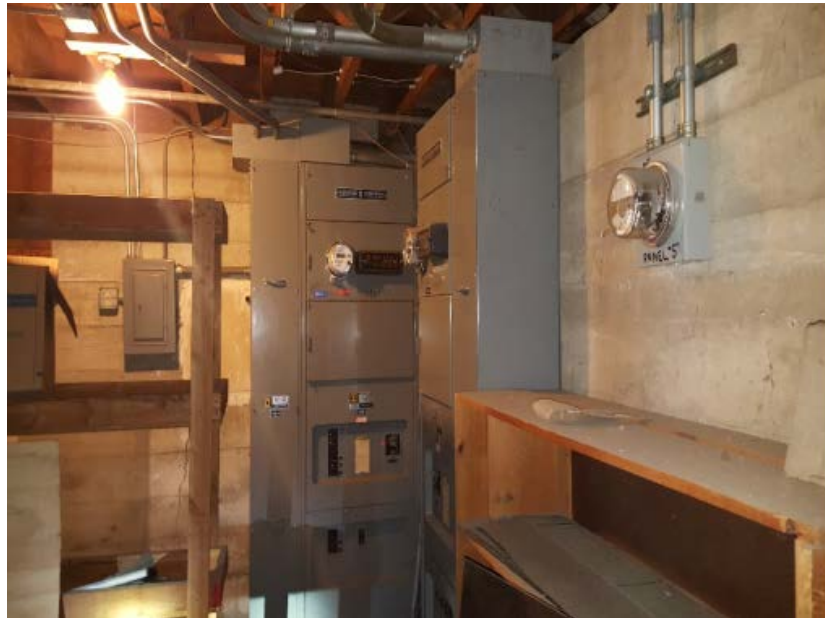
Electrical services at basement.

Description	AVG	EFF	RUL	QTY	UNIT	UNIT COST
	EUL (YR)	AGE (YR)				
Infrared testing of the electrical service	5	1	4	1	EA	\$1,200

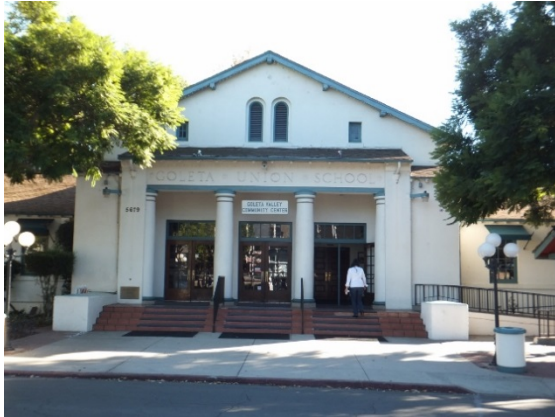
Community Center Exterior.

Description	AVG EUL (YR)	EFF AGE (YR)	RUL (YR)	QTY	UNIT	UNIT COST	YR 1	YR 2	YR 3	YR 4	YR 5	YR 6	YR 7	YR 8	YR 9	YR 10	Total Cost
Exterior cleaning, painting, sealing (includes refinishing windows, removing and replacing sealants, painting building and site metals, painting soffits, painting walkways)	7	5	2	47,000	SF	\$1.25		\$ 58,750							\$ 58,750		\$ 117,500
																	\$ -

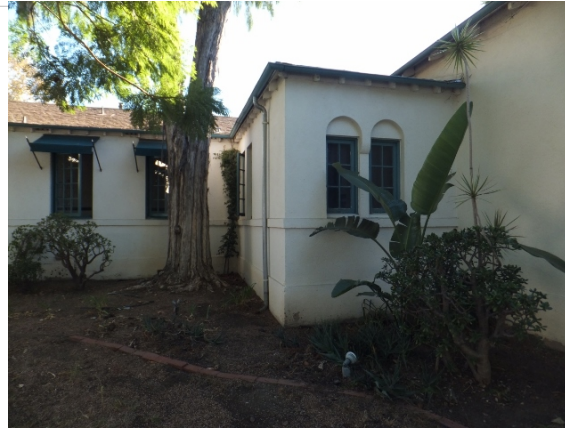
General Condition of Community Center Exteriors.

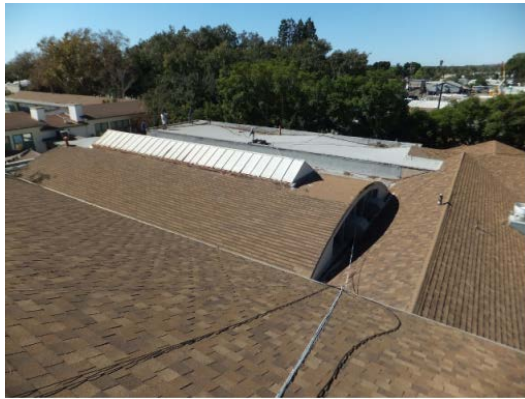
L: Roof over Auditorium, Assembly Room, kitchen and west classroom wing, Main Building  
R: mi-flat roof over east wing classrooms and open hallway

Description	AVG EFF			QTY	UNIT	UNIT COST	YR 1	YR 2	YR 3	YR 4	YR 5	YR 6	YR 7	YR 8	YR 9	YR 10	Total Cost
	EUL (YR)	AGE (YR)	RUL (YR)														
Roof replacement - Asphalt shingles, includes repairs or replacement of gutters and downspouts	20	17	3	36,700	SF	\$3.00			\$ 110,100								\$ 110,100
Roof replacement - BUR, includes repairs or replacement of scuppers, roof drains and downspouts	20	18	2	12,000	SF	\$6.50	\$ 78,000										\$ 78,000

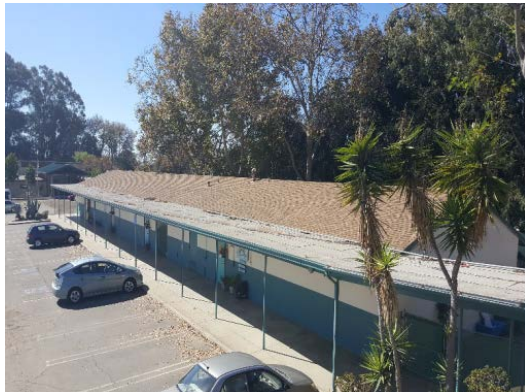
L: Building C4 Roof Overview  
R: Roof Drains

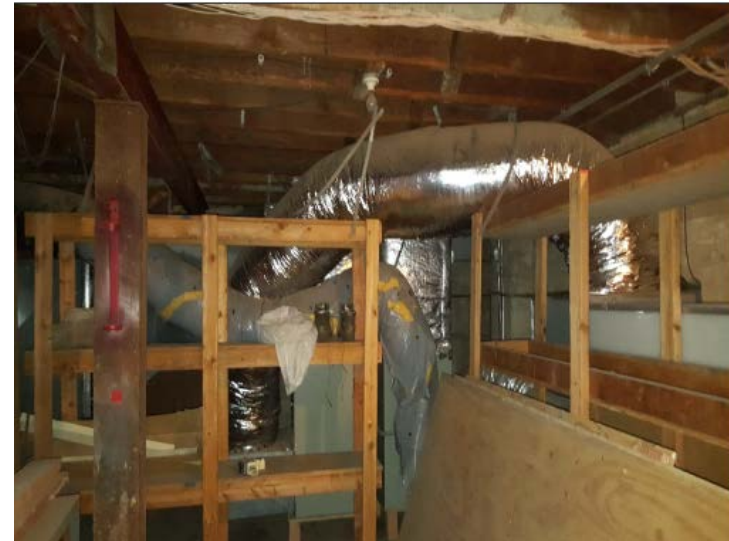
Community Center furnace at basement.

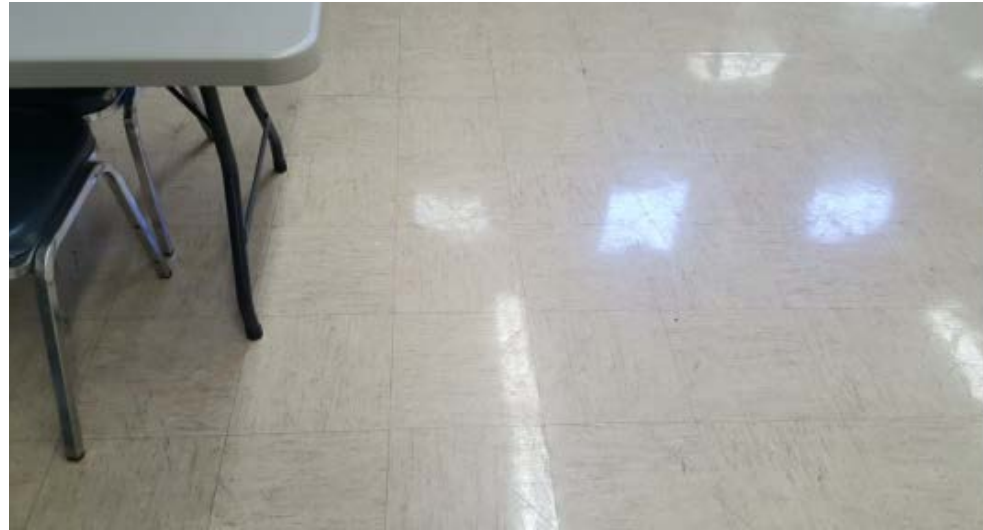
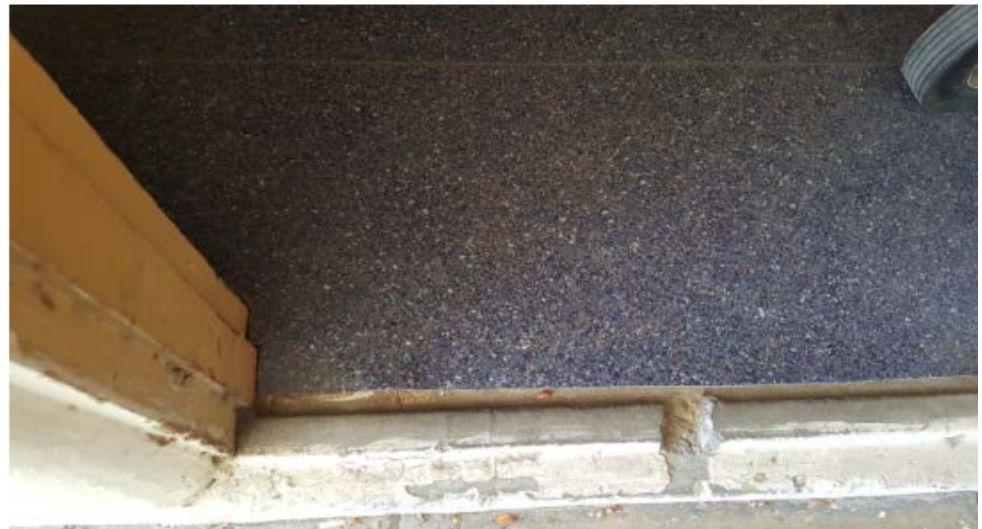
# Friable Regulated Asbestos-Containing Materials (RACM)

The following materials were confirmed to contain asbestos:

- Beige Speck Sheet Vinyl Flooring- Community Building  
Various Flooring- 650 SF
- White Sheet Vinyl Flooring-  
Community Building Flooring-  
220 SF
- Beige Speck Sheet Vinyl  
Flooring- Community Building  
Flooring- 220 SF

The identified hazardous materials **should be properly removed and segregated prior to renovation/demolition activities.** Proper packaging and disposal should be conducted in compliance with federal, state, and local regulations. **Certain restrictions regarding packaging methods (lab packs), transportation (hazmat certification & manifesting), and disposal (landfill regulations) of hazardous materials could apply.**

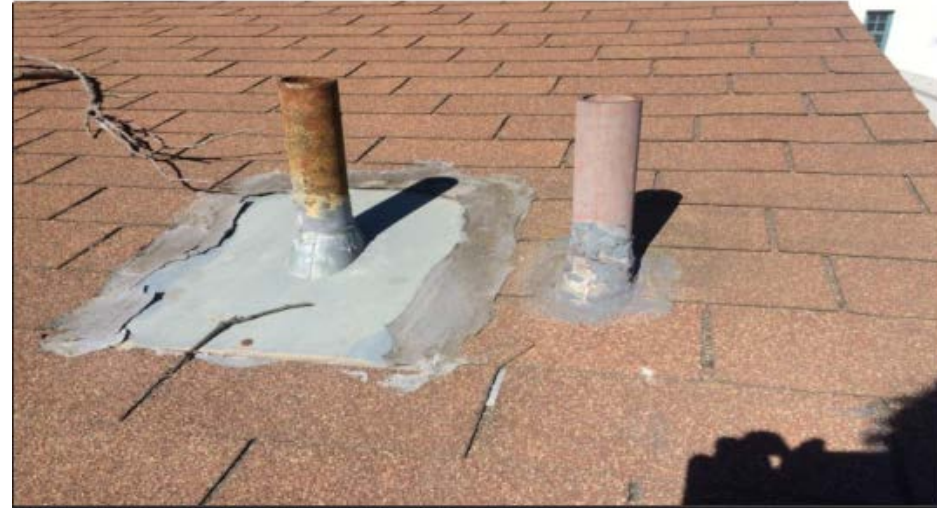
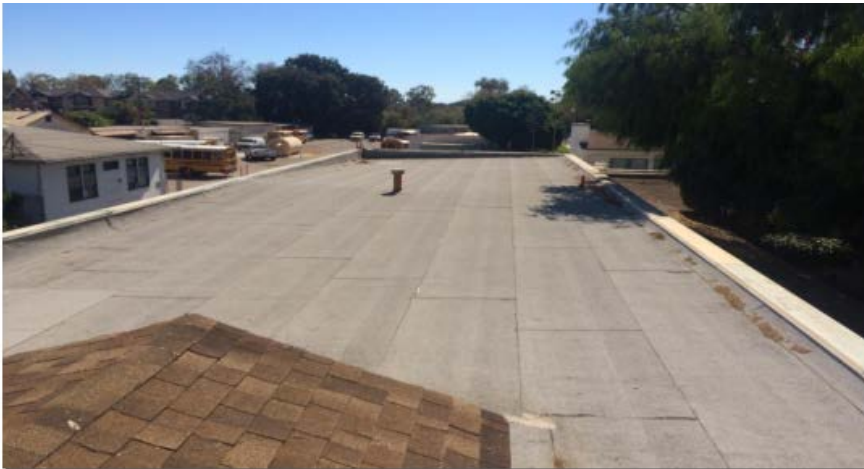
# Non-Friable Category I and II ACM

- Beige 12x12 Vinyl Floor Tile and Mastic- Community Building Flooring- 2,100 SF
- Grey Roof Patch & Penetration Mastic- Community Building Roof- 80 LF
- Transite Pipe- Community Building Janitor Closet- 6 LF

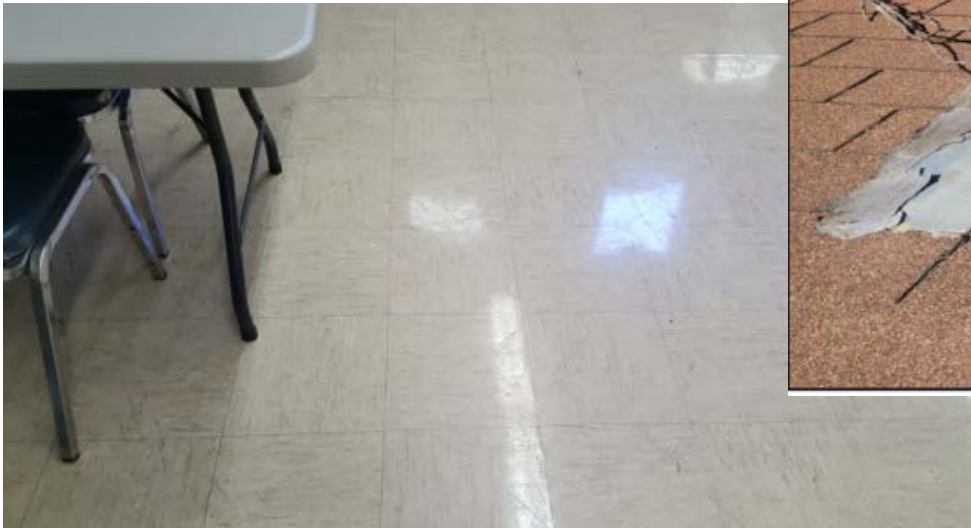
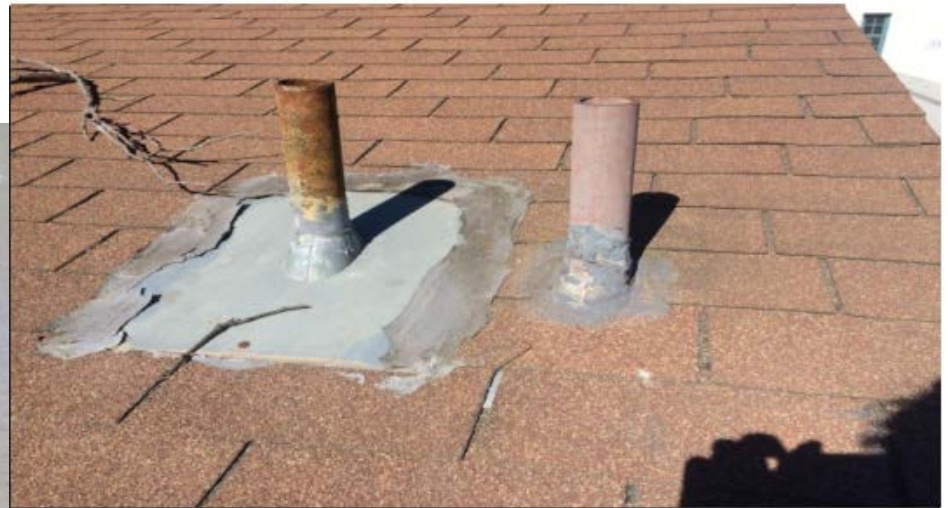
# Asbestos-Containing Construction Material (ACCM) – Cal/OSHA (<1% Asbestos)

- Grey Roof Patch & Penetration Mastic- Community Building Roof- 40 LF
- Grey Roof Patch & Penetration Mastic- Community Building Roof- 40 LF
- White 12x12 Vinyl Floor Tile Mastic- Community Building Flooring- 220 SF
