# POTENTIAL IMPACT STUDY

## GOLETA COMMUNITY CENTER GOLETA, CALIFORNIA [16128]

PREPARED FOR:  
City of Goleta  
Neighborhood Services and Public Safety Department  
130 Cremona Drive, Suite B  
Goleta, CA 93117

FEBRUARY 2017

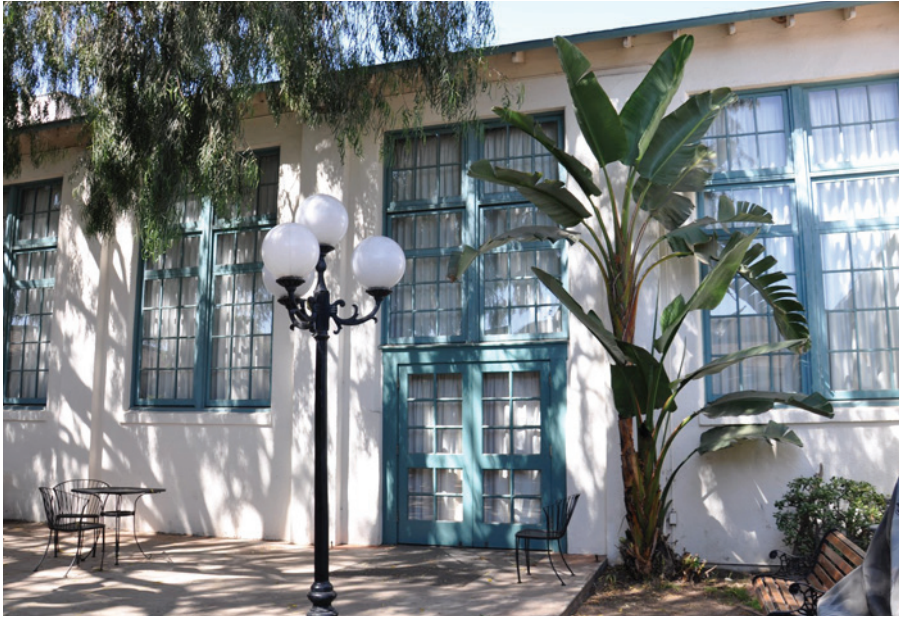
Figure 6. West façade in east patio, looking west at Auditorium.

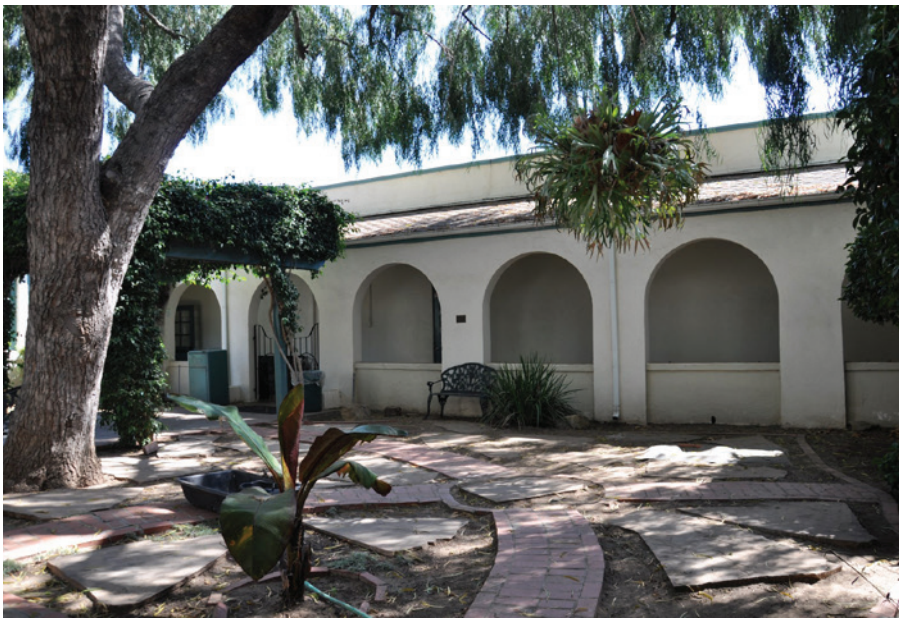
Figure 7. East patio, looking east at arched corridor.

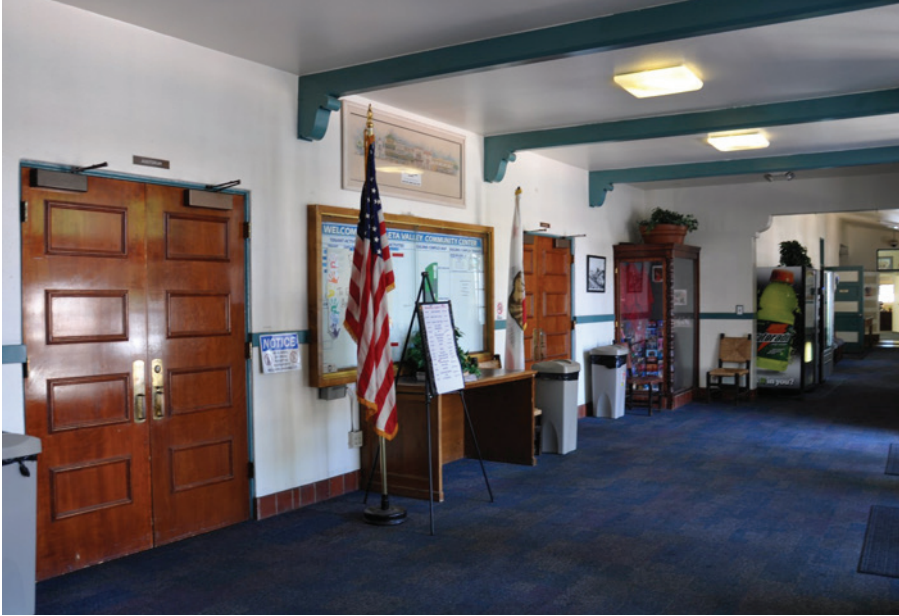
Figure 12. Entry corridor in front of Auditorium, looking southwest. Note the decorative beams.

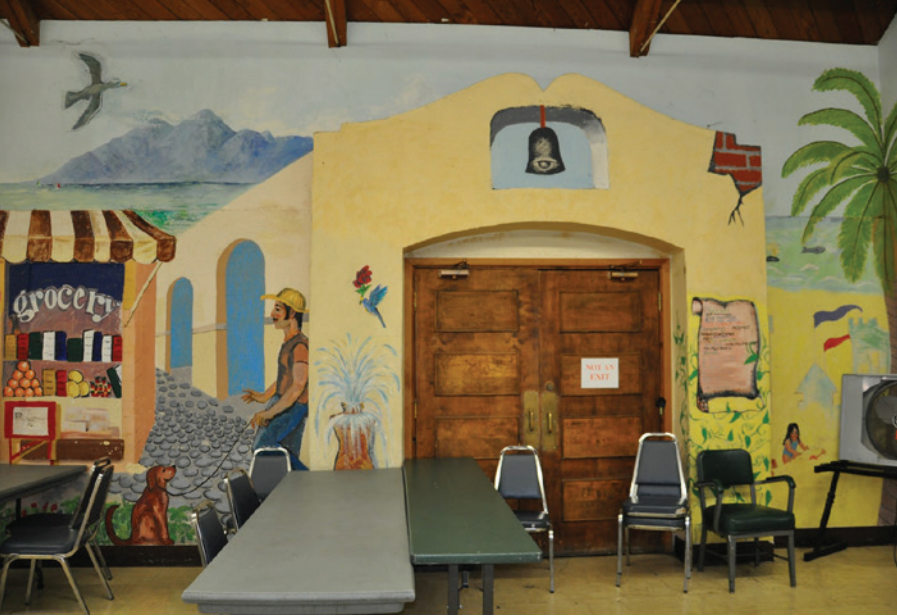
Figure 13. Decorative concrete door surround in Dining Room.

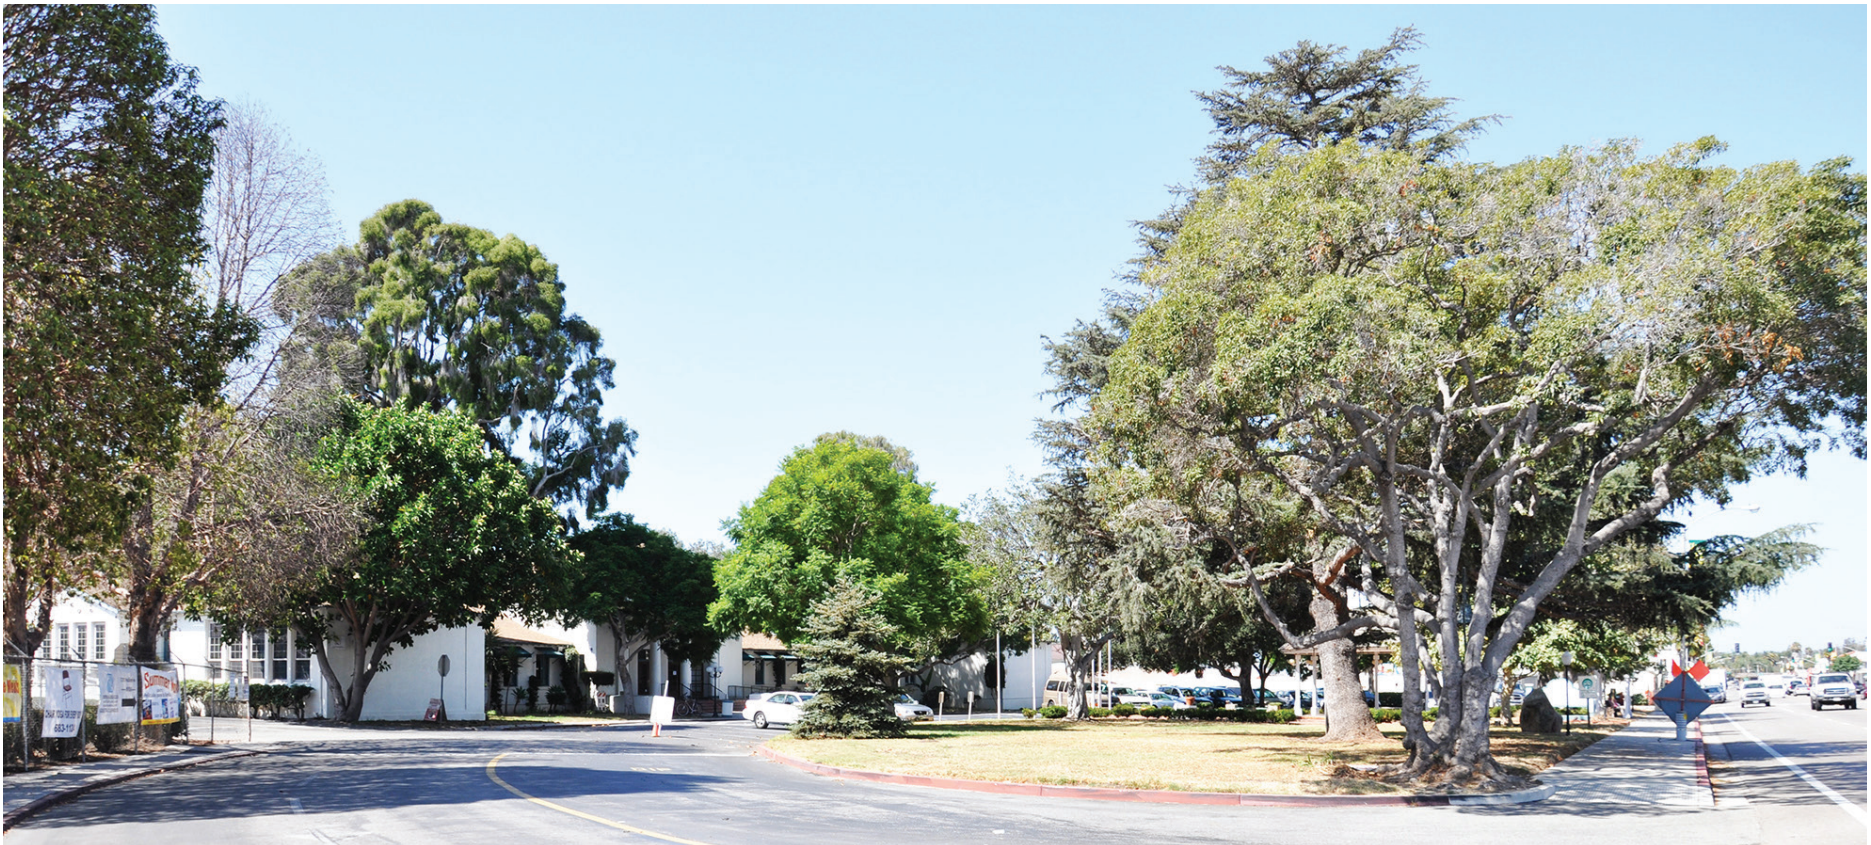
Figure 18. Main Building (left) set back from Hollister Avenue (right) behind semi-circular landscape area and driveway.

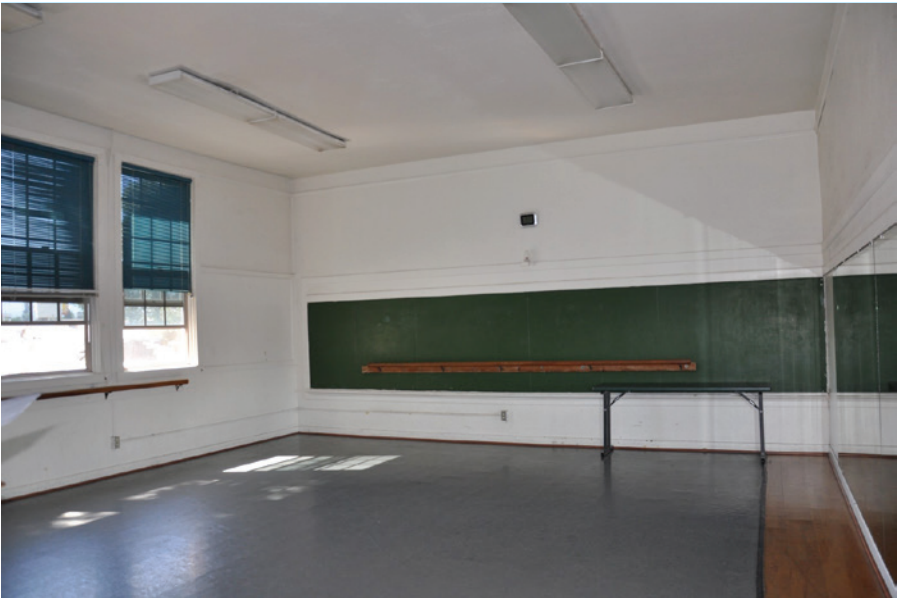
**Figure 22.** Typical Main Building classroom interior. Finishes can be upgraded and new systems installed without significantly altering the space.

- Interior finishes should not be gutted to install new systems like electrical wiring. If removal of interior finishes is required, it should be done selectively and the historic material shall be repaired in-kind to match adjacent finishes.
- Surface-mounted conduit and wiring may be done sensitively to avoid the need to channel into existing finishes. Select architectural-quality surface mounted conduit and locate to minimize impact on the character-defining qualities of the space.
- Deteriorated historic interior features shall be repaired rather than replaced.
- Maintain the type of historic finish. Painted surfaces shall remain painted. A paint analysis study is often helpful to understanding if finishes have changed over time.

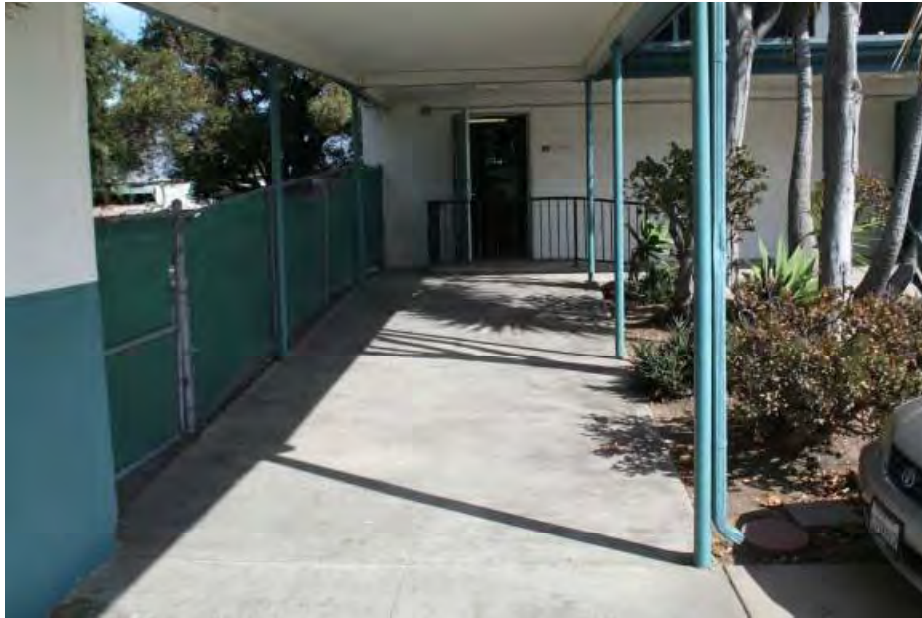
- Overall, it appears the Main Building has no fire and life-safety deficiencies for its current use.
- Future changes to the building's use may trigger mandatory code requirements and upgrades depending on the use and the related occupancy classification.
