# Goleta Community Center

City of Goleta  
City Council  
2 May 2017

Phase 1  
Historic Resource Evaluation (HRE)

# Phase 2 Potential Impact Study

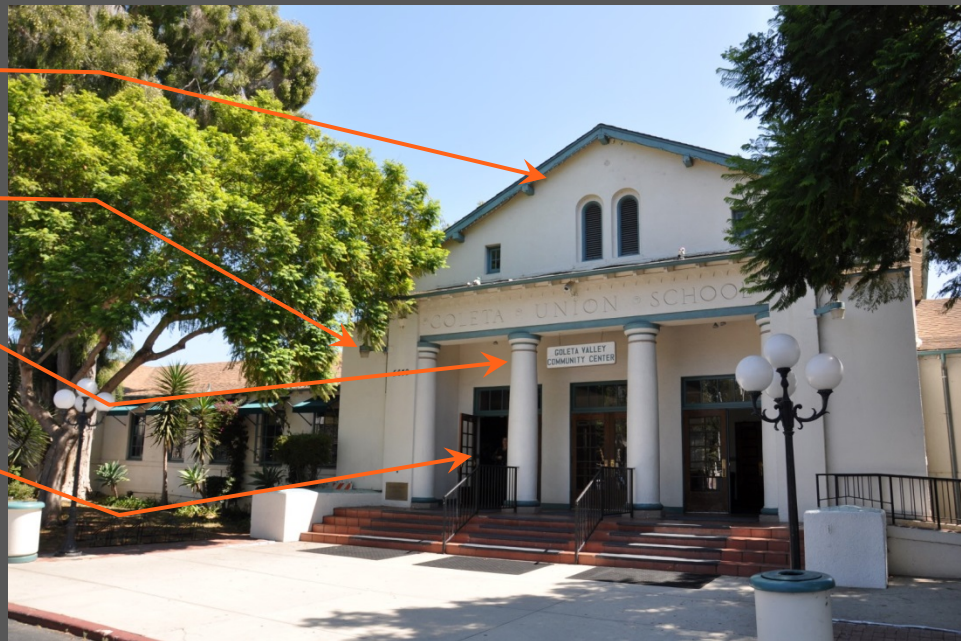
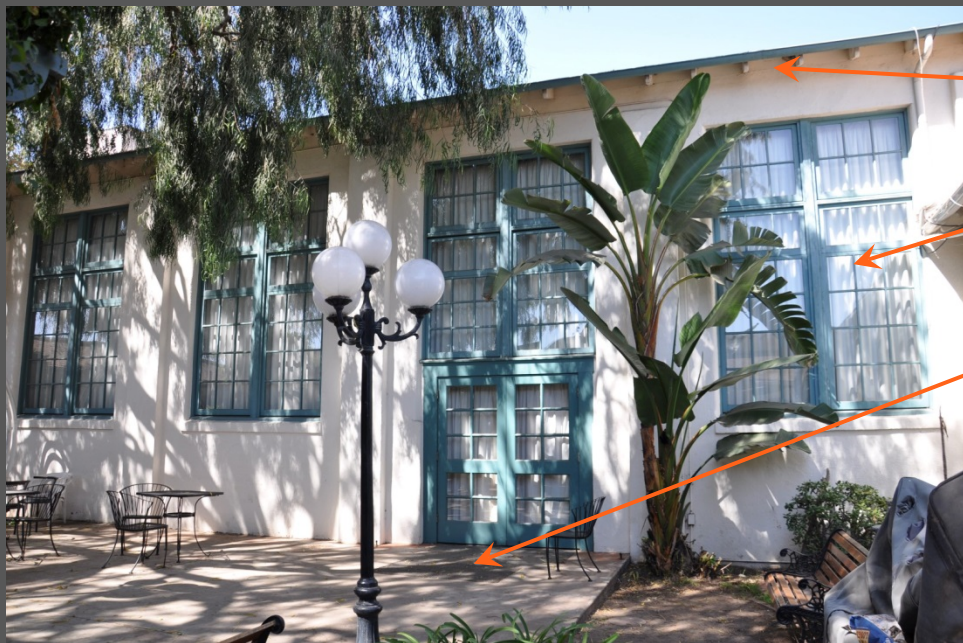
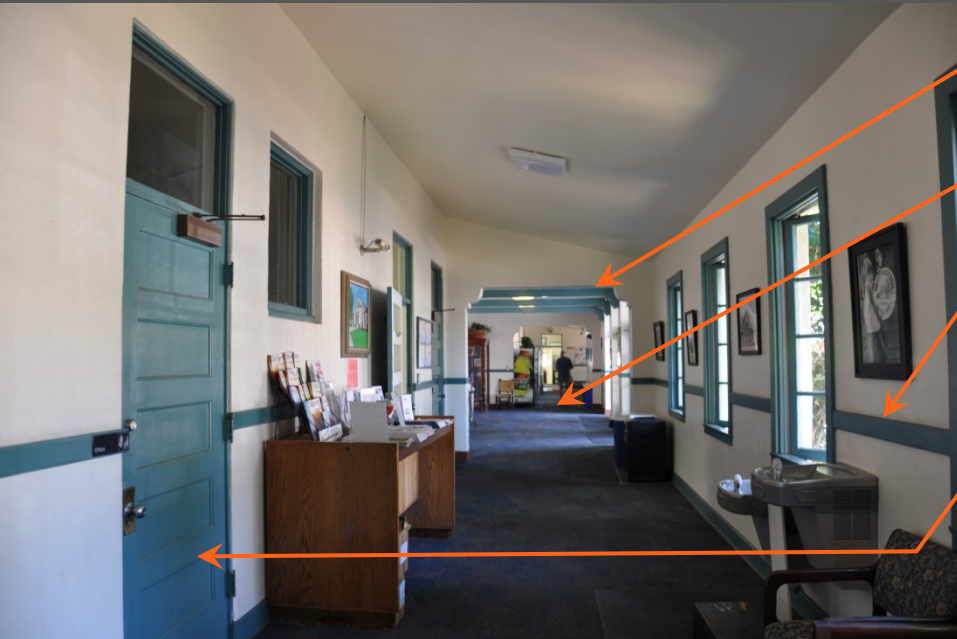
Front Gable with Central Massing

1

Concrete Walls

2

Monumental Portico with Tuscan columns

3

Multi-light doors with transom windows

4

5

Overhanging eaves and exposed rafter tails

6

Multi-light wood windows

7

East Patio

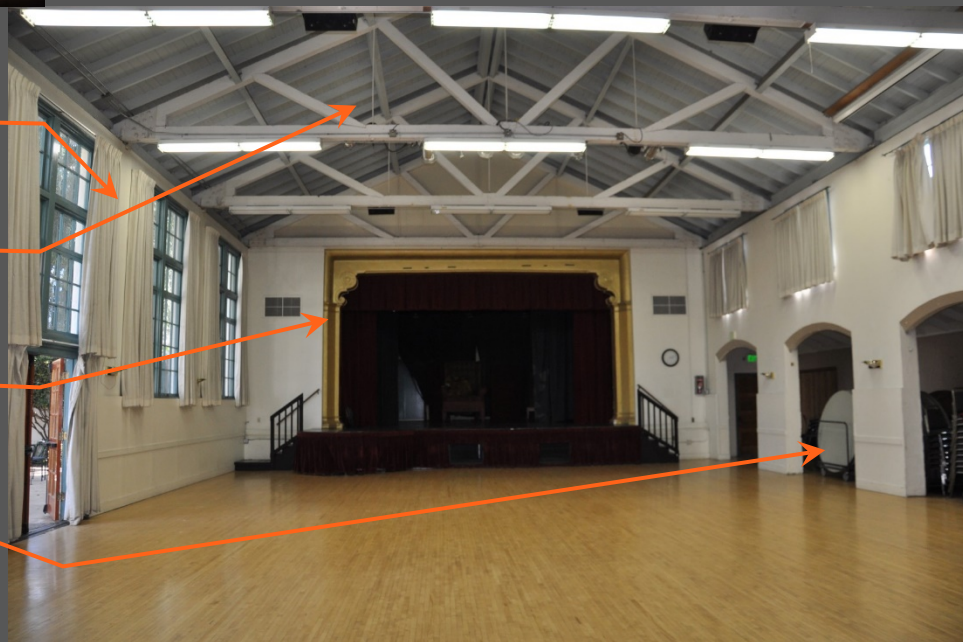
8

Decorative beams and plastered brackets

9

Main circulation corridor

10

Picture rail

11

Wood paneled doors with transoms

Auditorium space

1

Exposed ceiling and trusses

2

Stage surround

3

Arched corridor

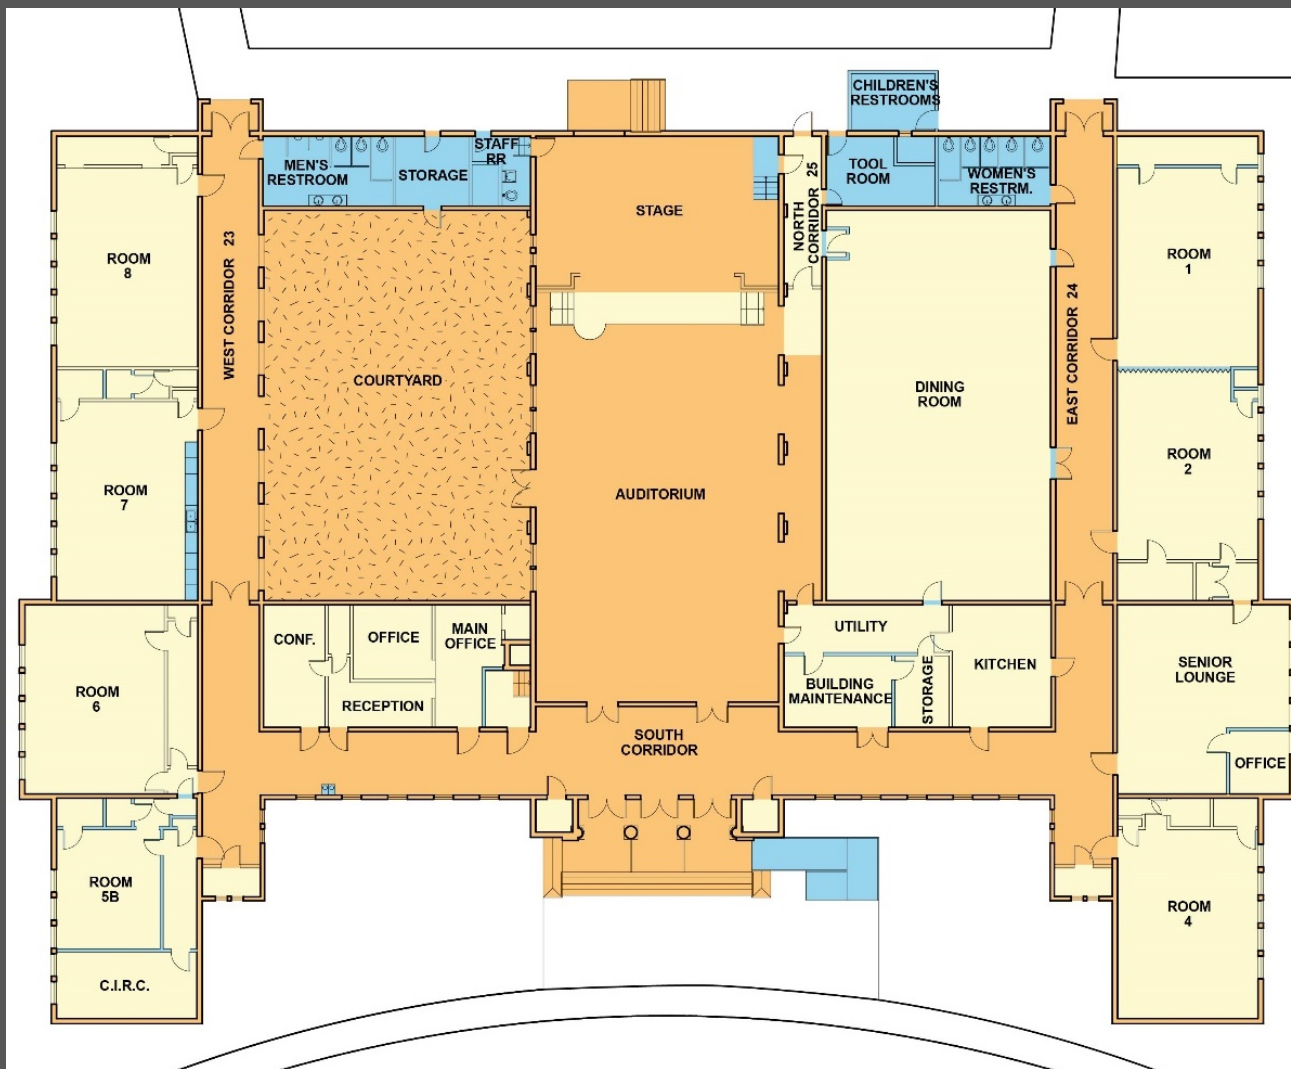
**Primary Significance**

- Most intact
- Highest preservation priority

**Secondary Significance**

- Some alterations, but contribute to historic character
- Preserve remaining historic character
- Changes should be compatible

**Not Significant**

- Non-significant or heavily altered / little or no historic features remain
- Most flexibility

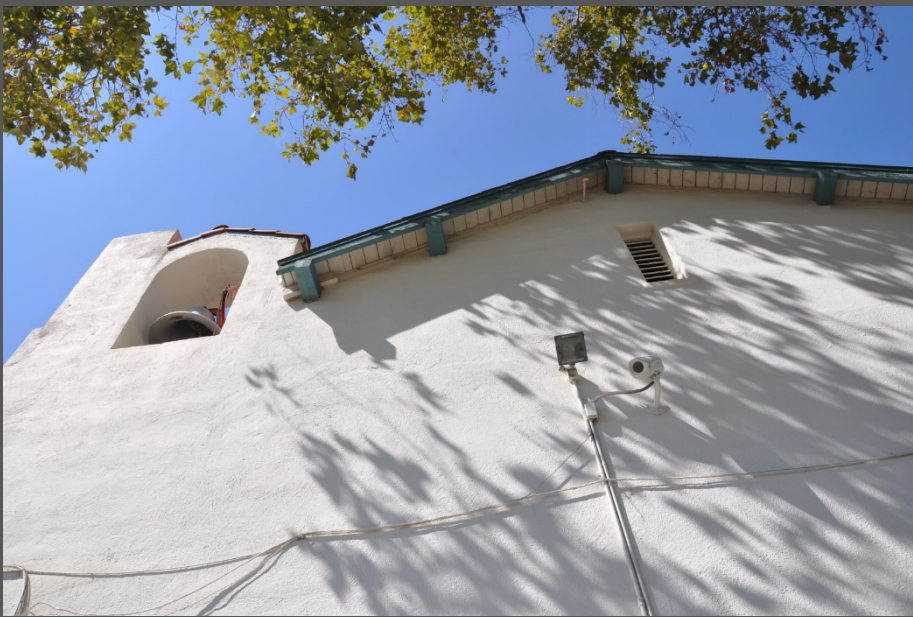
## Strengthen Existing Roof Diaphragm at Auditorium

- New plywood sheathing over existing non-compliant sheathing

- Exposed interior ceiling
- Overhanging eaves with exposed wood rafters

- Install new plywood from above to avoid exposed wood ceiling
- Nailing should be consistent w/ spacing of existing structural members to avoid 'shiners'
- Coordinate roof edge details to minimize thickness of roof edge

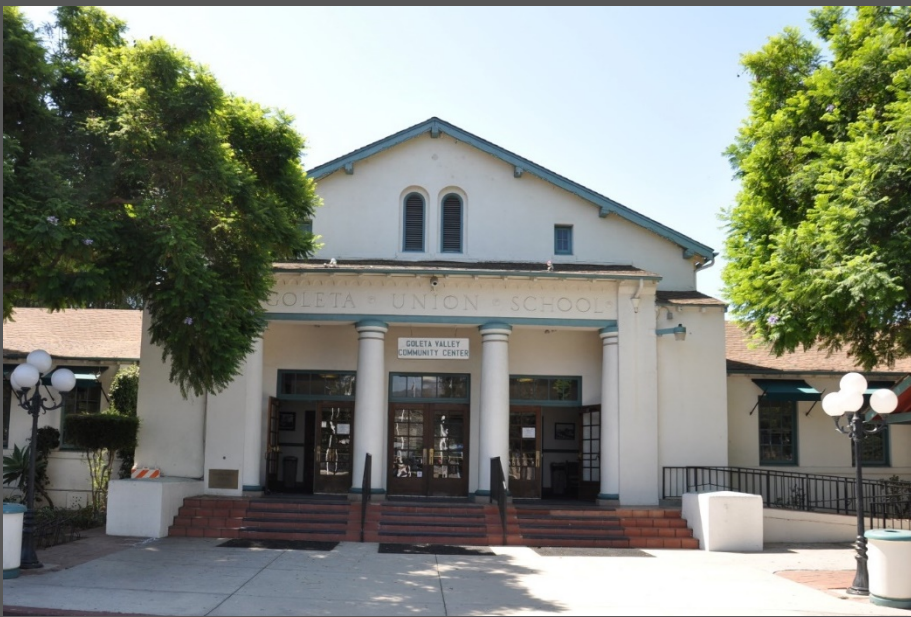
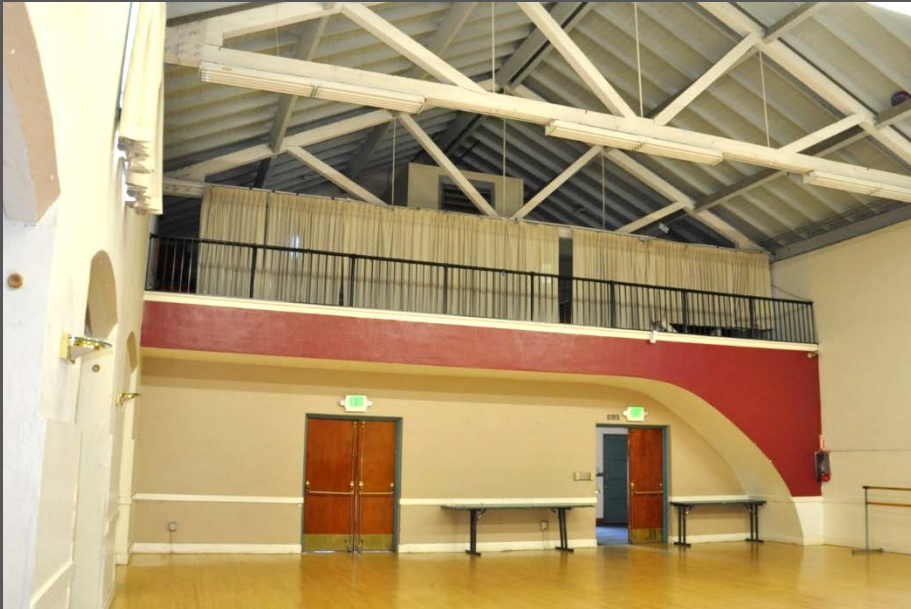
## Strengthen Connection of Roof Framing to Exterior Walls at Auditorium

- New through-wall connections and blocking at gable walls
- New connections of trusses, beams, and rafters to walls

- Visibility of connectors
- Removal, salvage and reinstallation of beams to install connectors

- Approach supplements and avoids removing historic fabric
- New elements should be finished to match adjacent surfaces

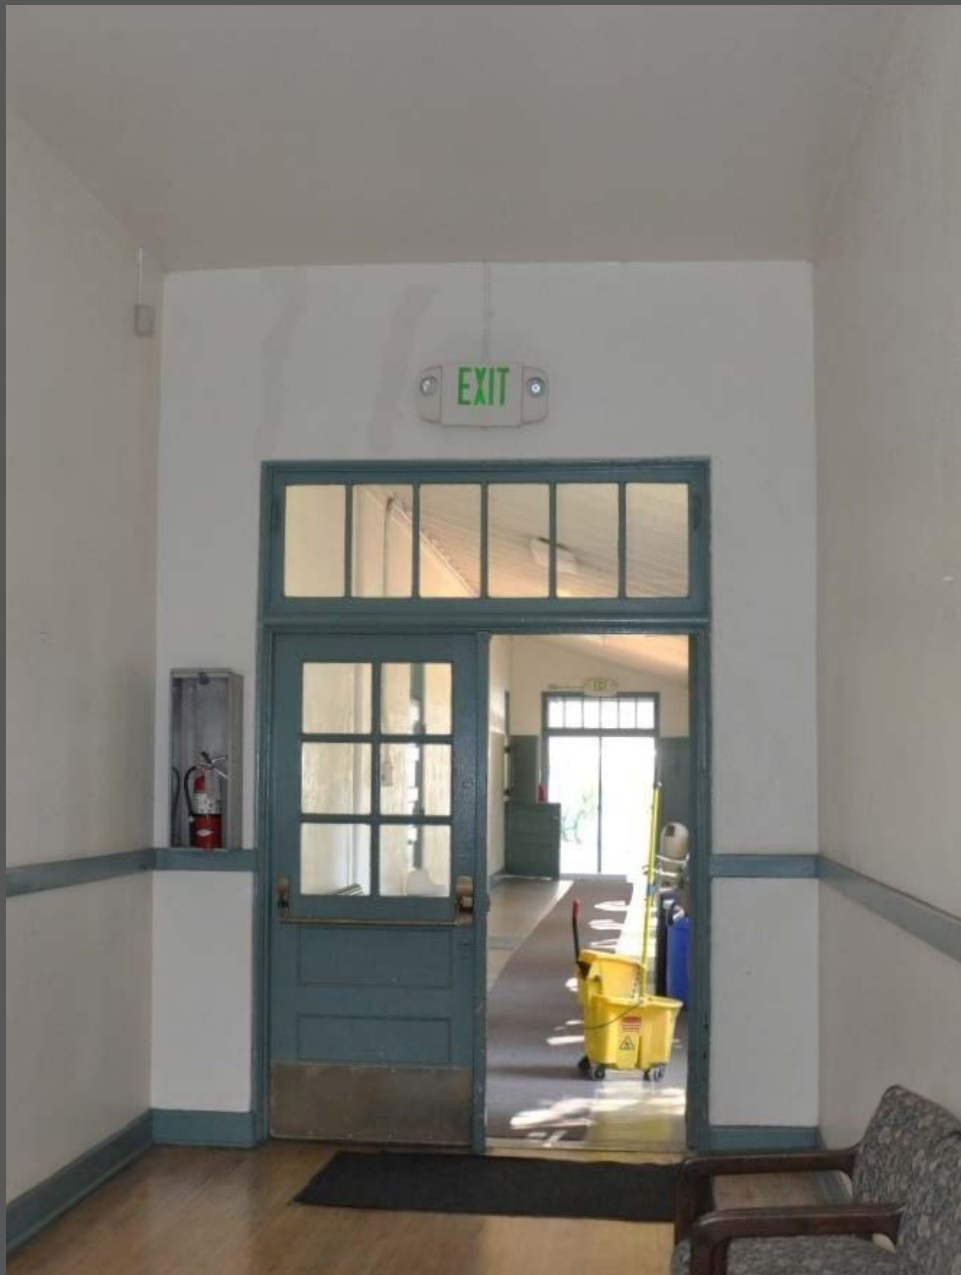
# Fire & Life Safety

## No deficiencies identified for current use

- No upgrades required if use continues
- Exiting is compliant
- Fire alarm and automatic fire sprinkler system not required, but recommended
- Unrated original wood doors, frames and interior windows may remain

- Future changes to the building may trigger upgrades
- Fire alarm and fire sprinklers
  - Allows original interior wood doors and interior windows to remain under the California Historical Building Code
  - Can be sensitively integrated with historic character

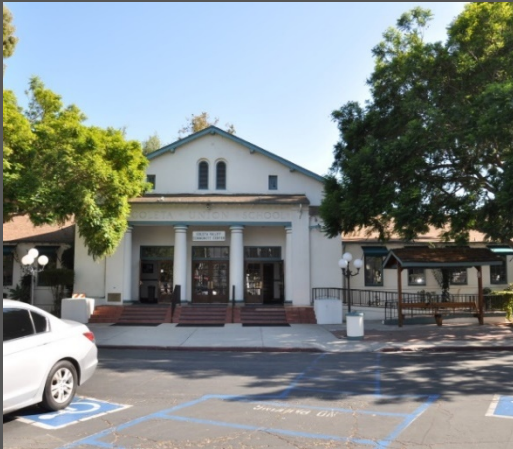
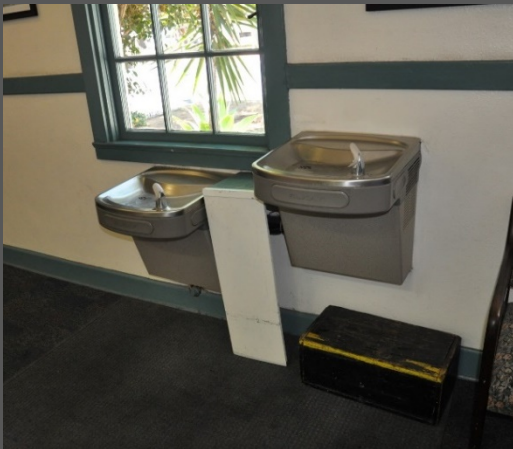
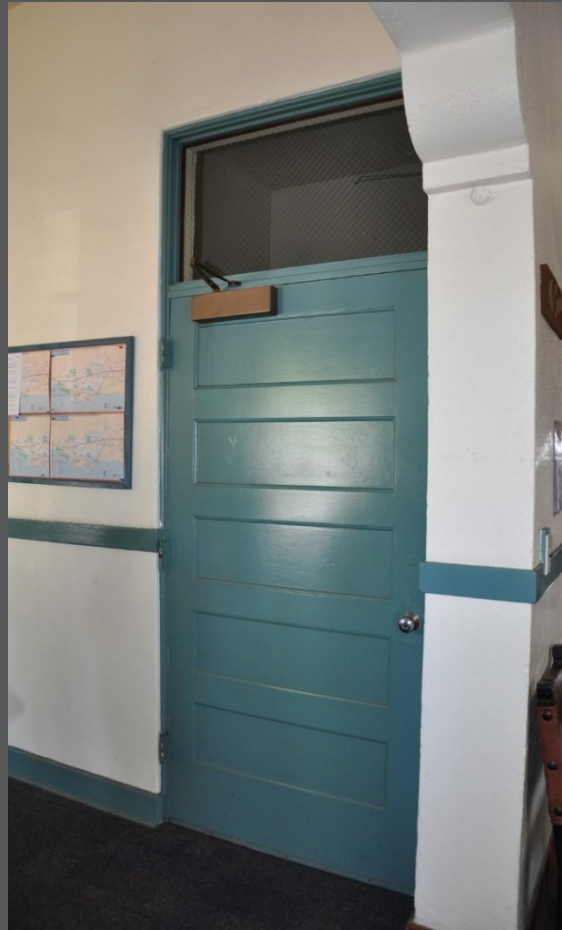
# Accessibility

## Main Building Deficiencies

- Ones identified are minor
  - Main stairs handrails and contrasting striping
  - Door hardware
    - Knobs and closers
  - Restrooms
  - Minor interior elements
    - Drinking fountain, counter heights, door threshold and thermostat heights

- Changes can be easily accommodated without impacting historic character
