PLAYGROUND SURFACING

APRIL 3, 2018 CITY COUNCIL PRESENTED BY: JOANNE PLUMMER, PARKS & RECREATION MANAGER DEPARTMENT OF NEIGHBORHOOD SERVICES & PUBLIC SAFETY

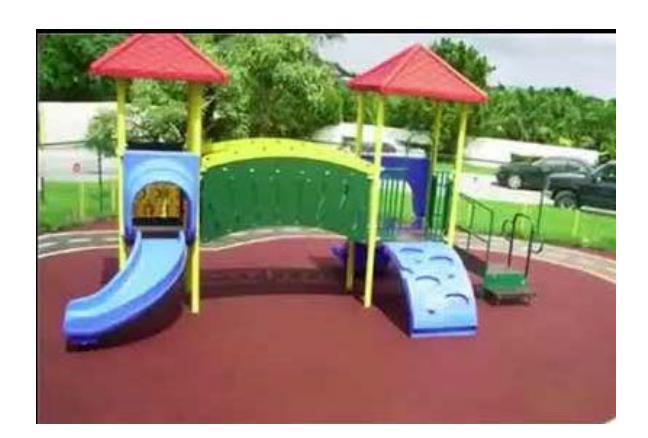
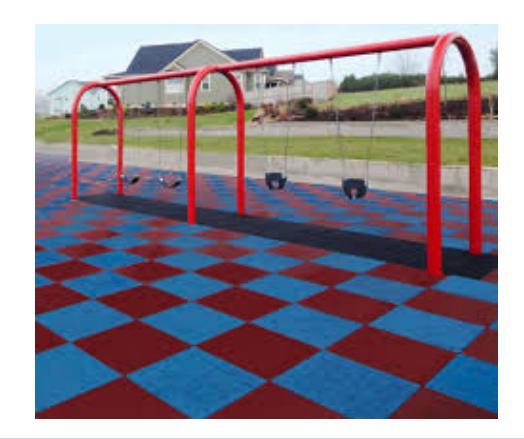
UNITARY SURFACING

- Rubber surfacing that is a combination of energyabsorbing materials held in place by a binding agent and cured to create a unitary shock absorbing surface.
- Common forms: Poured in place and cured, or tiles that are premanufactured and assembled/locked in place.

PROS & CONS UNITARY SURFACE

Can have creative designs, fun colors

- Debris is easily visible, cleaned easily by blowing off or hosing down
- Maintains attenuation rates for at least five years

- Can be three to four times more expensive to install than EWF
- Health related studies have not identified conclusive results

Can be costly to repair and/or replace

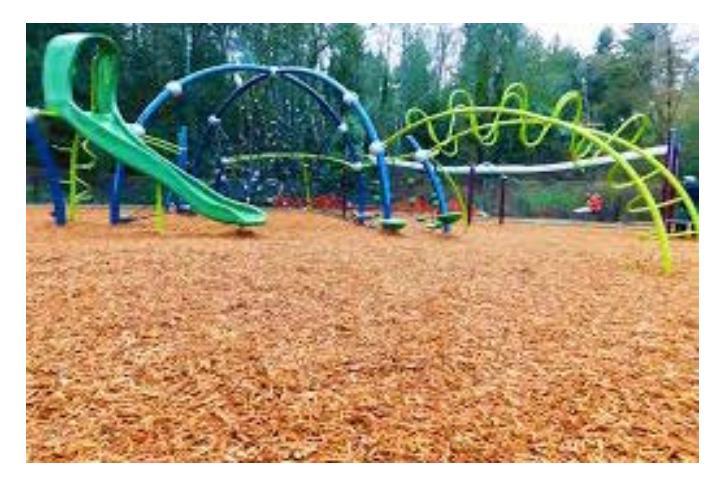
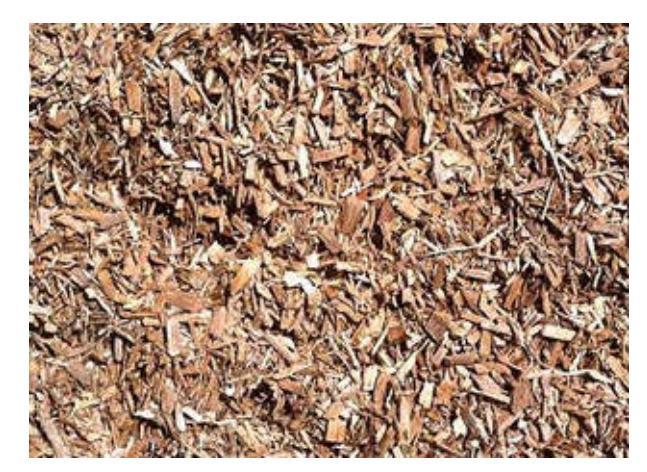
GOLETA ENGINEERED WOOD FIBER SURFACING

- A natural safety surfacing product created from the inside of trees, not the bark.
- Certified for impact attenuation, ADA accessible for wheelchairs and strollers, slip resistant and it is free of chemicals, hazards, etc.

CITY OF OLETA PROS & CONS GOLETA ENGINEERED WOOD FIBER

- Costs for installation are typically three to four times lower than a rubberized surface
- The product is clean and natural
- The product meets all accessibility and safety criteria

- Requires ongoing maintenance to ensure compliance with safety criteria
- Requires annual replenishment of materials
- Debris can be difficult to see during visual inspections

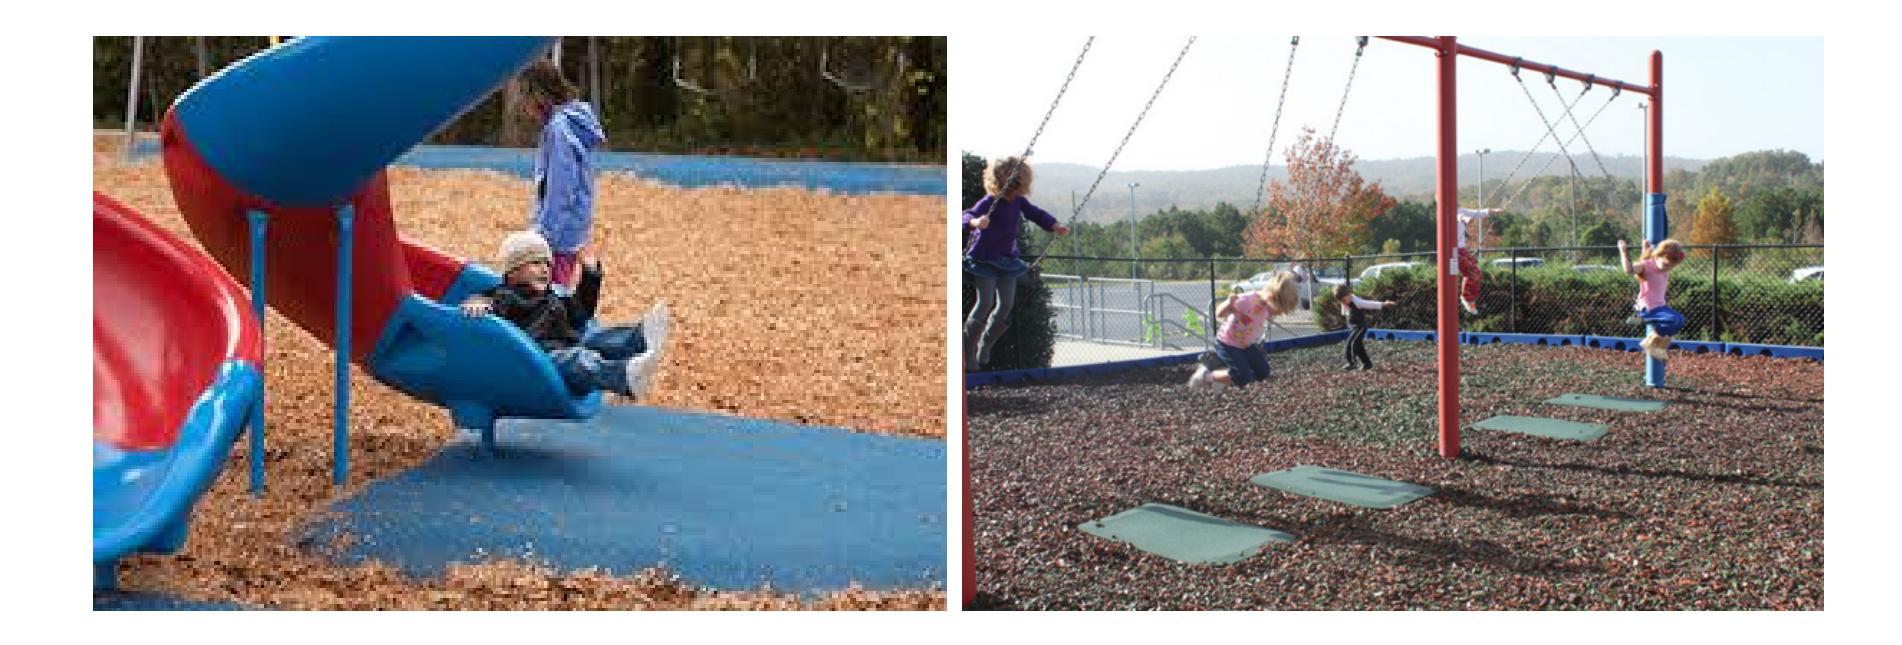
OPTION #3 BOTH UNITARY & EWF

Places rubber surfaces in high traffic areas, utilizing chips for the remainder of the play surface area

- 1. Move forward with a unitary surface for the current playground renovations and continue to monitor ongoing studies
- 2. Move forward with an Engineered Wood Fiber for the current playground renovations, understanding the financial and risk management obligations
- 3. Movie forward with a unitary surface below the high traffic areas (slides, swings) and utilize engineered wood fiber for the majority of the play area
