Agenda Item E.2
DISCUSSION/ACTION ITEM
Meeting Date: May 2, 2017

SUBJECT: Goleta Community Center Special Studies Update

HAZARDOUS MATERIALS SURVEY REPORT

5679, 5681, & 5689 HOLLISTER AVENUE
GOLETA, CALIFORNIA 93117

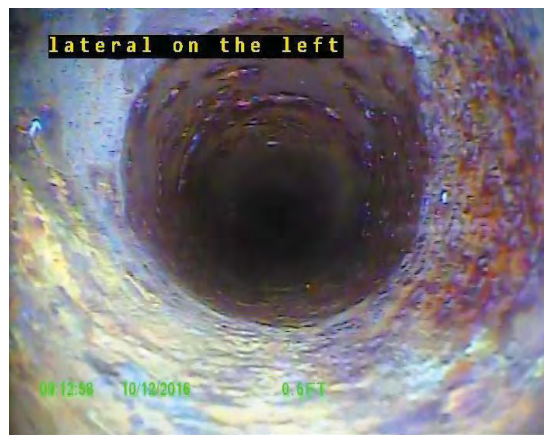
Lateral on left at 0.60 ft.

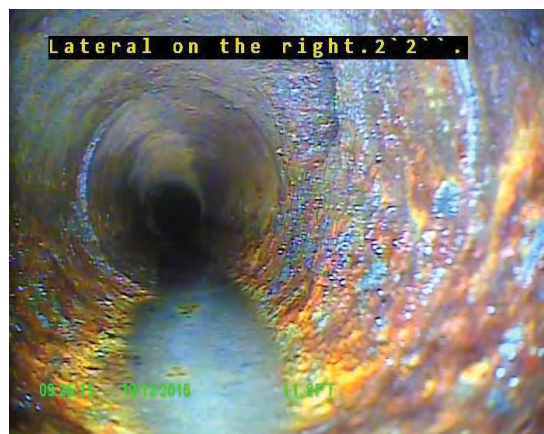
Lateral on right at 11.80 ft.

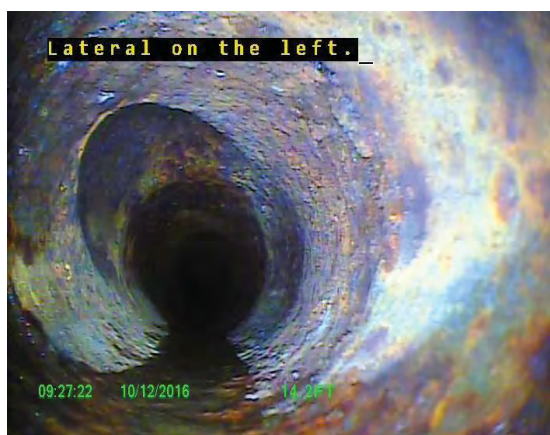
Lateral on left at 14.20 ft.

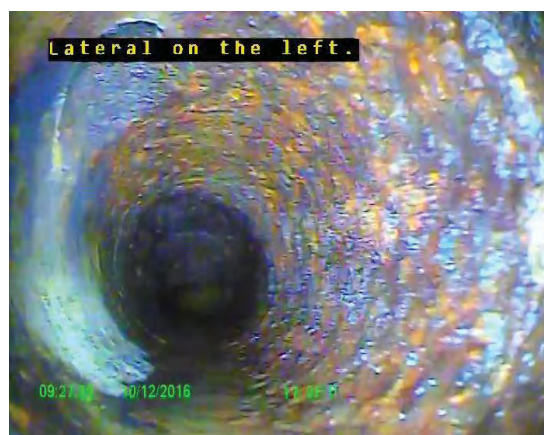
Lateral on left at 17.00 ft.

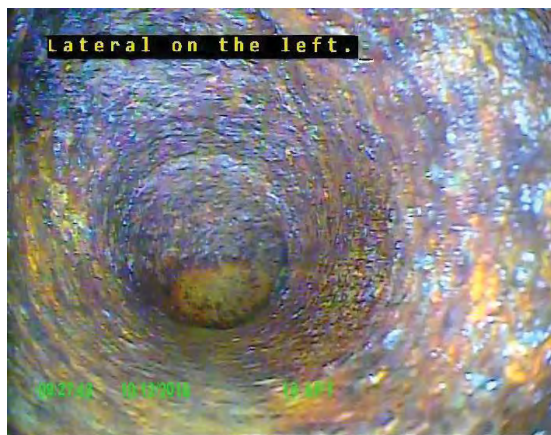
Lateral form above at 18.60 ft.

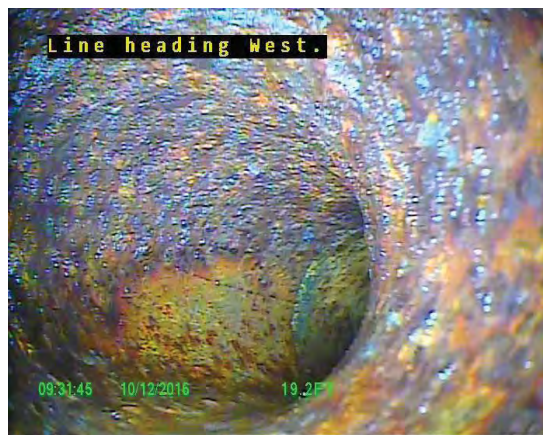
Line heads West at 19.20 ft.

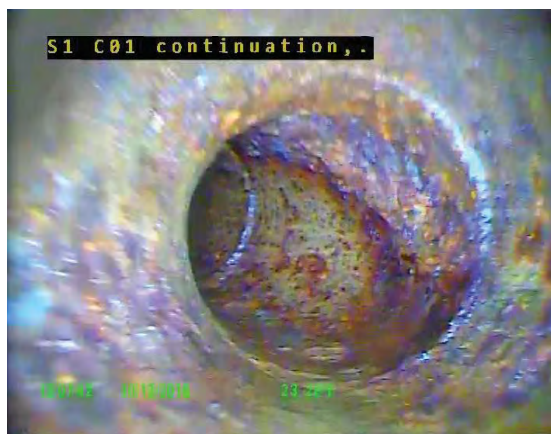
Line turns left at 23.20 ft.

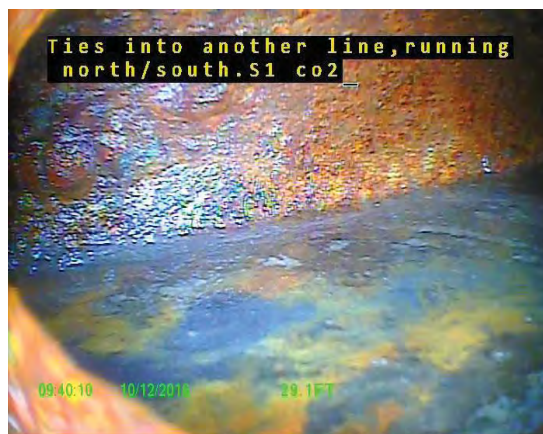
Line ties into S1 CO2 at 29.10 ft.

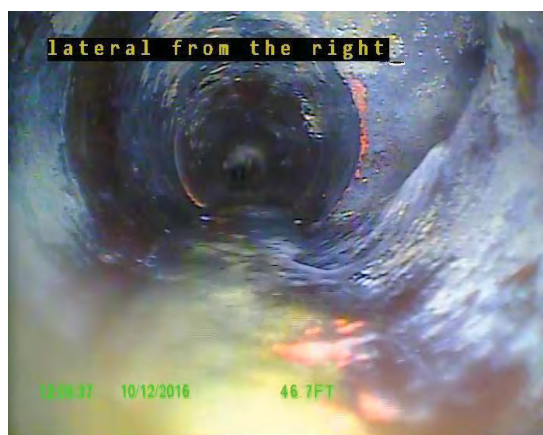
Lateral on right at 46.70 ft.

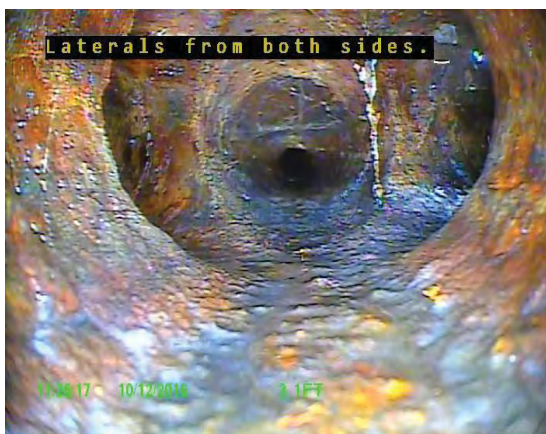
"Y" intersection at 2.10 ft.

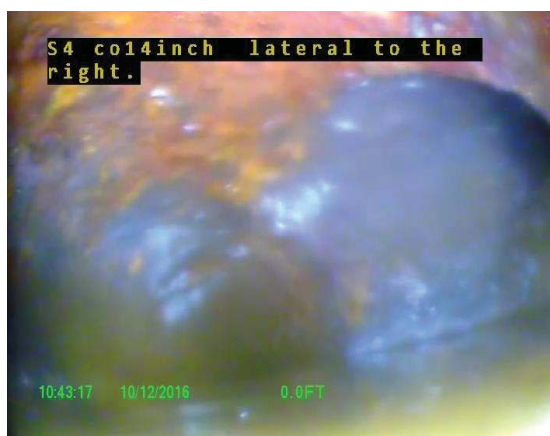
Lateral on right at entry point.

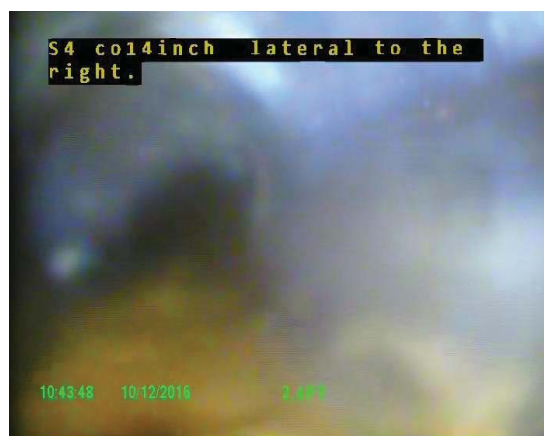
Lateral on the right at 2.40 ft.

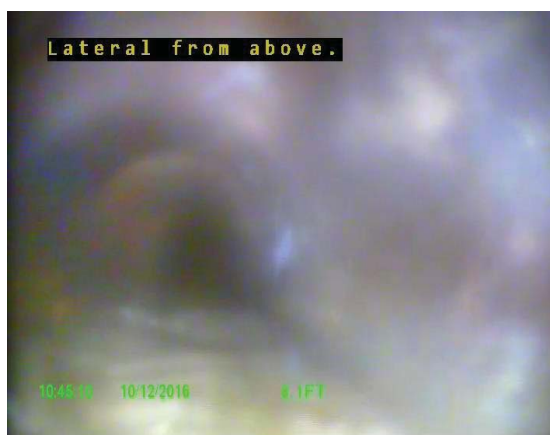
Lateral from above at 5.10 ft.

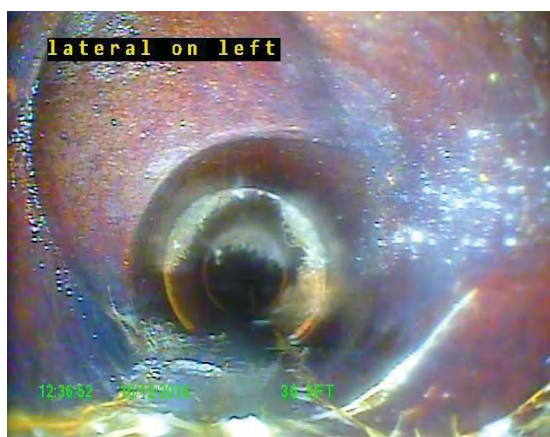
Lateral from top left at 36.30 ft.

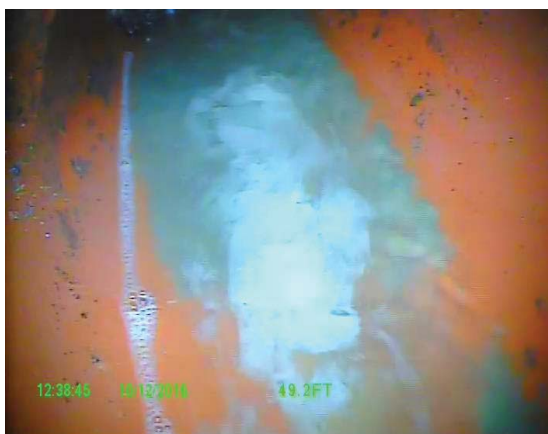
Line drops to second line at 49.20 ft.

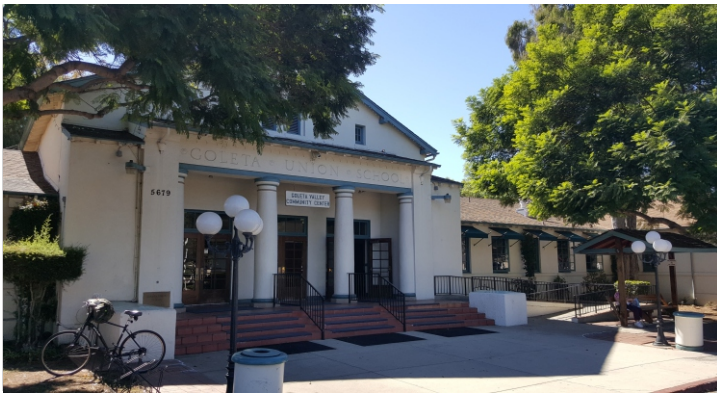
1. View of the stucco exteriors.

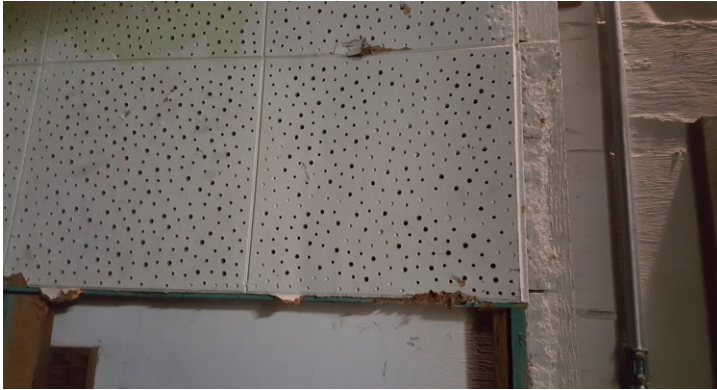
3. View of the 12x12 acoustic ceiling tiles.

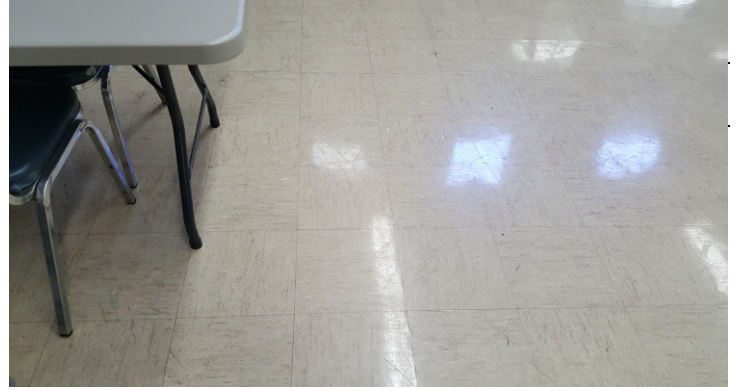
4. View of the beige 12x12 vinyl floor tile.

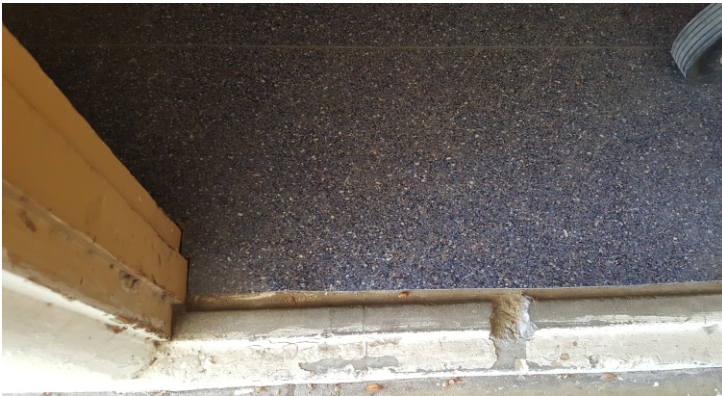
5. View of the blue speck sheet vinyl flooring.

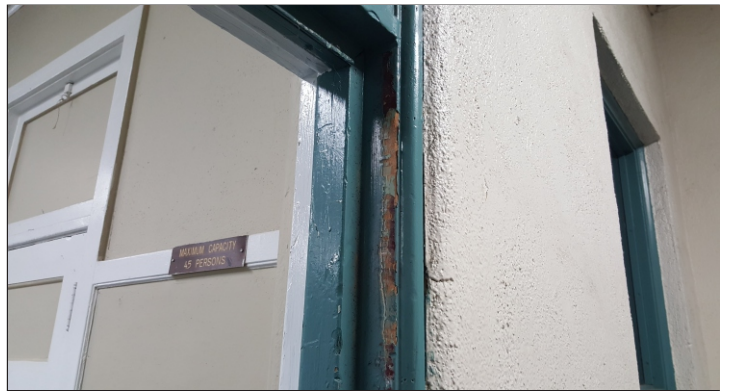
6. View of the wood door components.

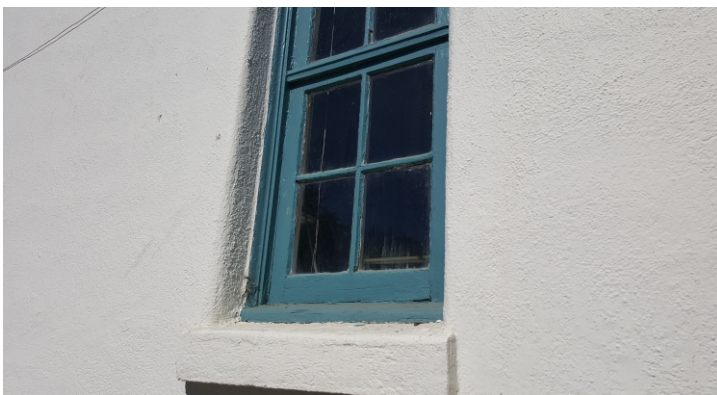
7. View of the exterior window components.

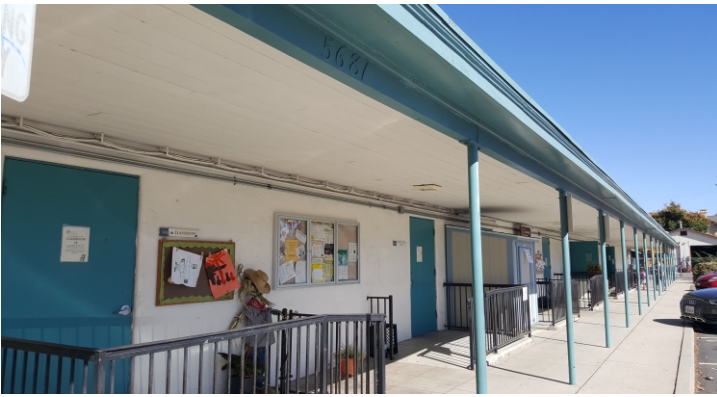
9. View of the patio overhang components.

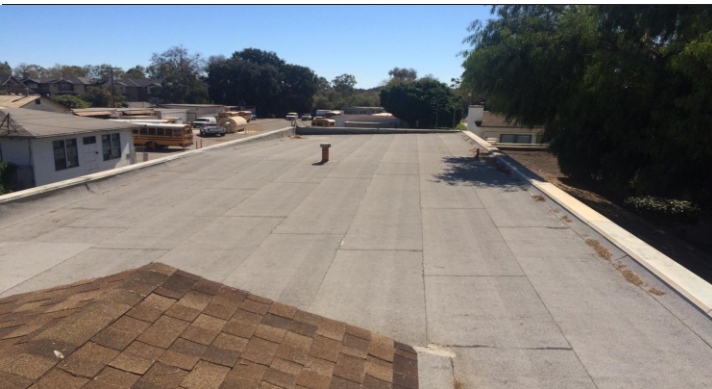
13. View of the grey rolled on roofing.

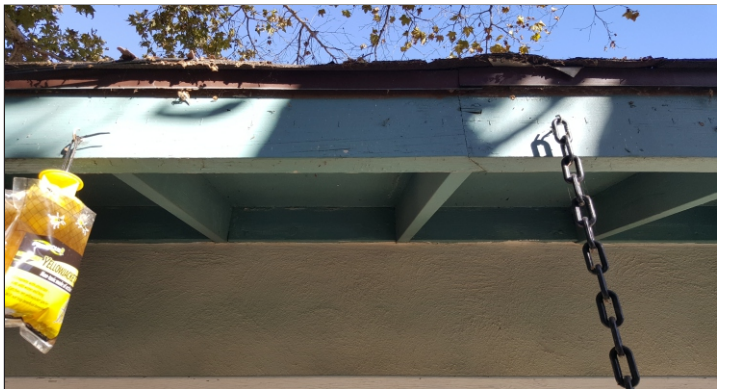
14. View of the exterior overhang components.

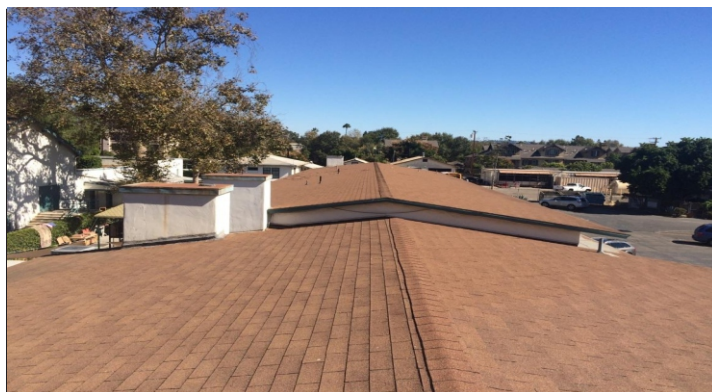
15. View of the brown asphalt roof shingles.

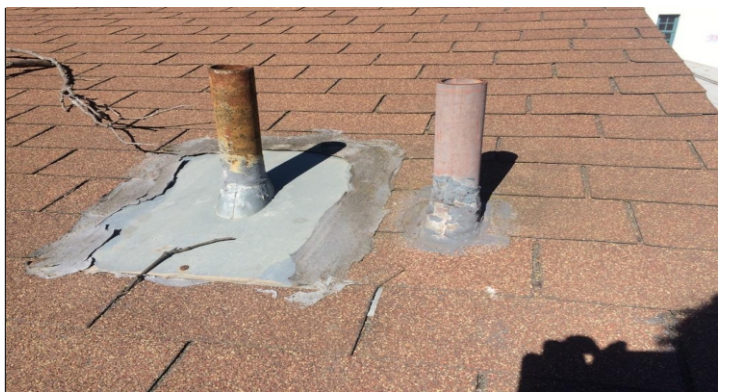
16. View of the grey roof mastic.
