PROPERTY CONDITION REPORT

Goleta Community Center
5679, 5681 & 5689 Hollister Avenue
Goleta, California 93117

December 30, 2016
Partner Project Number: 16-170535.1

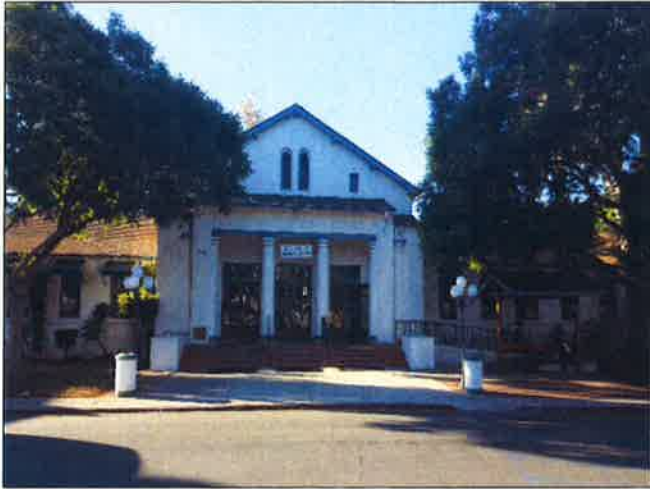
1. Community Center front elevation

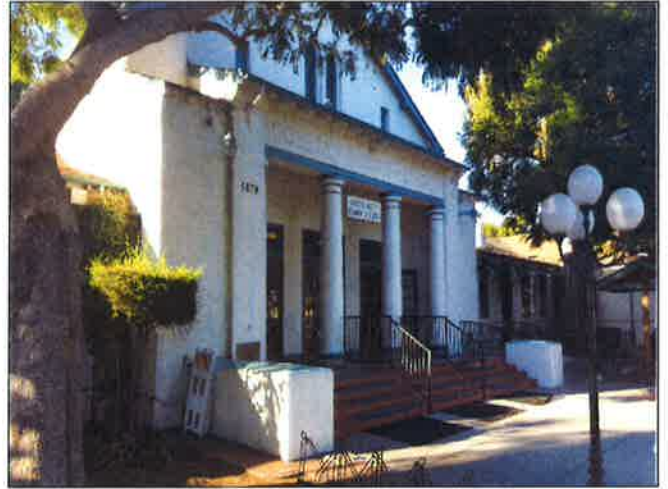
2. Community Center main entrance

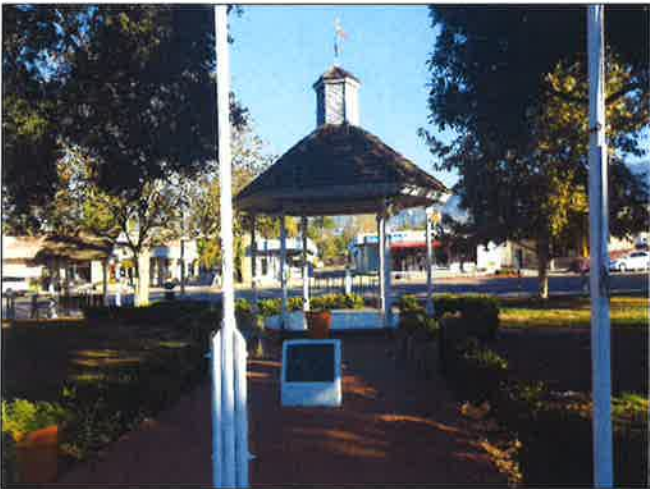
3. Gazebo in front of building at Hollister Avenue

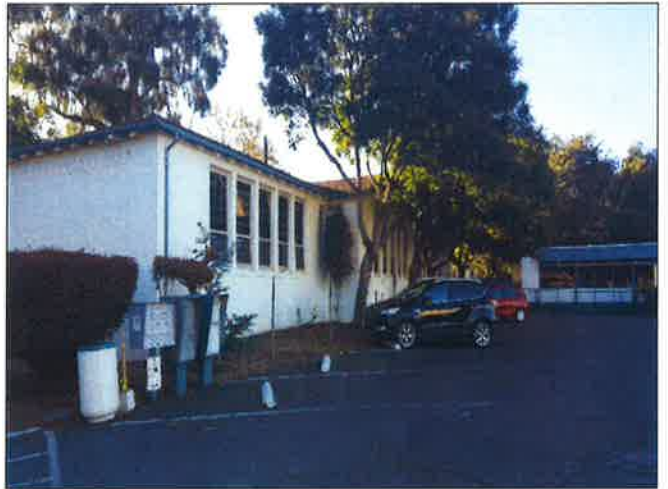
4. Partial Community Center west elevation

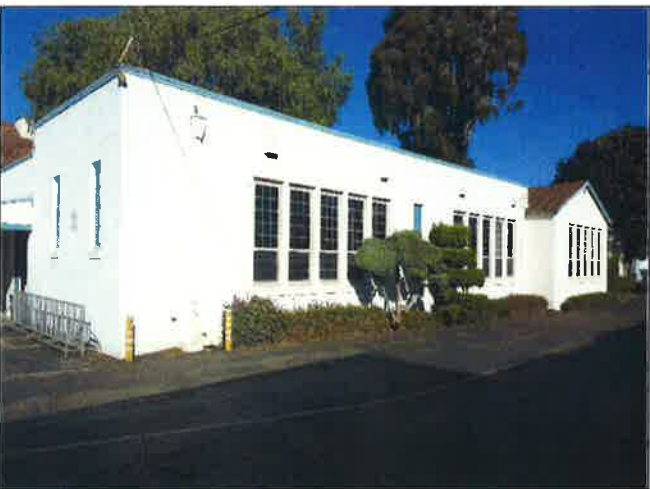
5. Partial Community Center east elevation

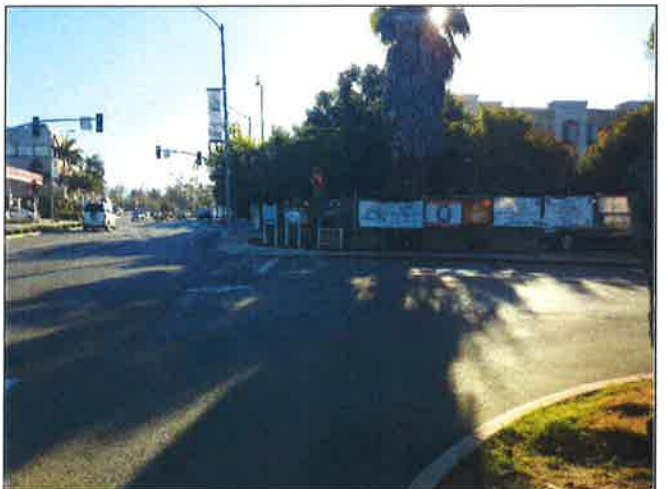
6. Property exit at Hollister Avenue

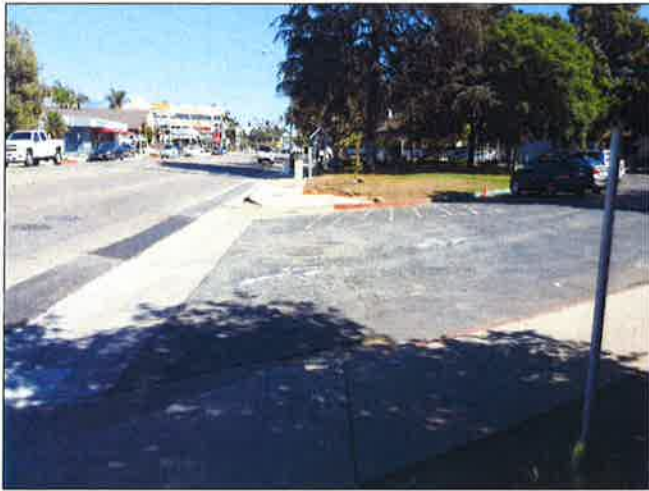
7. Property entrance at Hollister Avenue

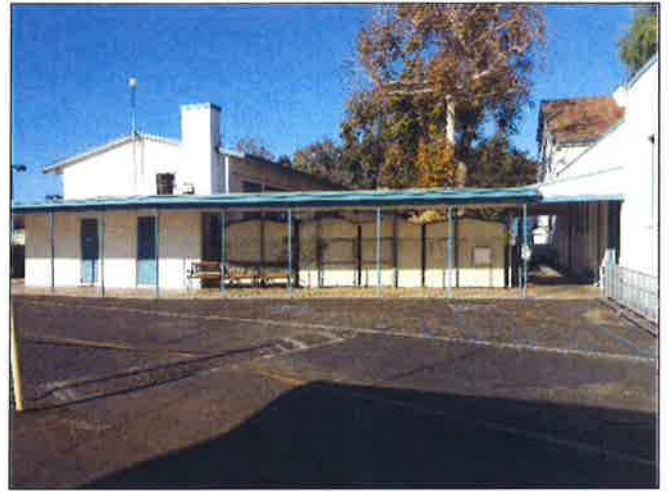
8. Bus parking at rear of Community Center building

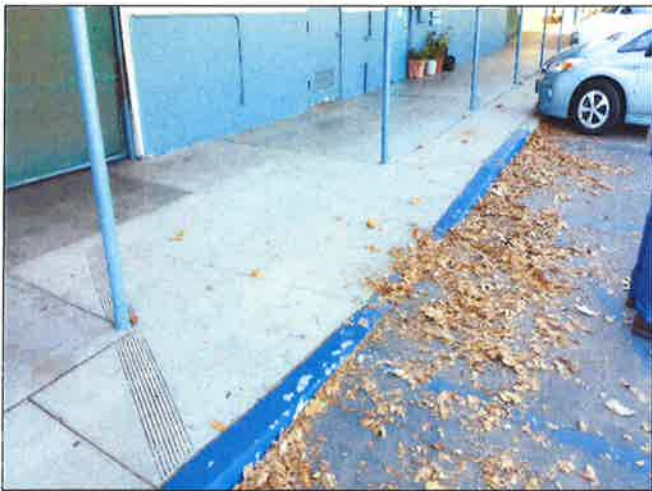
9. Non-compliant ADA curb cut along Building C4

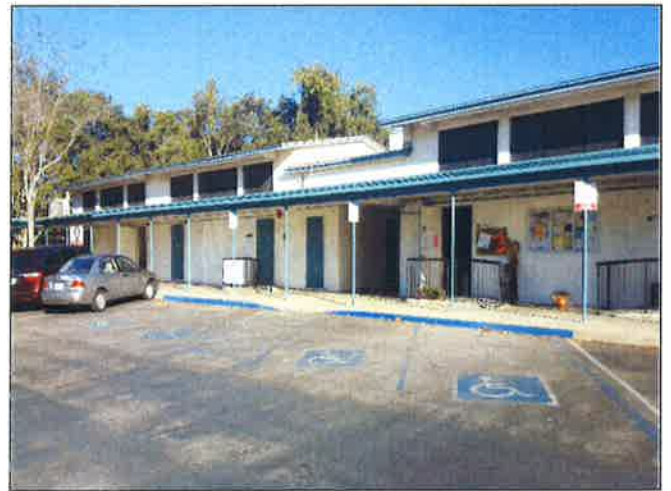
10. ADA parking at Day Care/ CAC Head Start Building B

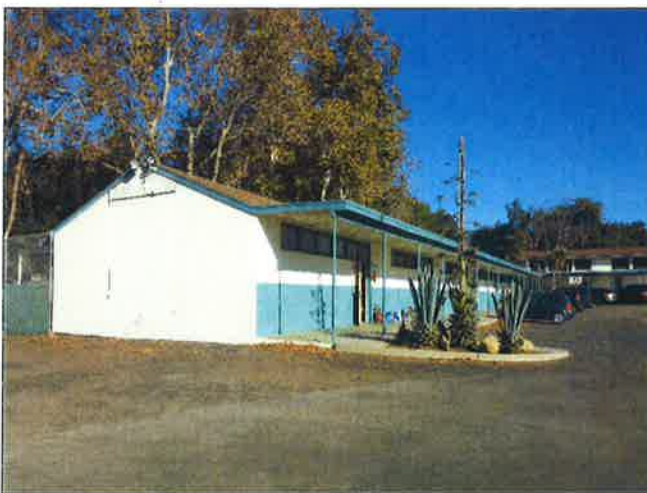
11. Day Care/Toddlers Rainbow School Building C4

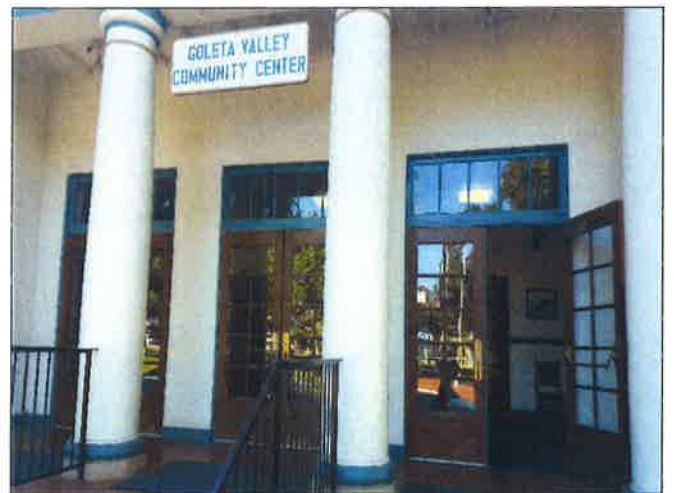
12. Property entry doors

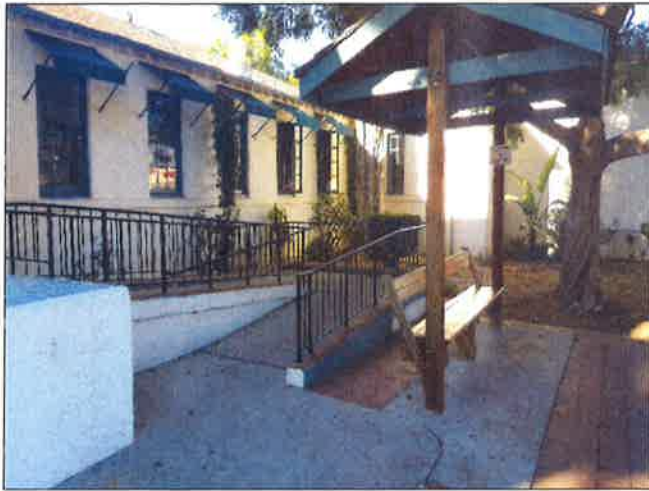
13. Loading area and ramp access to building

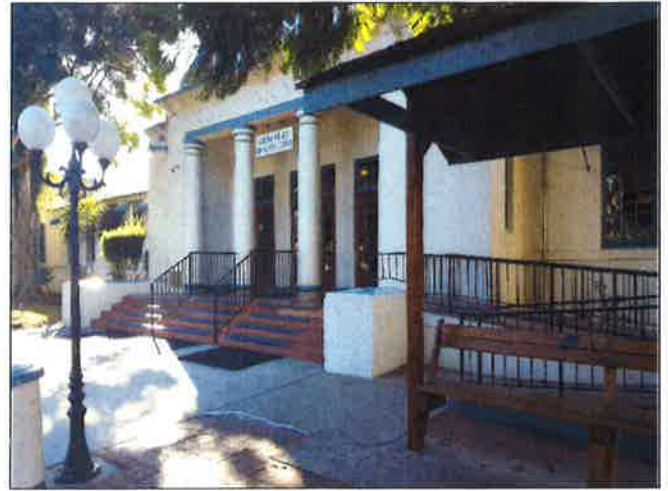
14. Stairs at main entrance area

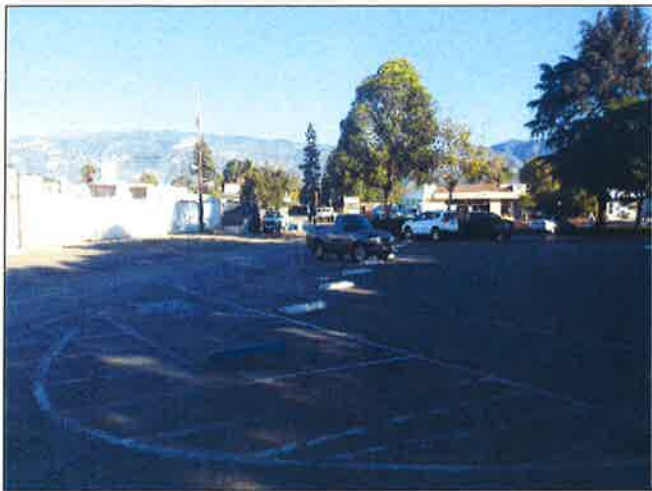
15. Parking at front of property

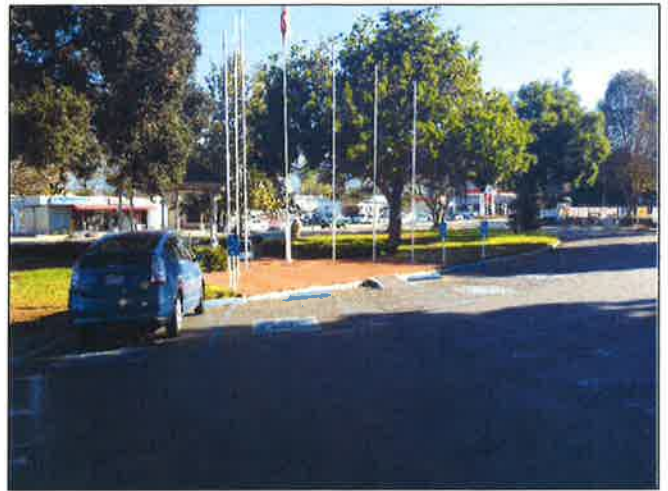
16. ADA parking in front of property

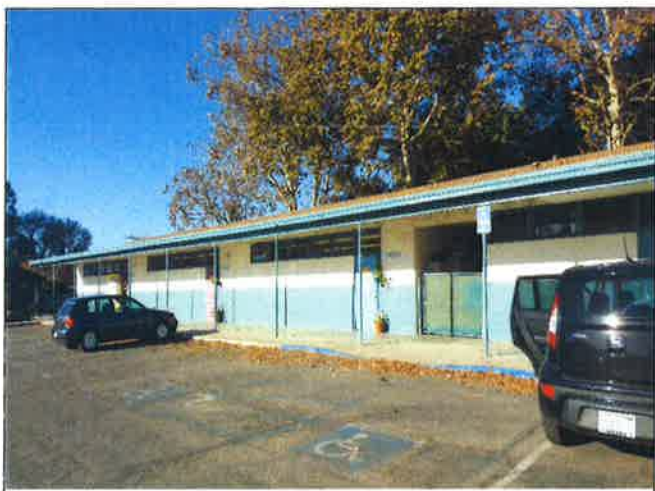
17. Accessible space along Day Care/Toddlers
Rainbow School Building C4

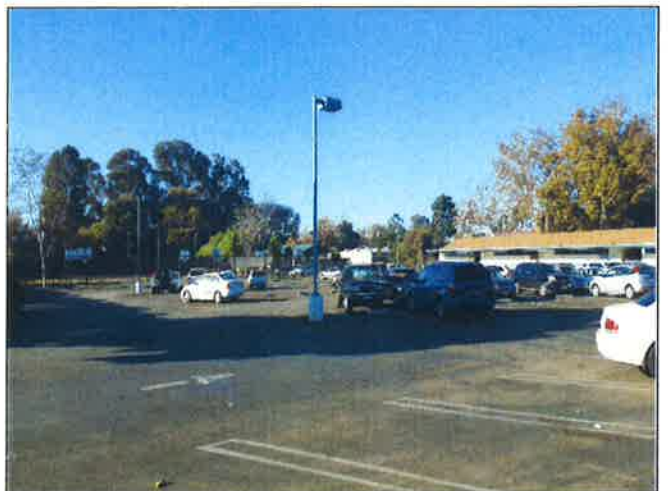
18. Overview of south parking

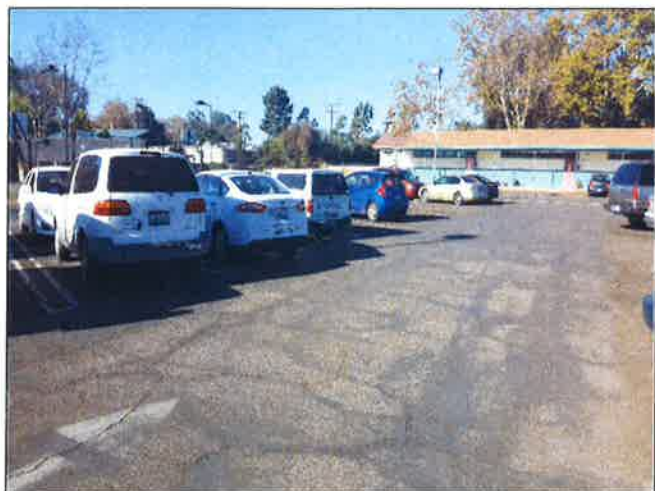
19. South parking paving conditions

3.6	Mill, grind and place asphalt overlay	25	24	1	102,000	SF	\$2.75	\$280,500									\$ 280,500
3.11	Throughout parking area Replace garage	15	13	2	1	LS	\$17,000	\$ 12,000									\$ 12,000
BUILDING STRUCTURE

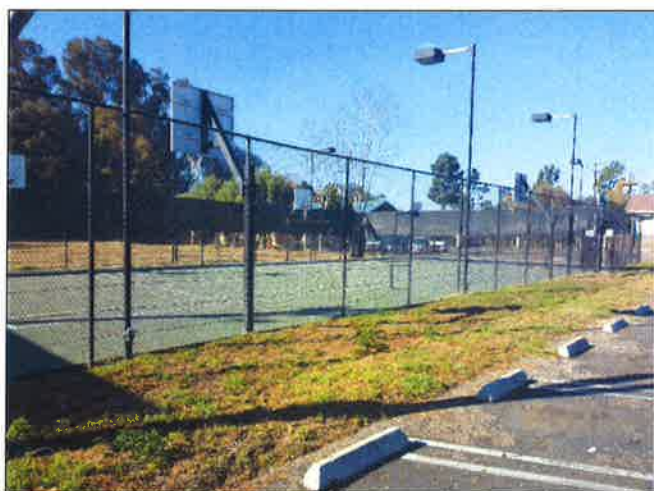
21. Boys Club tennis courts along south parking lot

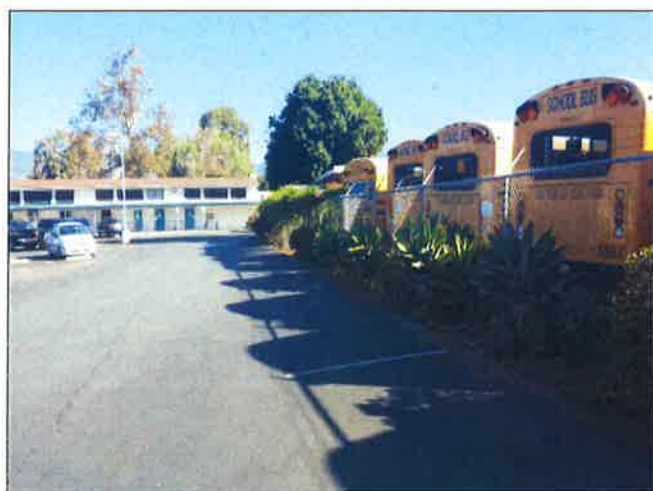
22. School district bus parking east of property

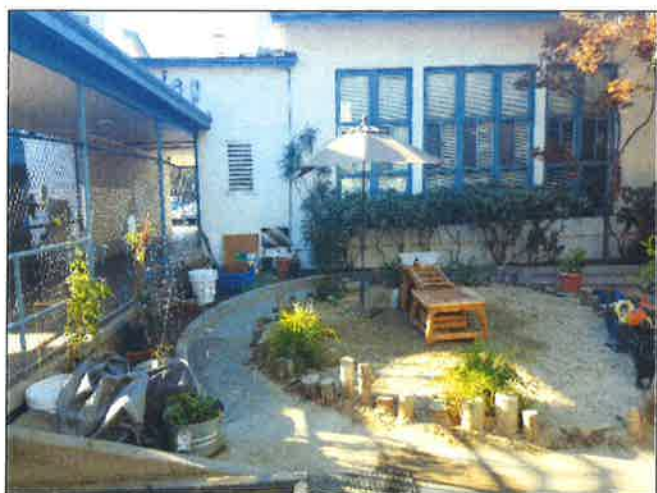
23. Day Care playground behind Building B

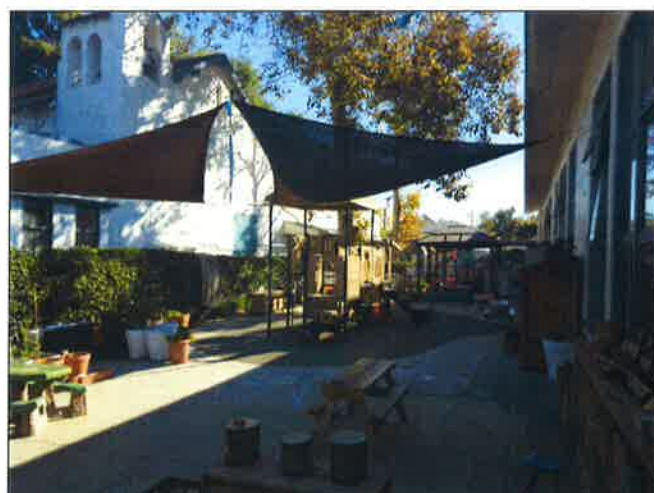
24. Head Start playground between Buildings A and B

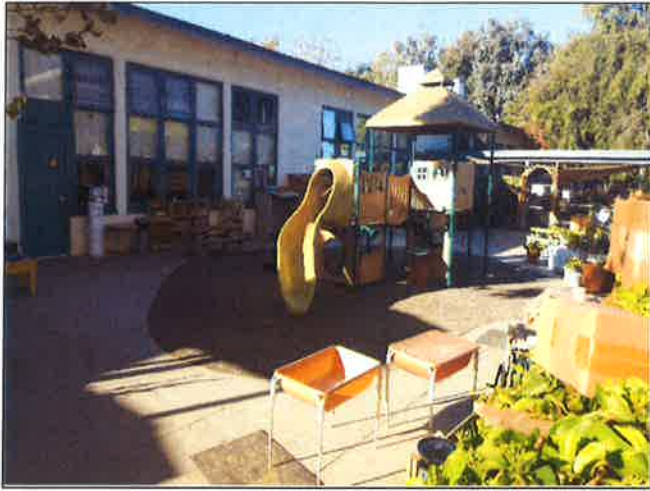
25. Playground area behind Building B

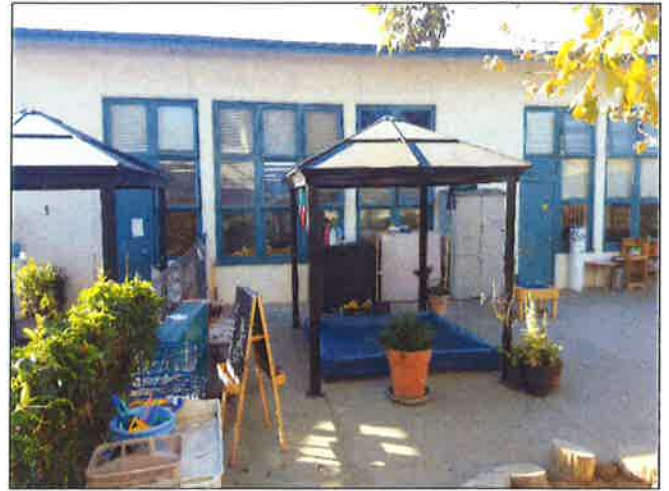
26. Playground area behind Building B

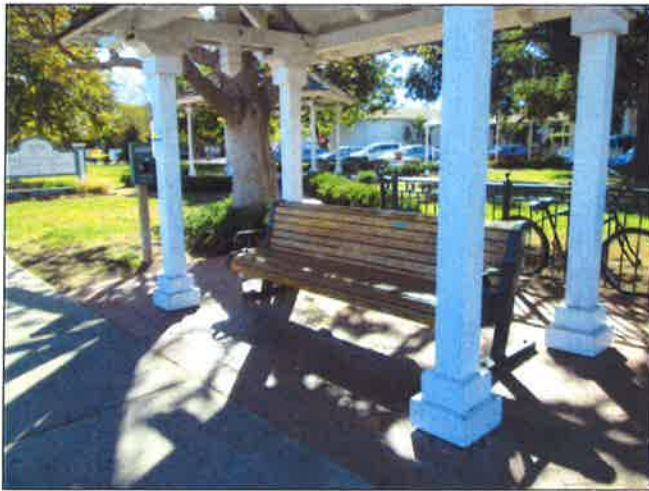
27. Bus Shelter along Hollister Avenue

7.0	None noted						
CODE REVIEW							
8.0	None noted						
ADA COMPLIANCE							
9.0	Modify bus shelters to provide wheelchair access	2	EA	\$1,500	\$3,000		\$ 3,000

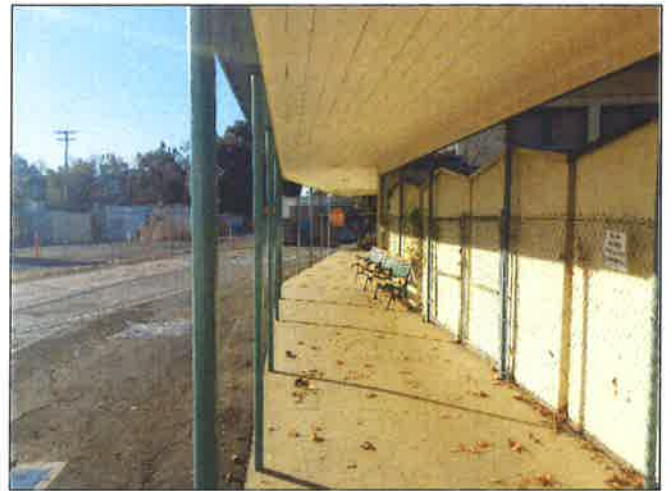
28. Typical exterior walkway along classroom building

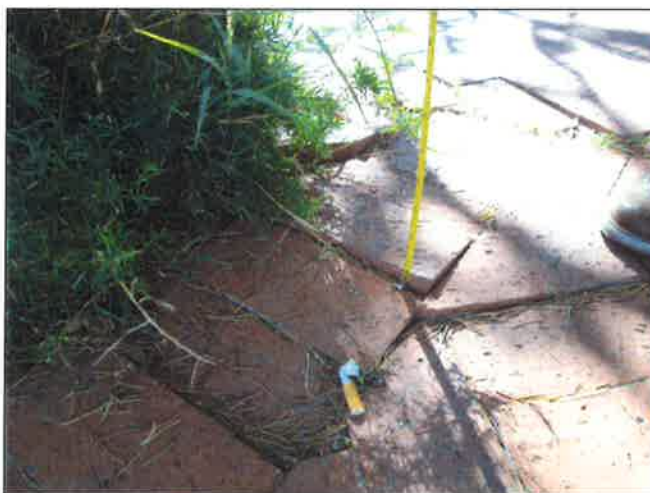
29. Uneven pavers at accessible route from Hollister Avenue

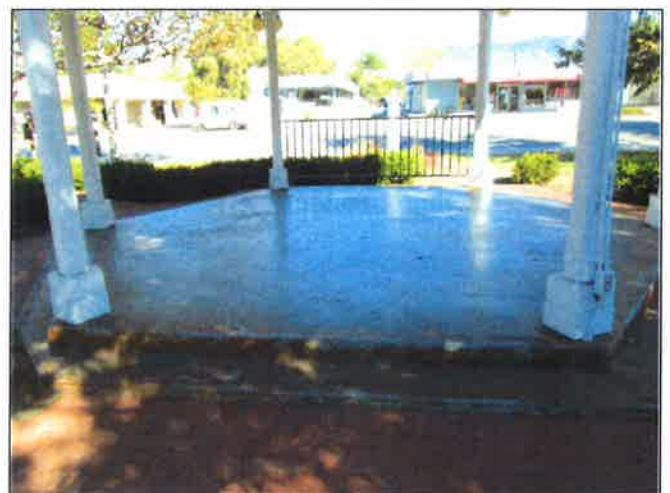
30. Accessible ramp required to top level of gazebo

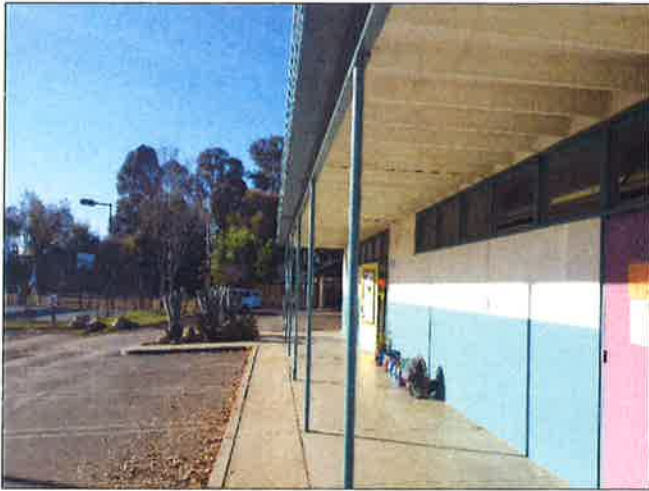
31. Typical exterior walkway along Day Care/Toddlers Rainbow School Building C4

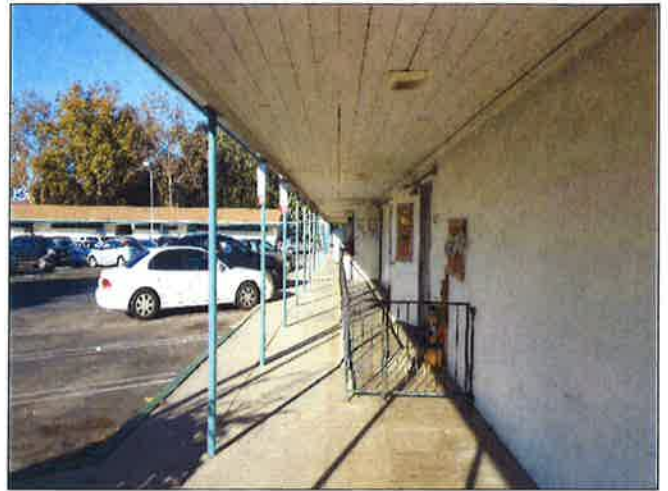
32. Walkway along Head Start School Building B

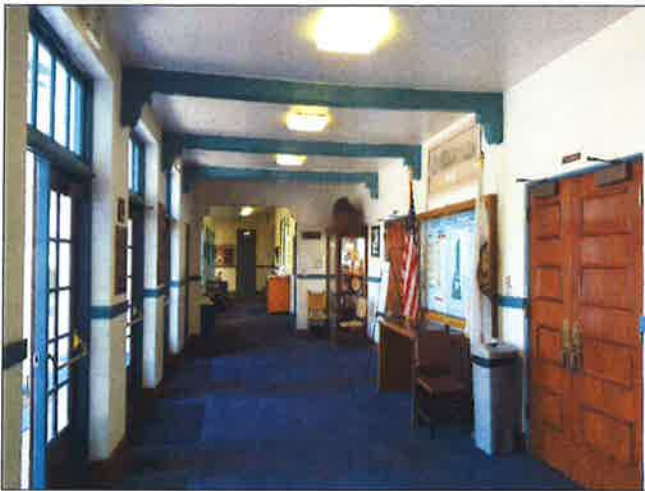
33. Main Building typical interior corridor

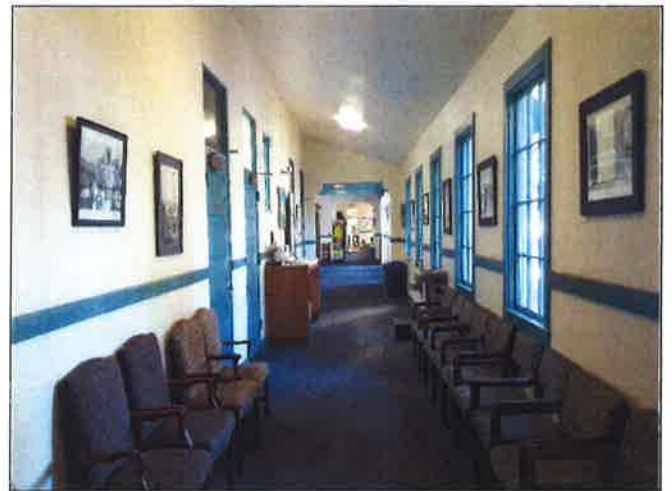
34. Interior corridor at administration office

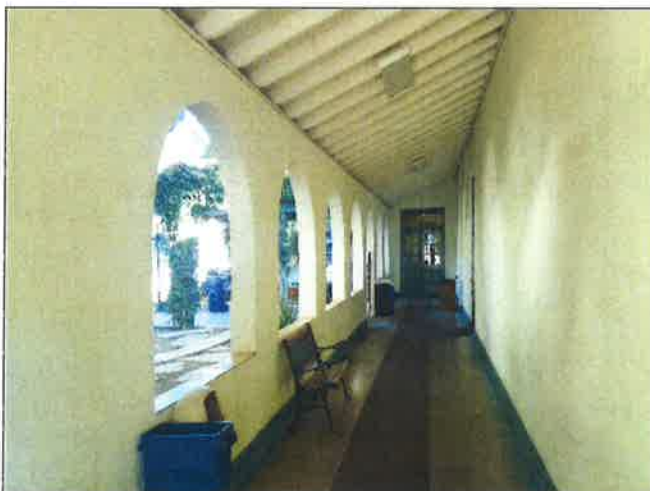
35. Interior corridor next to courtyard

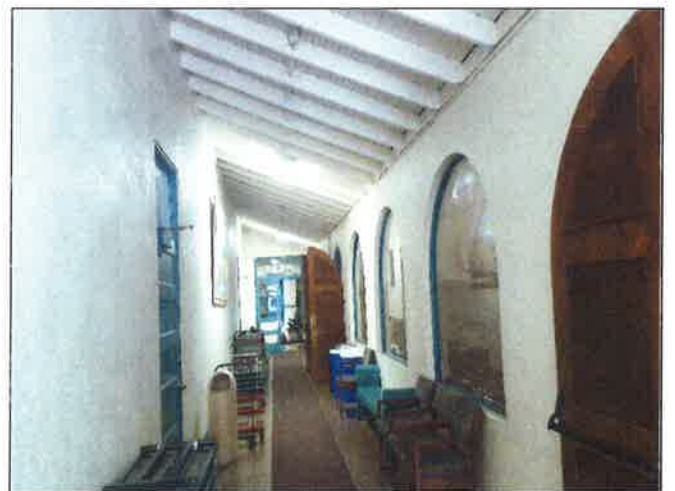
36. Interior corridor at performance room

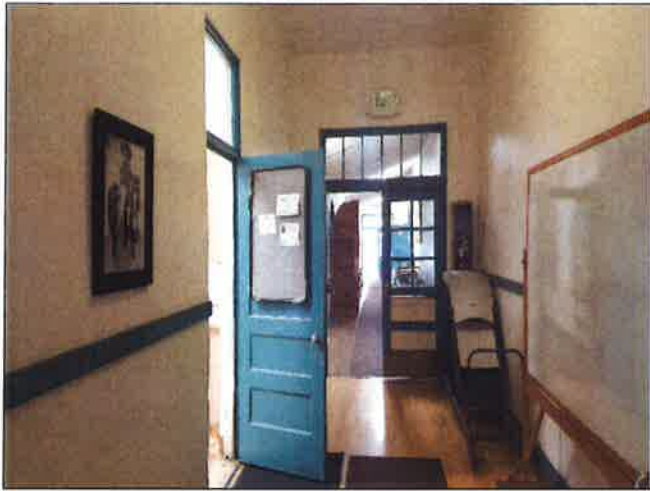
37. Typical Community center interior finishes

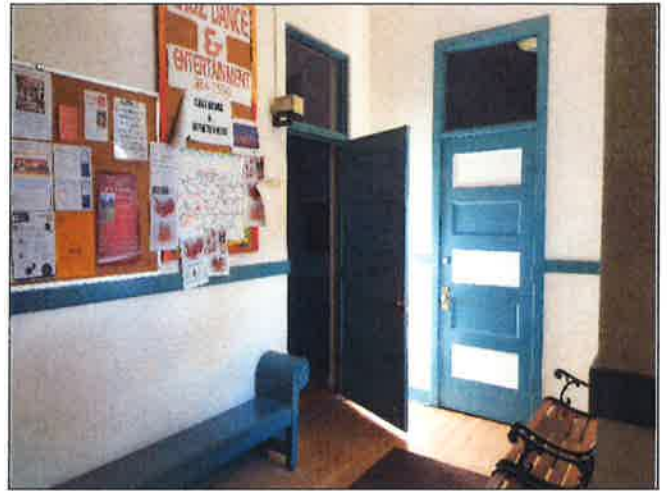
38. Interior finishes

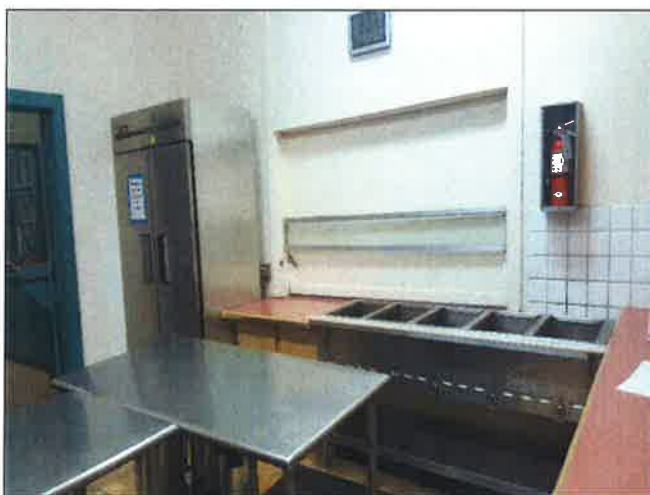
40. Kitchen interiors

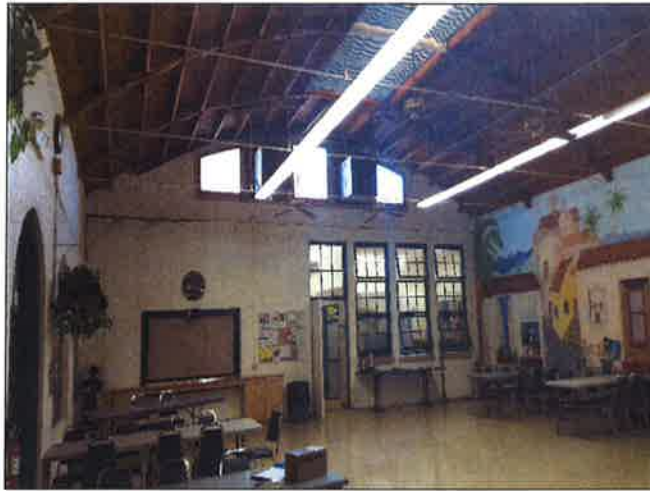
42. Multi-use room interiors. Note exposed roof structure

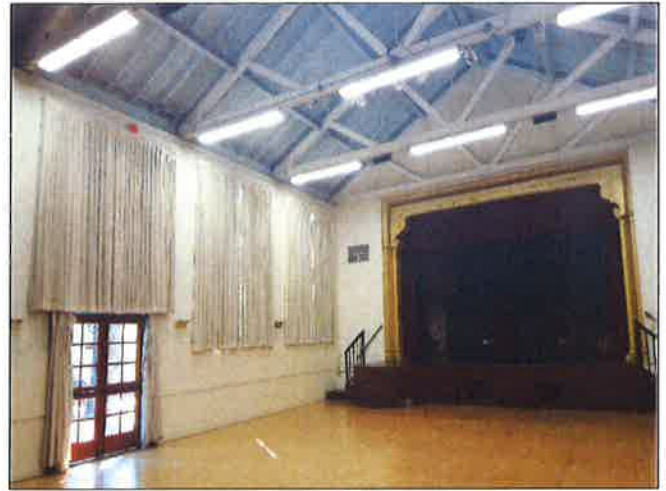
43. Multi-use room interiors

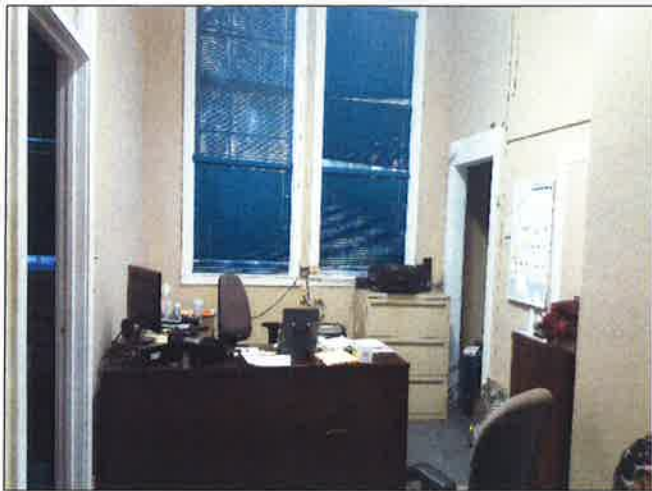
44. Assembly Hall interiors. Note exposed roof structure

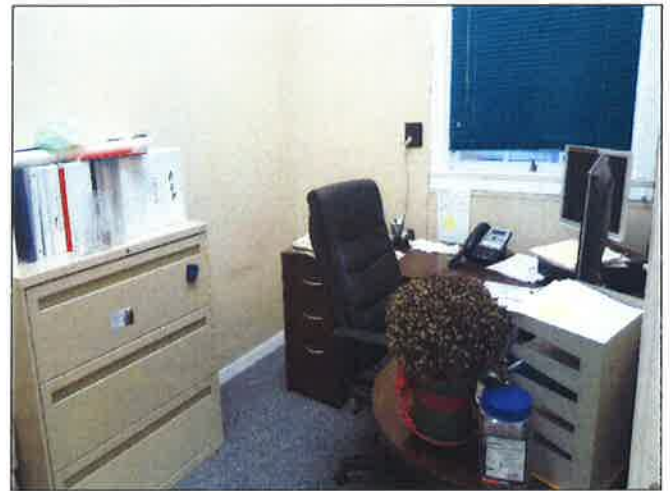
45. Typical administration office interiors

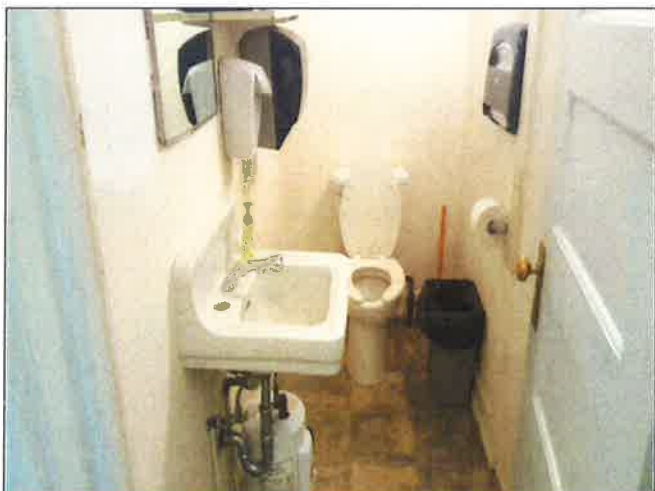
46. Office interiors

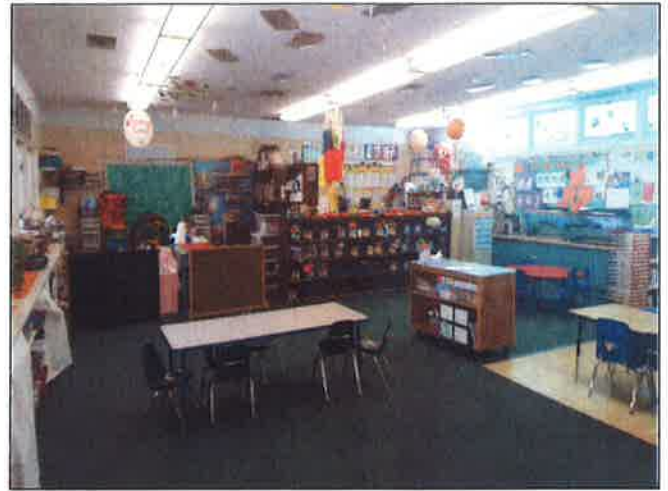
49. Classroom interiors

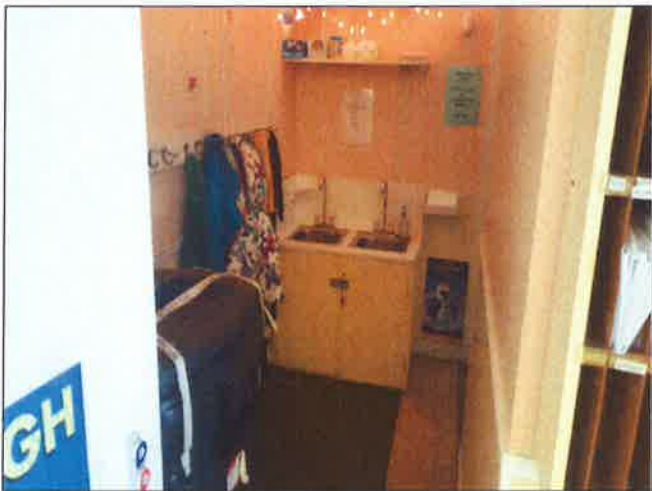
50. Classroom interior conditions

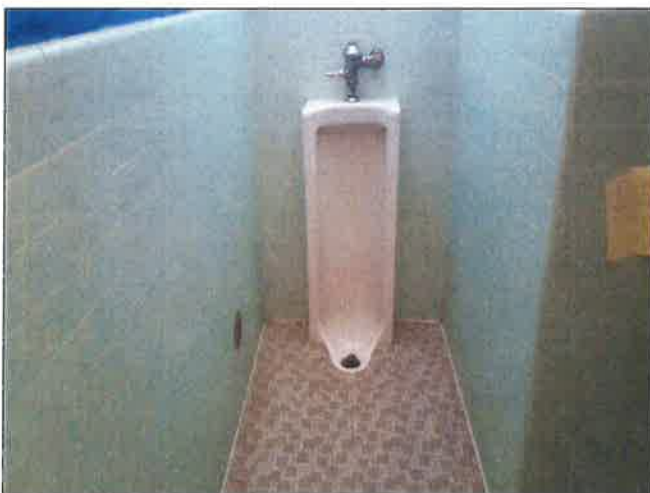
52. Kids toilet room

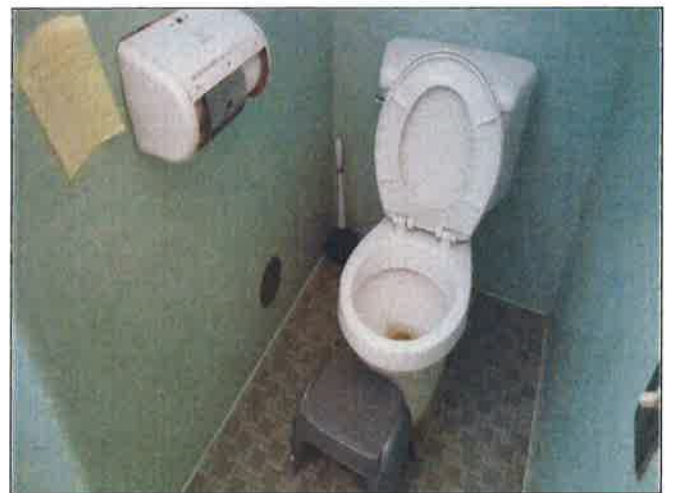
53. Urinal room

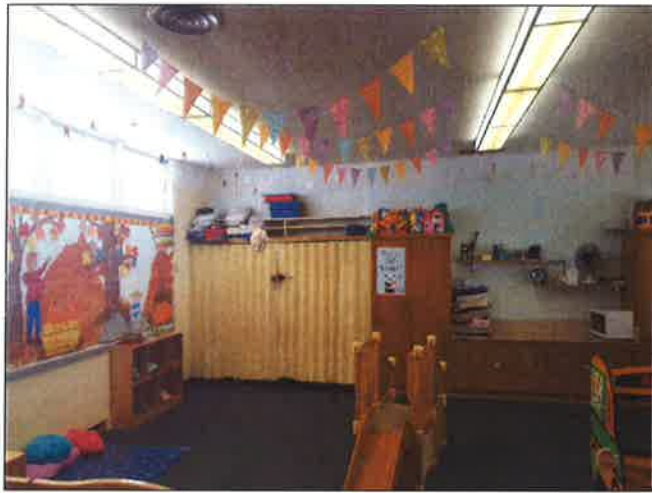
60. Toddlers Room 12, interiors

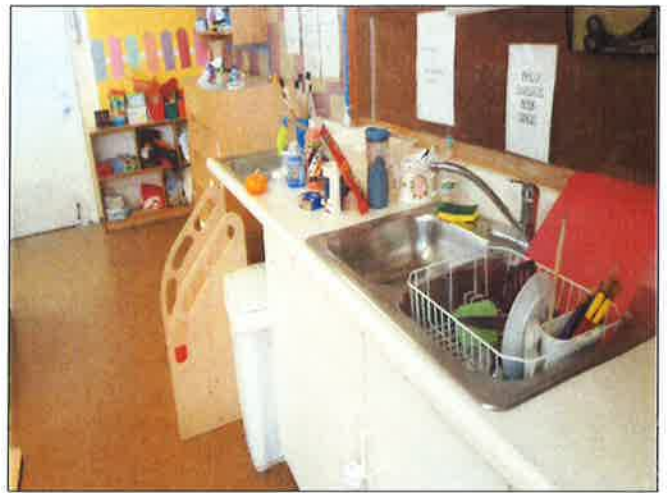
61. Classroom interior conditions

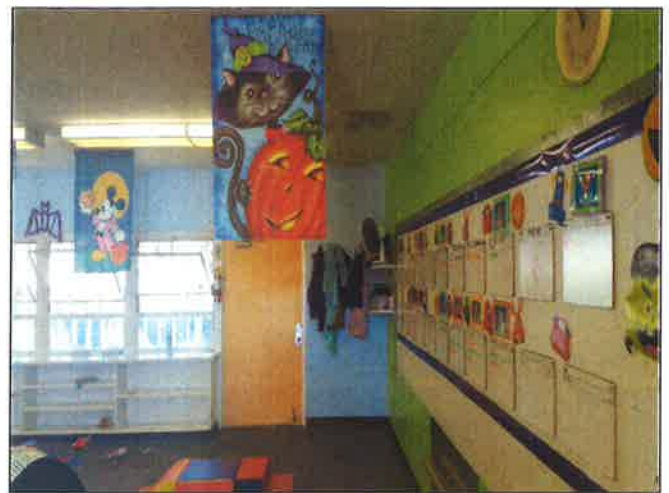
63. Infant room interiors

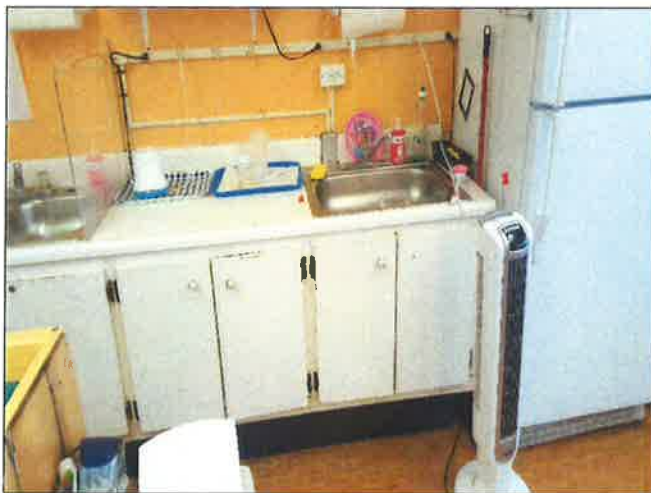
64. Interior conditions at infant classroom

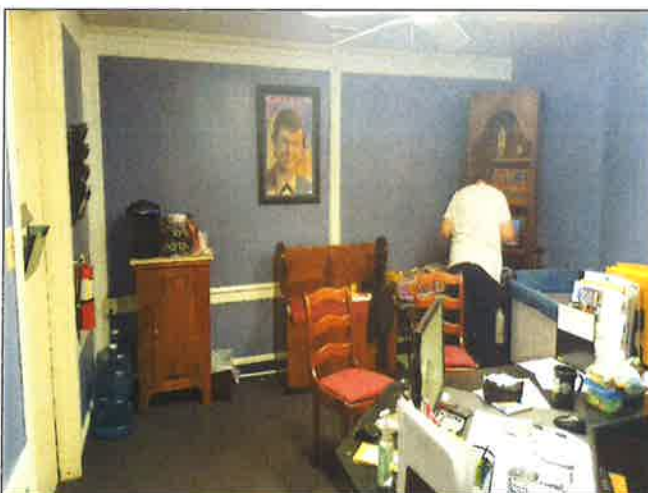
70. Teenagers school office interiors

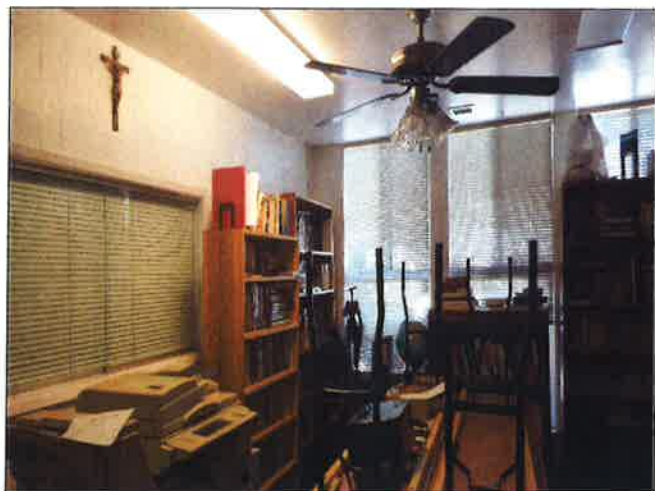
72. Classroom interiors

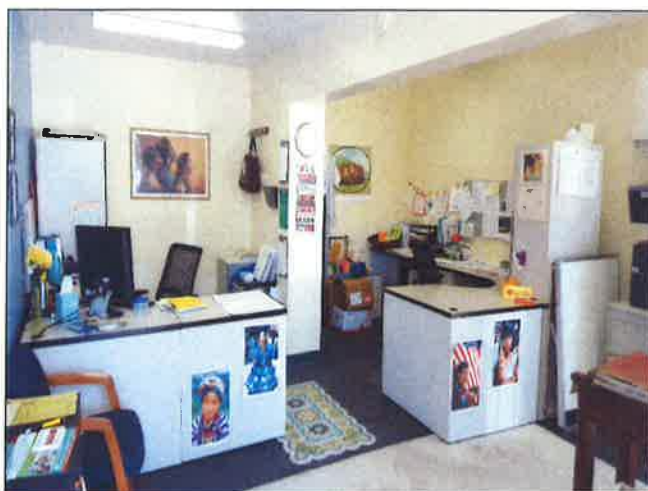
73. Classroom interiors

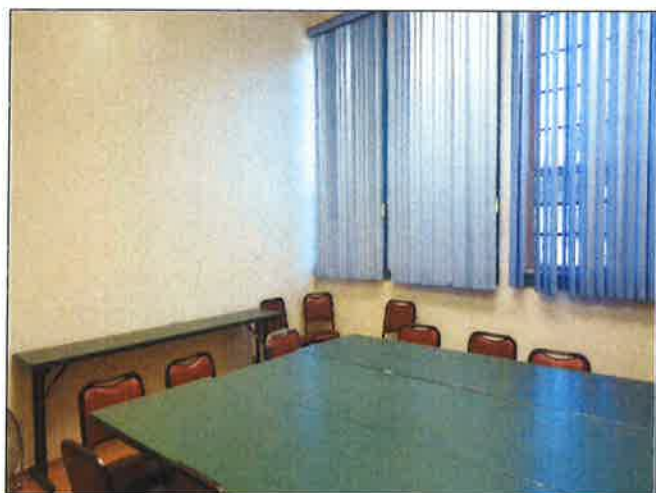
74. Goleta Center Office

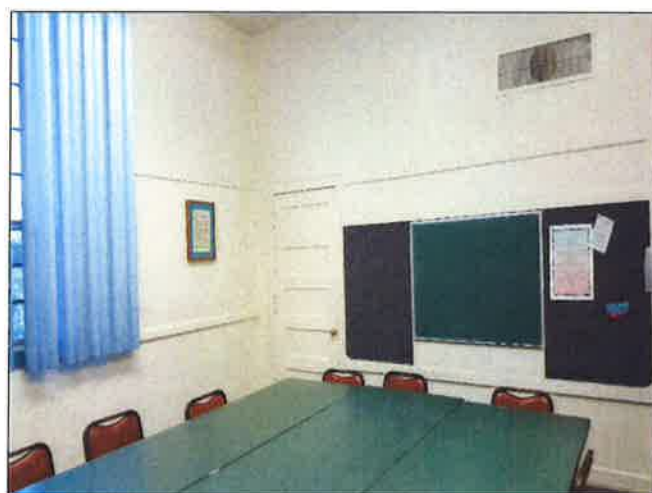
75. Classroom interiors

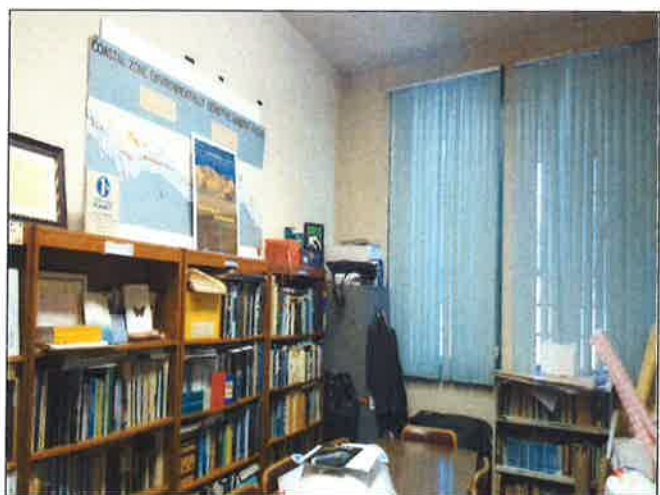
76. Typical multi-use room interiors

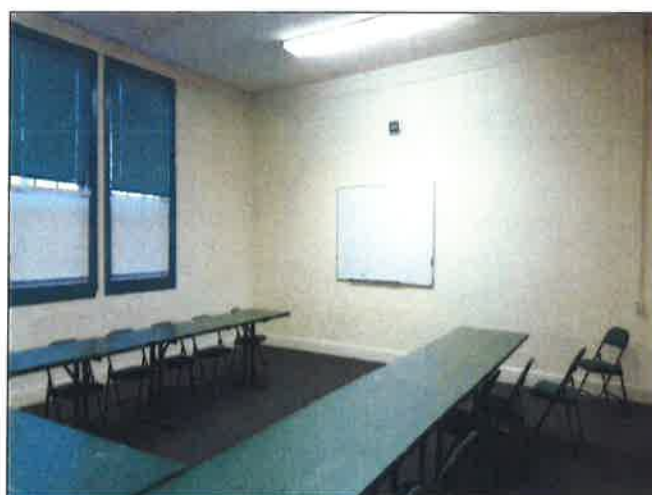
77. Office interiors

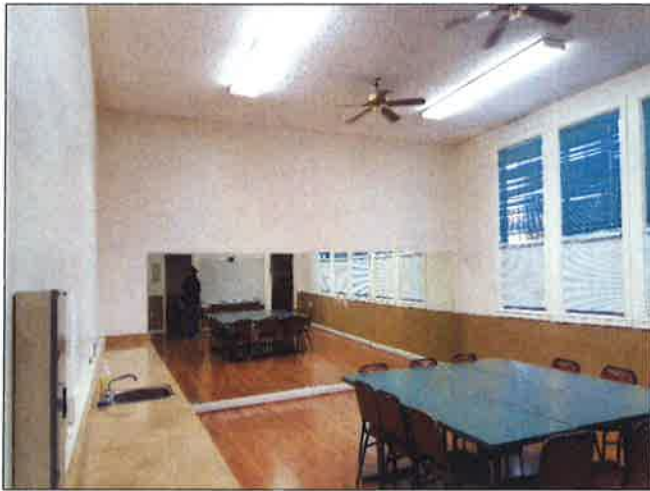
79. Multi-use classroom

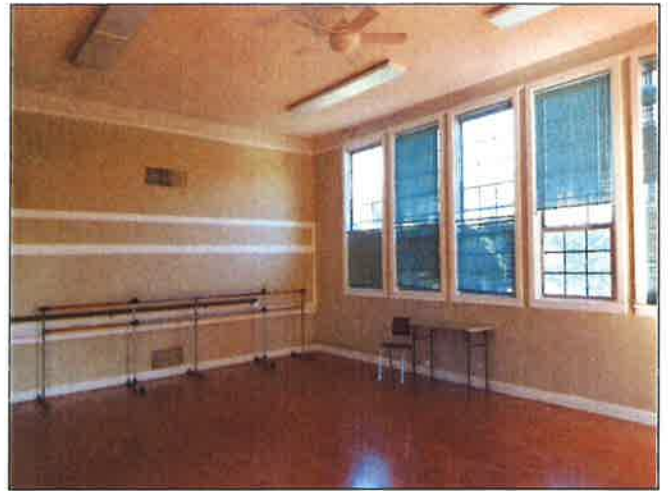
80. Classroom interiors

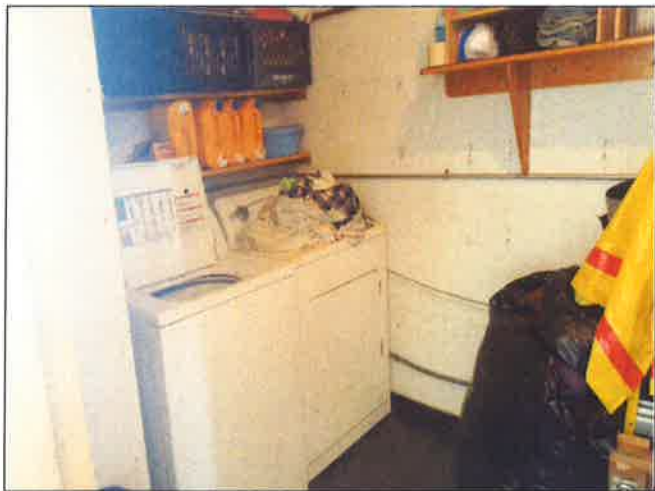
81. Laundry room

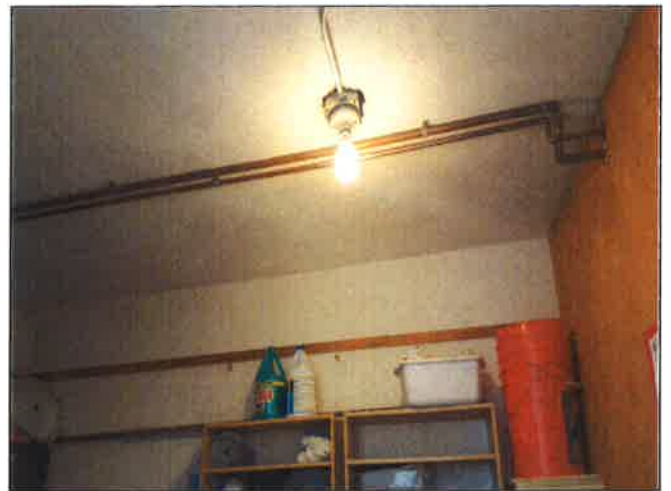
82. Laundry room with exposed plumbing pipes

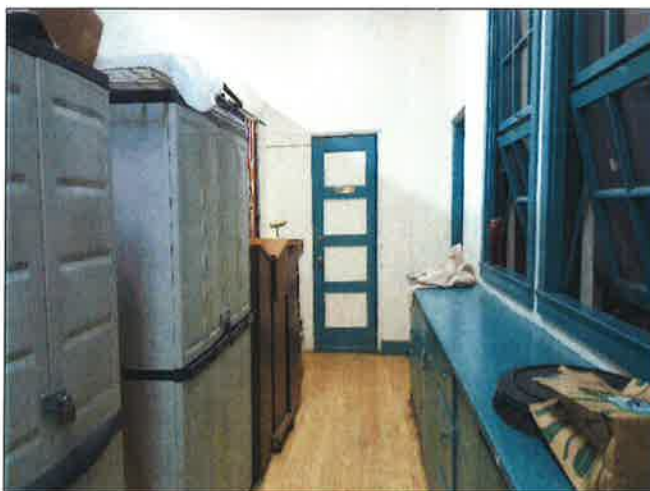
83. Kitchen storage area

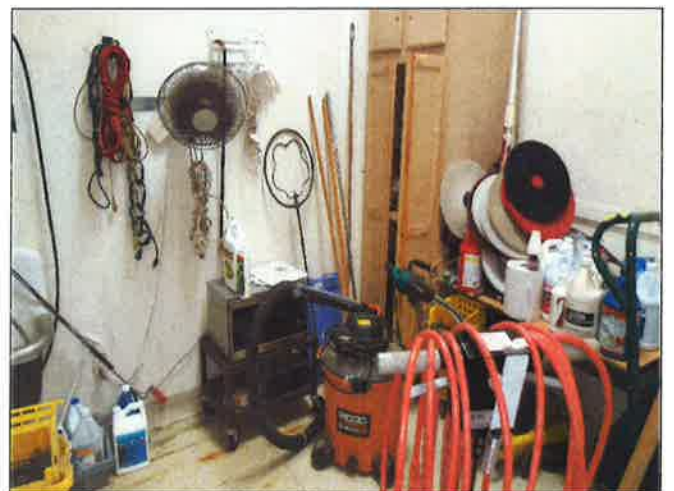
84. Maintenance room

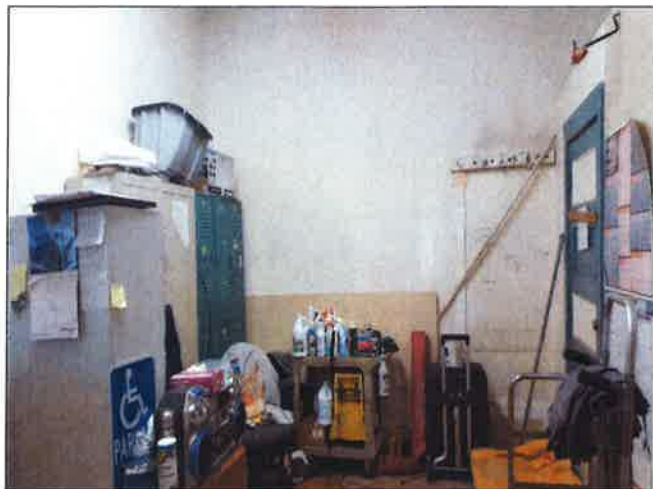
85. Maintenance room interiors

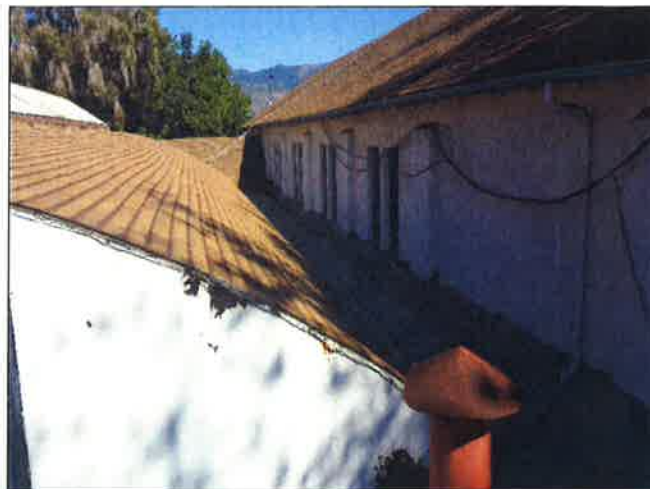
86. Typical pitched roof of Assembly Hall to flat roof and barrel roof

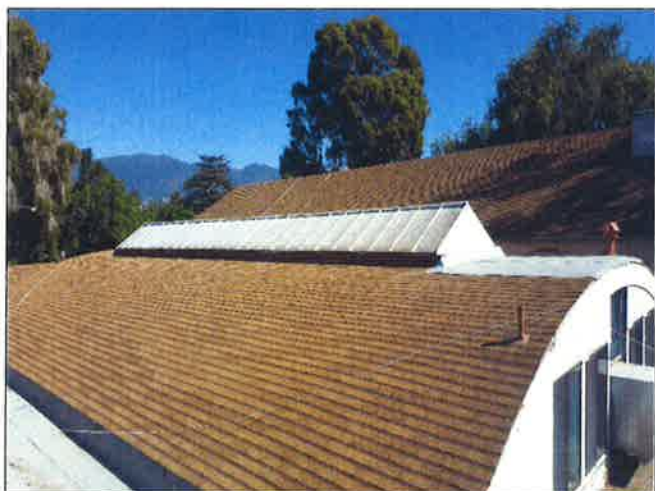
87. Barrel roof and skylight overview

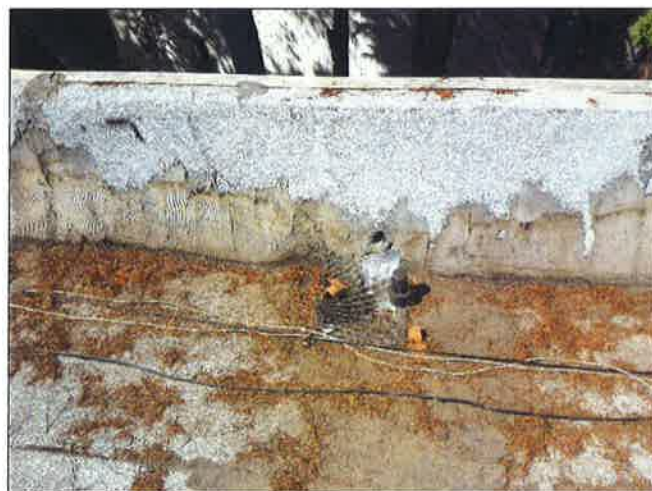
88. Roof drains

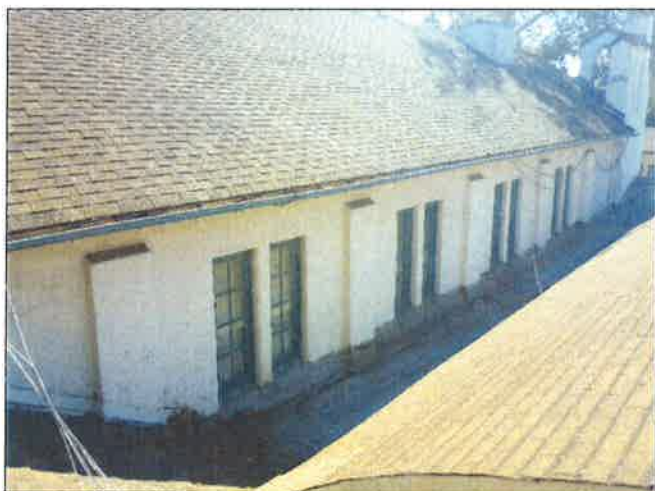
89. Windows and roof of Assembly Hall
