PROPERTY CONDITION REPORT

Goleta Community Center
5679, 5681 & 5689 Hollister Avenue
Goleta, California 93117

December 30, 2016
Partner Project Number: 16-170535.1

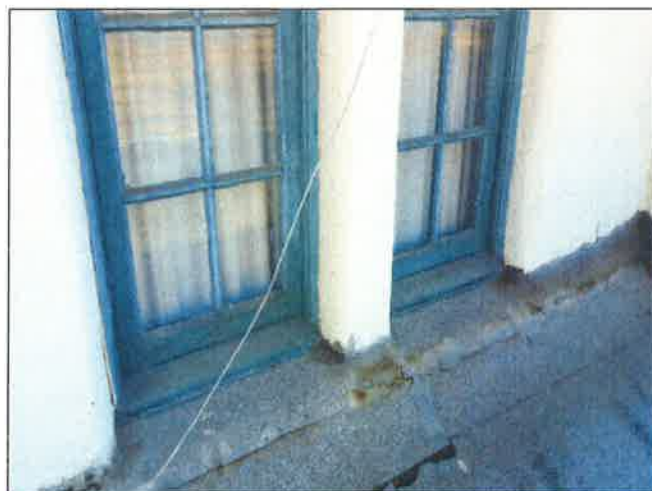
90. Assembly Hall windows conditions at roof area

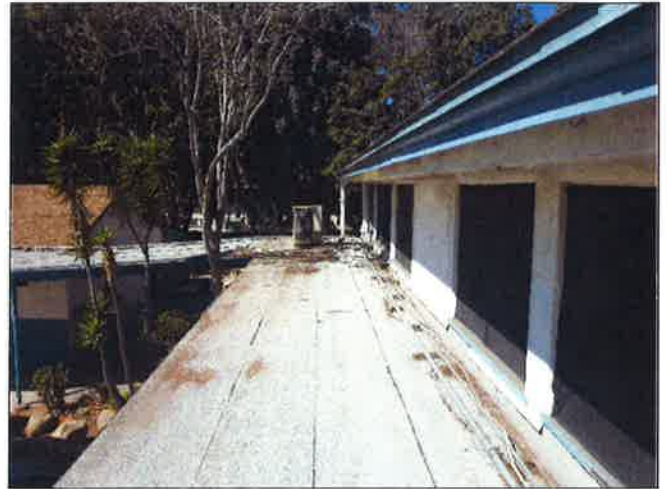
92. Roof of open walkways

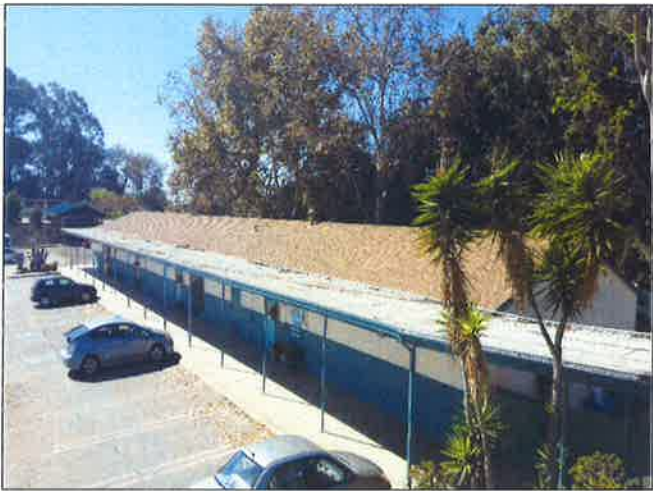
93. Building C4 Roof overview

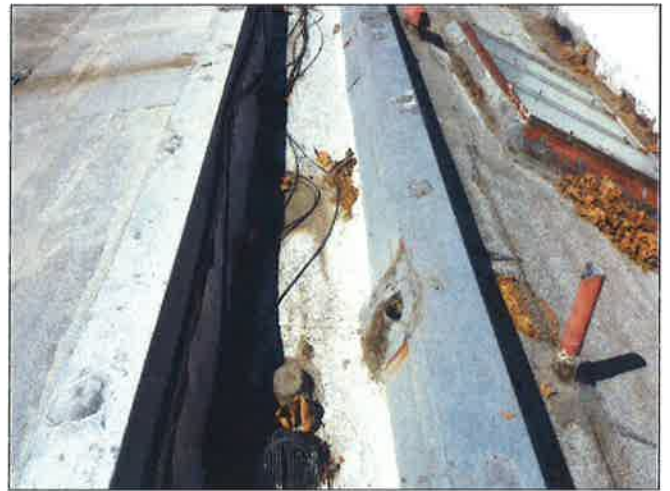
94. Typical parapets and drains at roof

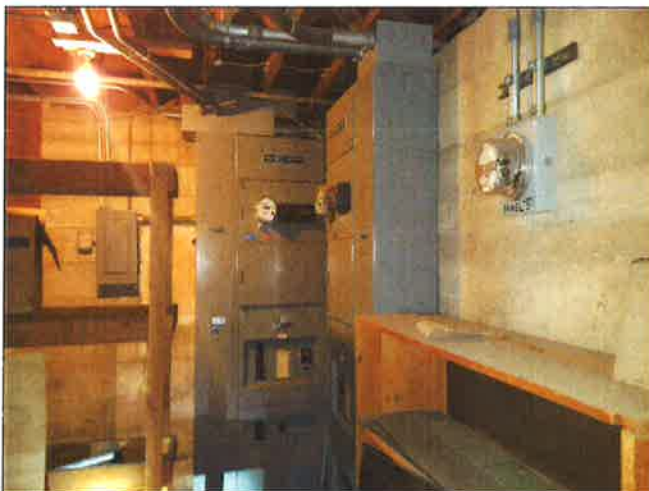
95. Electrical services at basement

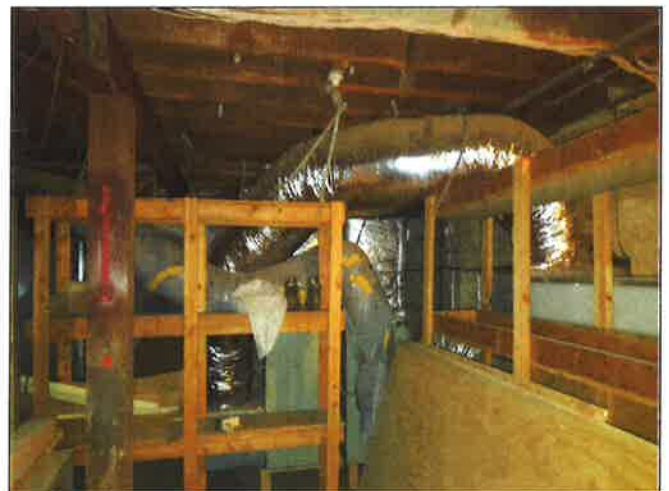
96. Community Center furnace at basement

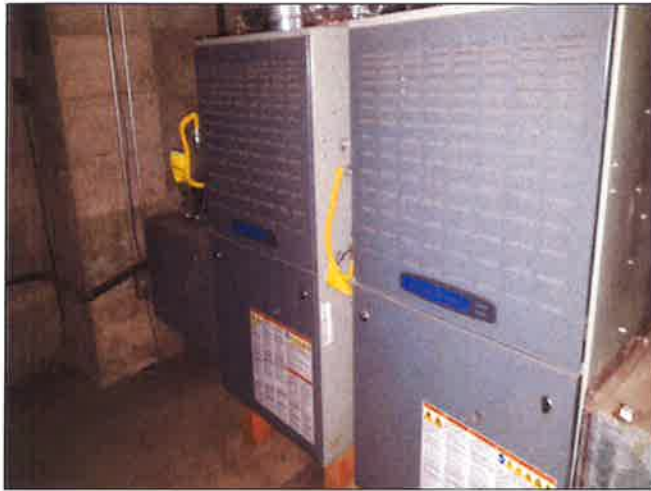
97. Furnaces for Community Center classroom's heaters at basement

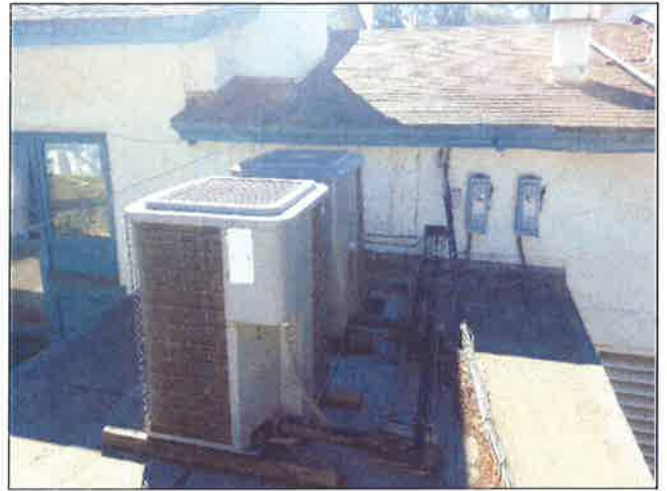
98. Condenser units at roof

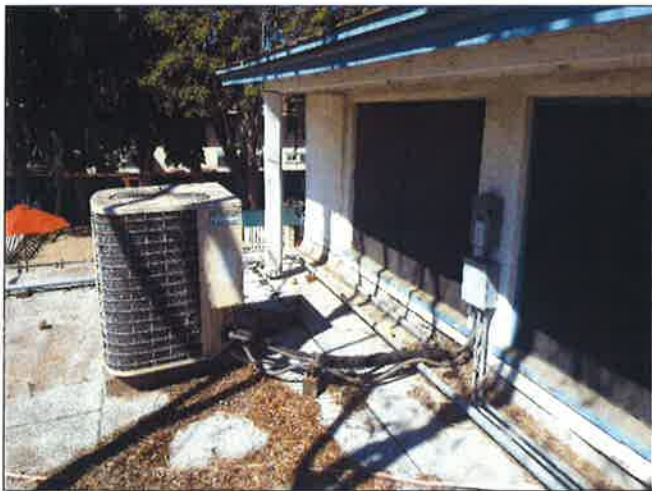
99. Condenser unit for Building B appears inoperative

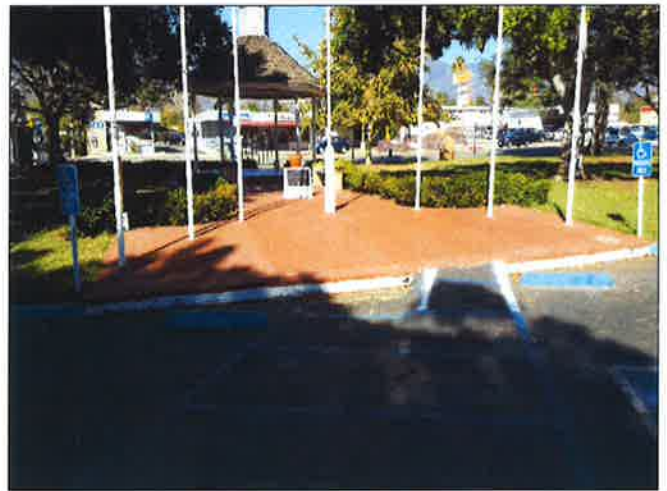
100. Curb ramps are non-compliant and requires reconfiguration

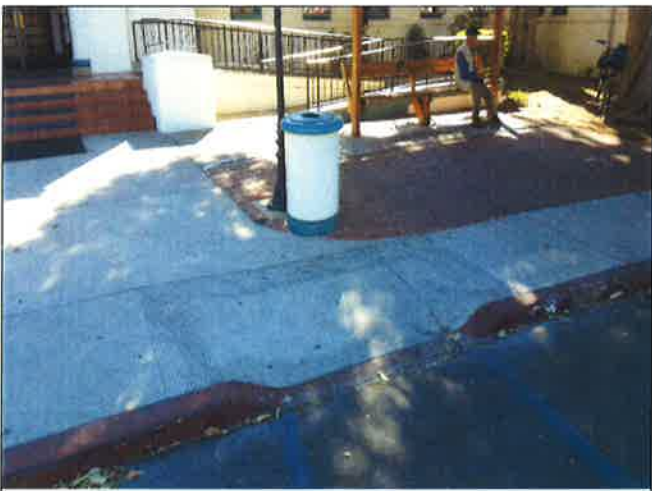
101. Non-compliant curb cut at sidewalk from accessible route

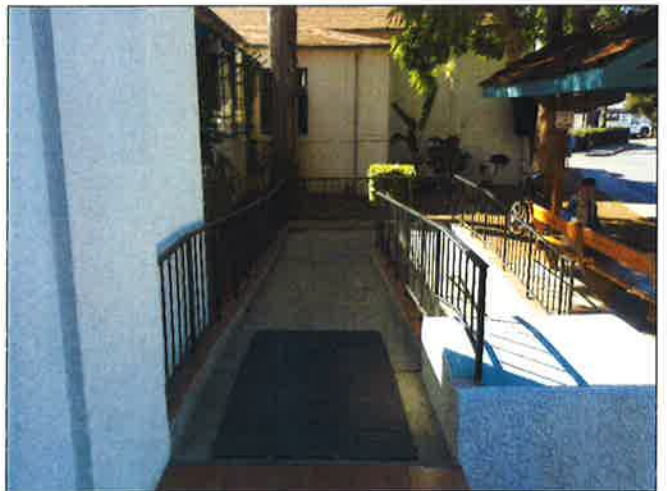
102. Non-compliant handrails at ADA ramp to main entrance

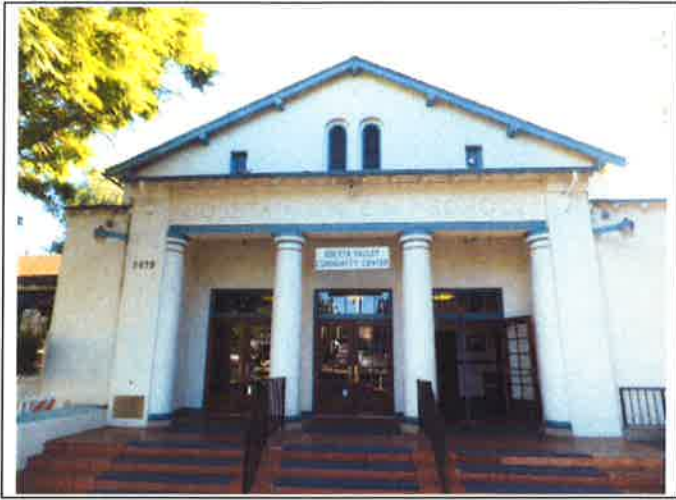
2. West wing of Main Building A and front entry beyond

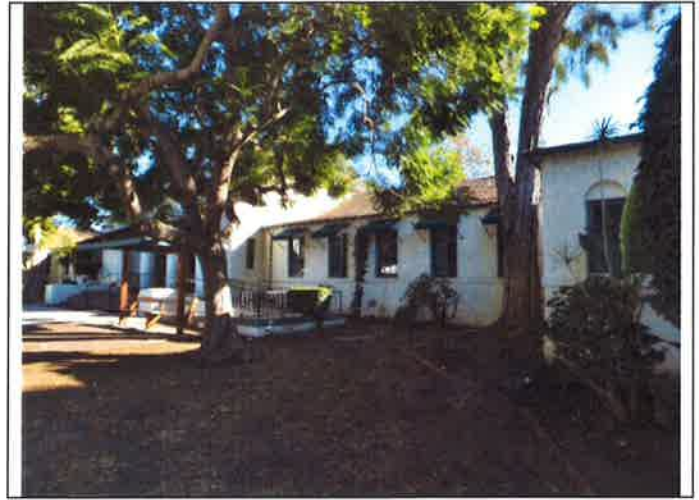
3. West of main entry to Main Building A, hallway and classrooms

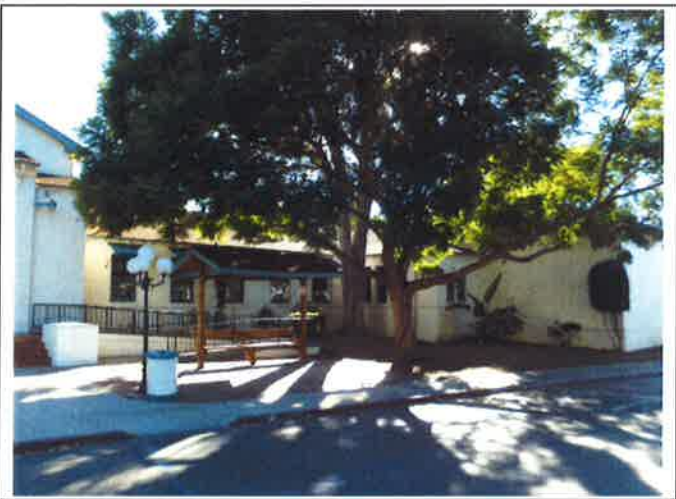
4. Hallway and classrooms to the east of the main entry of Main Building A

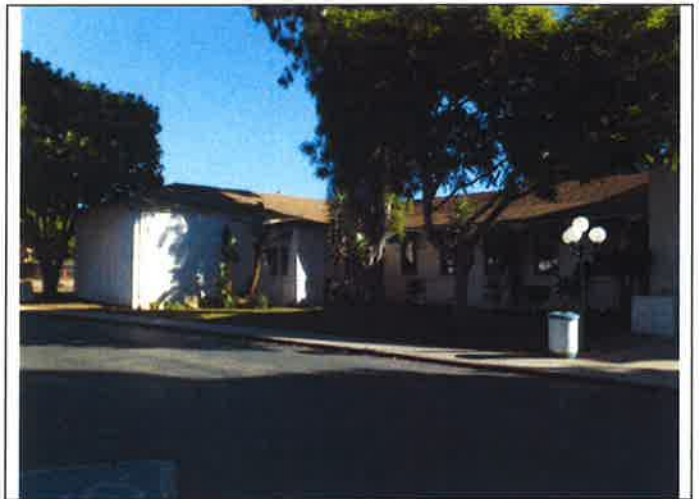
5. Main Building A, Spanish style architecture is missing the original red clay tile roof, replaced by composition shingles

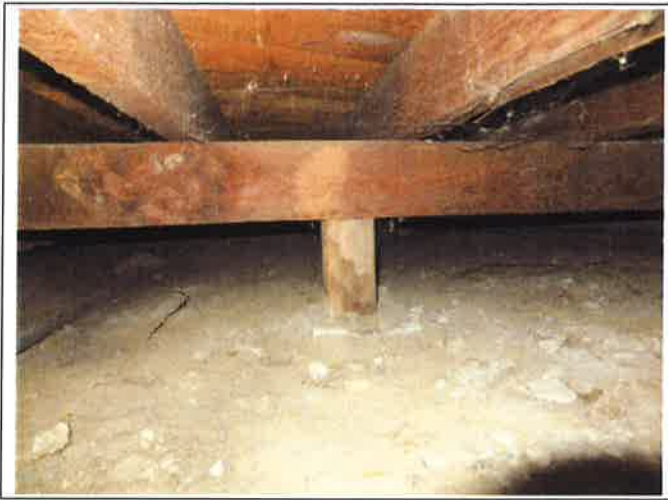
8. Main Building A substructure floor framing and foundation wall.

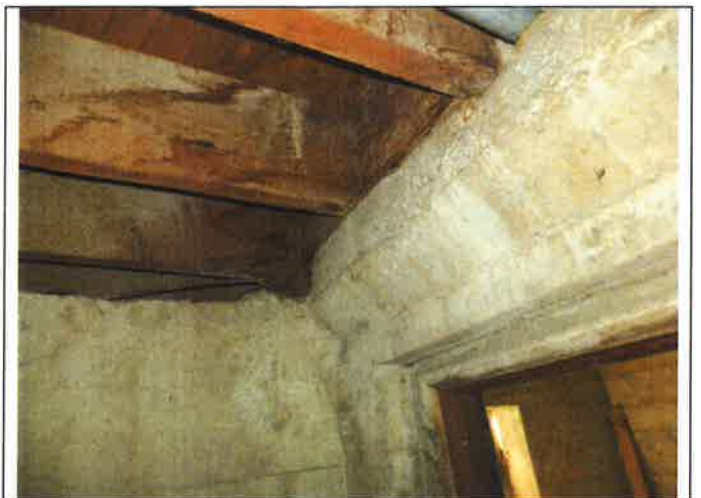
13. Foundation wall at east wall of basement, Main Building A

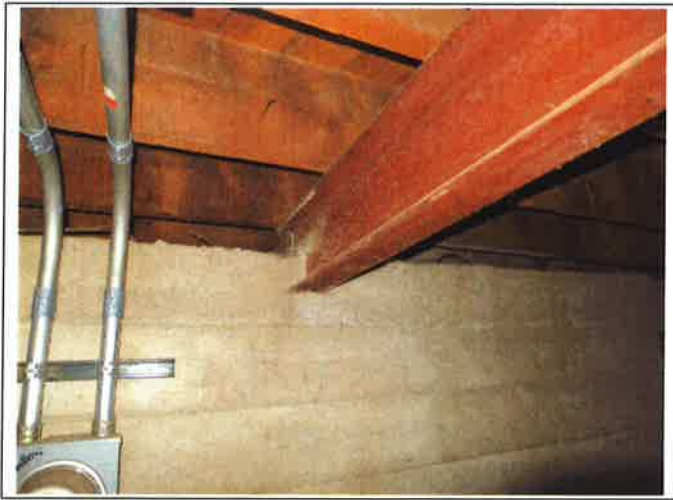
14. Basement floor joists, steel girder and wood post

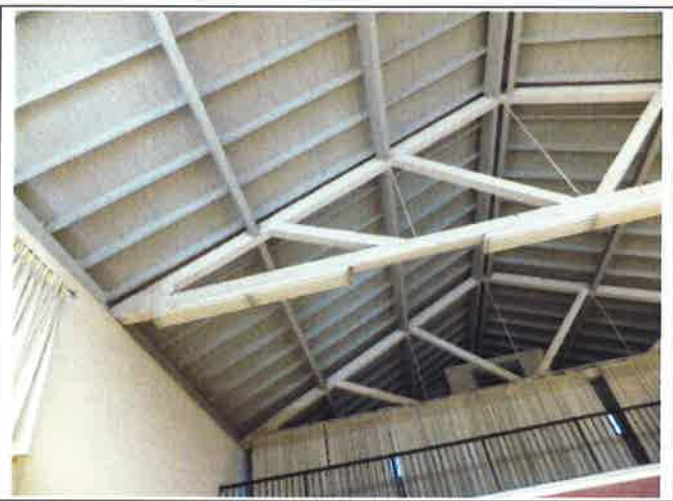
16. Auditorium Roof truss over stage opening

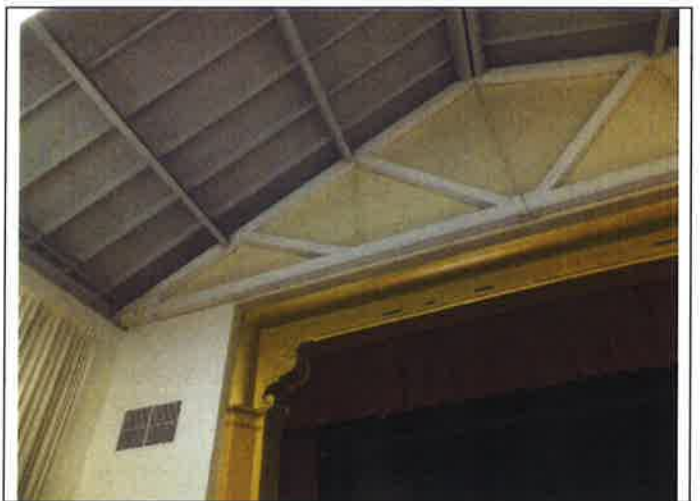
17. Auditorium roof structure

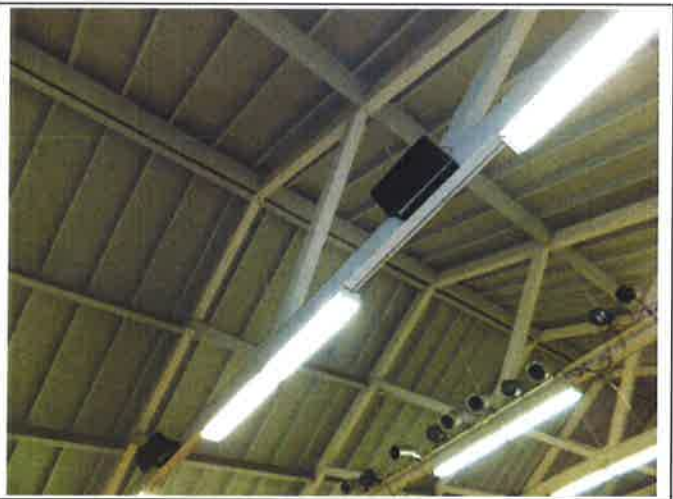
18. Auditorium roof in front of stage Main Building A

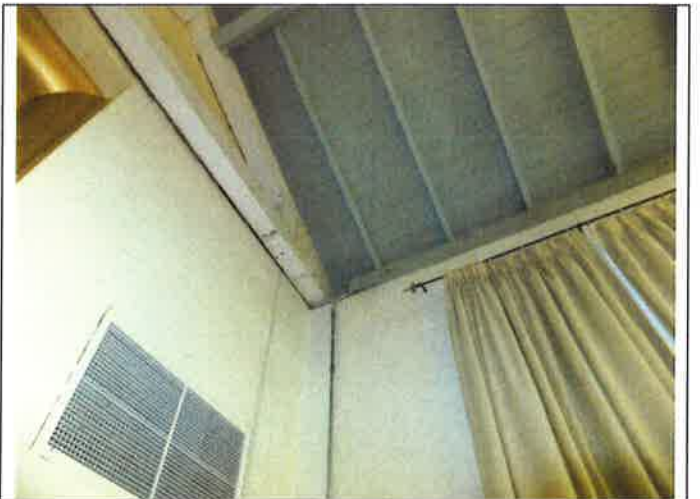
19. Interior, west wall of Auditorium, Main Building A

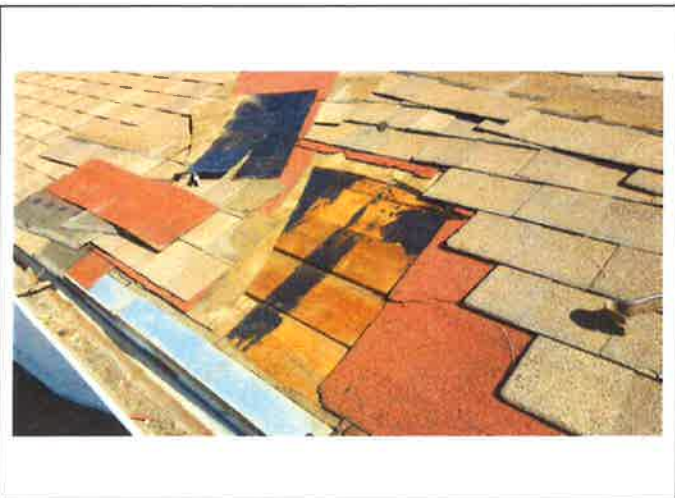
23. Auditorium roof with roof covering peeled back to expose 1x sheathing

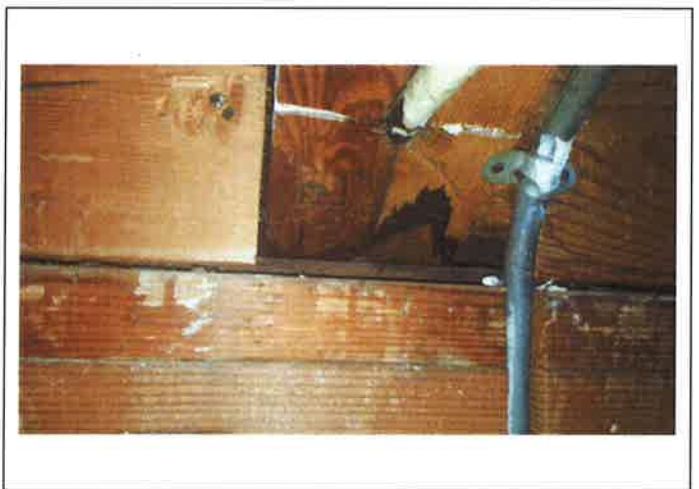
28. Barrel truss bearing plate and tie rod end plate, after wall plaster was removed

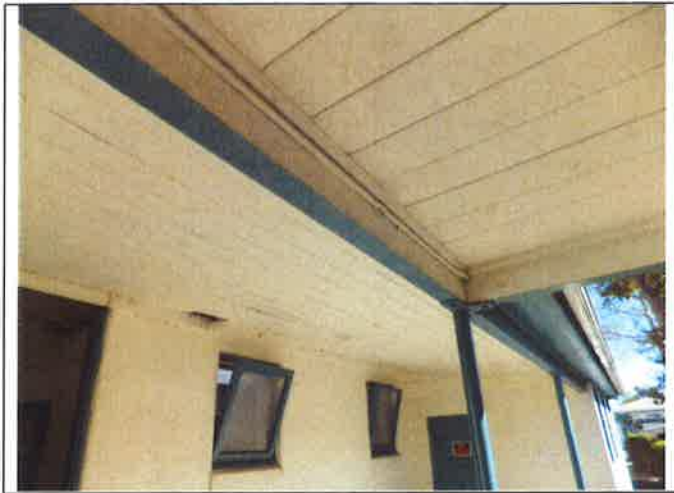
43. Fixed, rigid connection of walkway roof at Main Building A

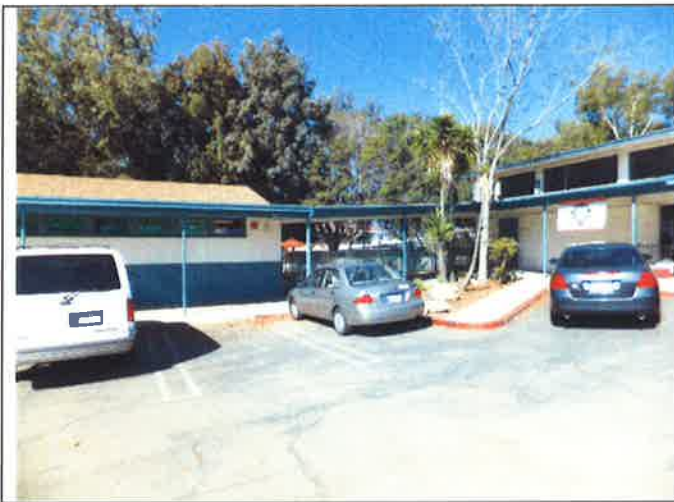
45. Covered walkway roof with fixed connections to Building B on right and Building C4 on left

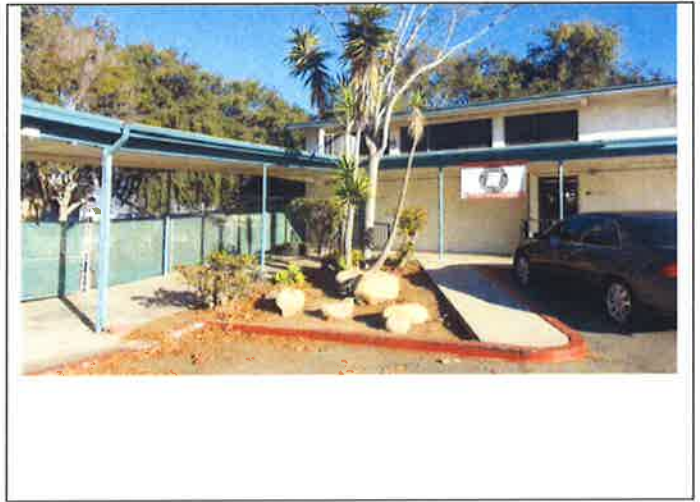
46. Covered walkway roof, fixed connections to Building B on right and Building C4 on left

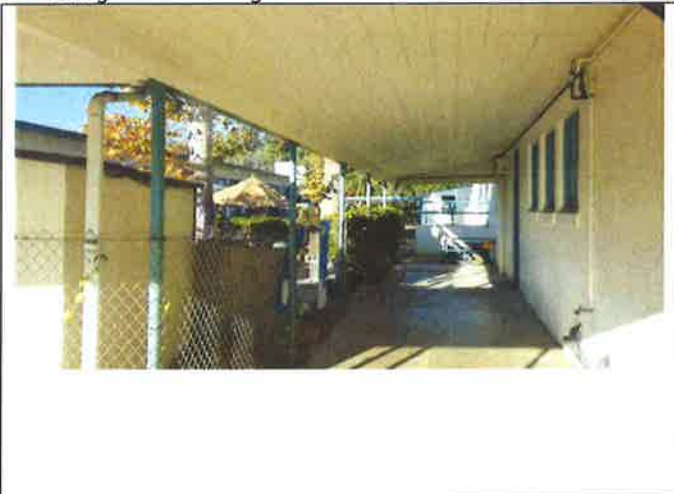
47. Covered walkway roof with fixed connections to Main Building A at south wall at east wing on right

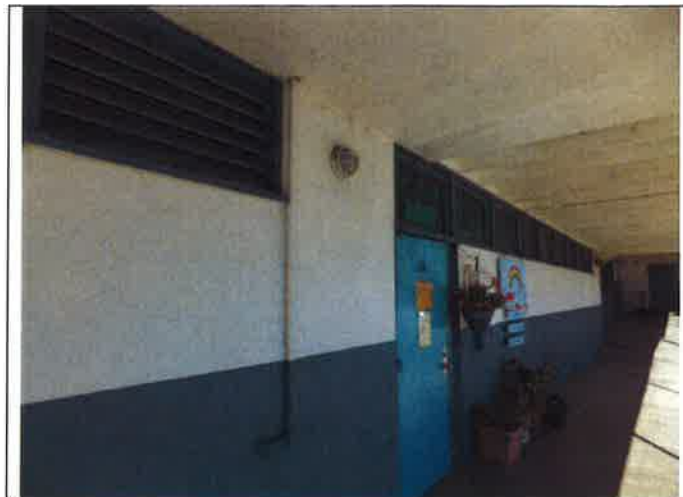
56. Full height Shear wall of Classroom Building C4 at east wall, Windows and louvered vent both sides of wall.

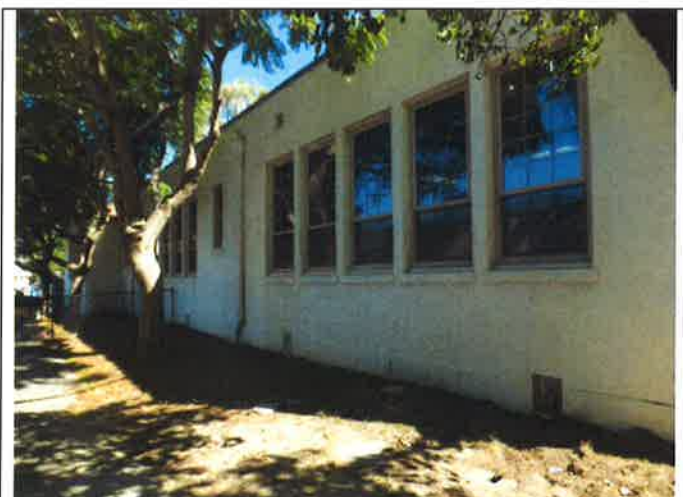
60. West wall of Main Building A, west classroom wing looking north northeast

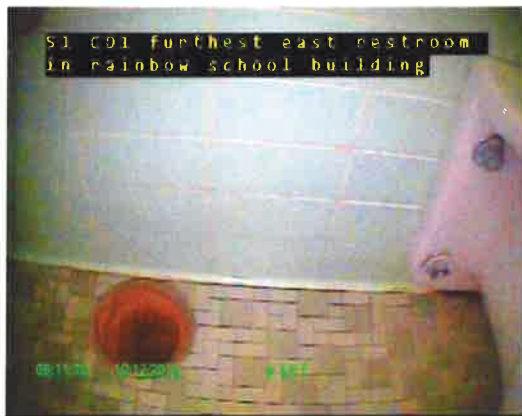
Entry point overview

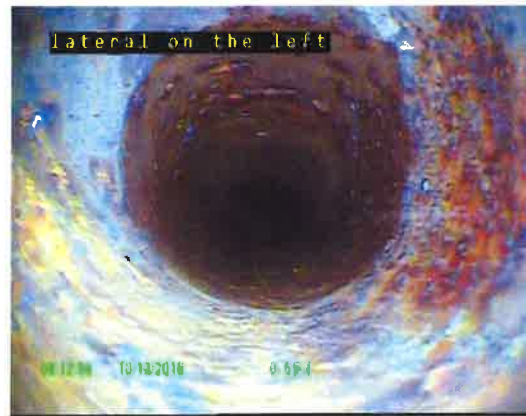
Lateral on left at 0.60 ft.

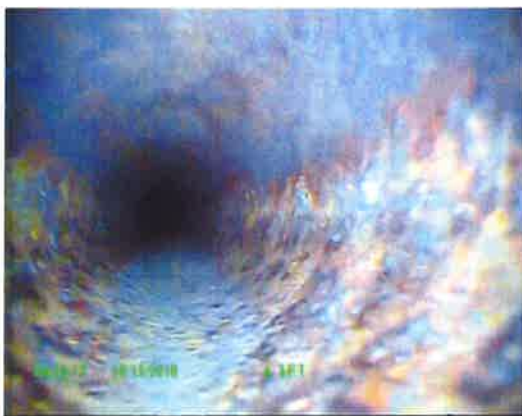
Typical clear line condition

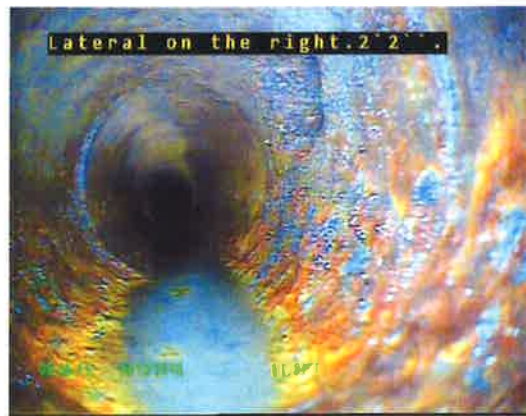
Lateral on right at 11.80 ft.

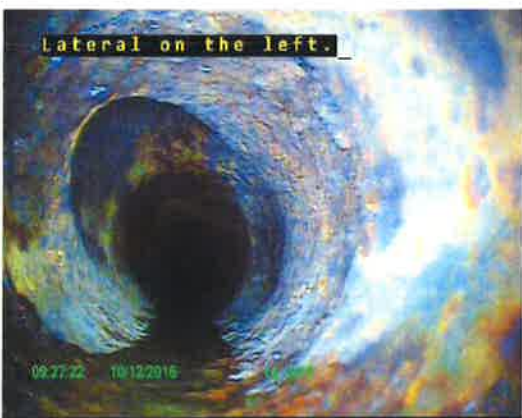
Lateral on left at 14.20 ft.

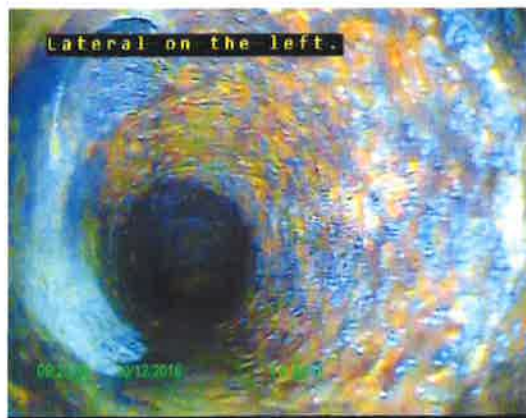
Lateral on left at 17.00 ft.

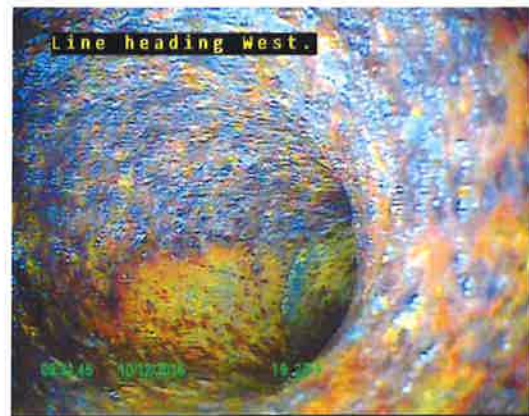
Line heads West at 19.20 ft.

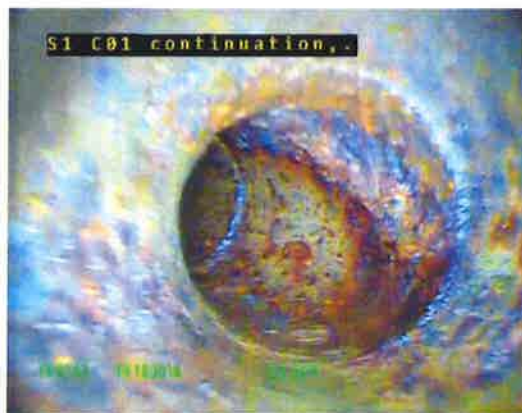
Line turns left at 23.20 ft.

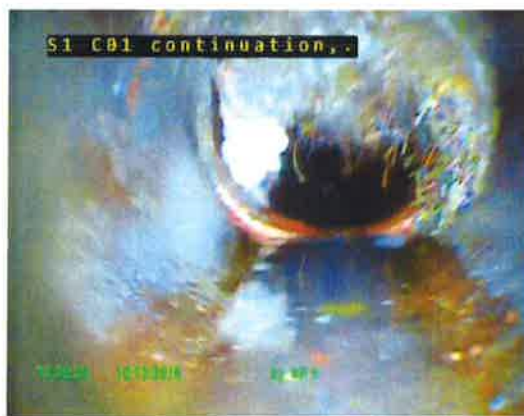
Root intrusion at 39.80 ft.

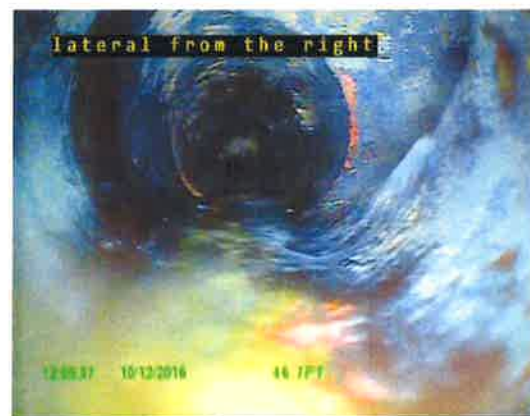
Lateral on right at 46.70 ft.

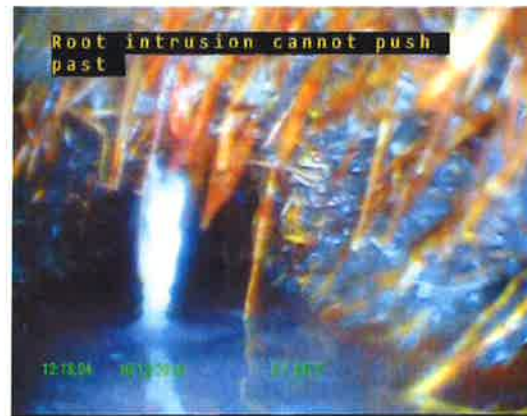
Unable to push past 50.40 ft. due to blockage with debris. Heavy root intrusion at 51.30 ft.

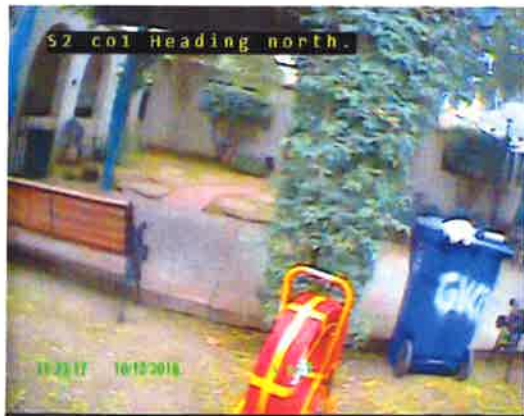
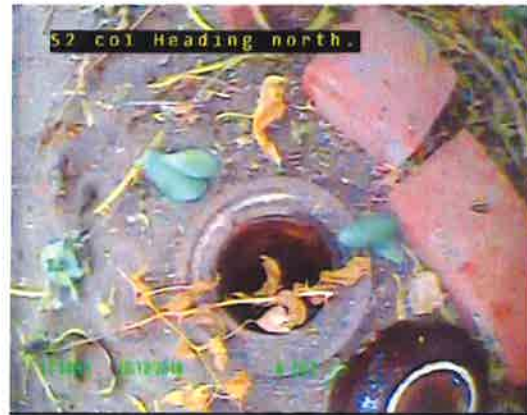
Entry point overview

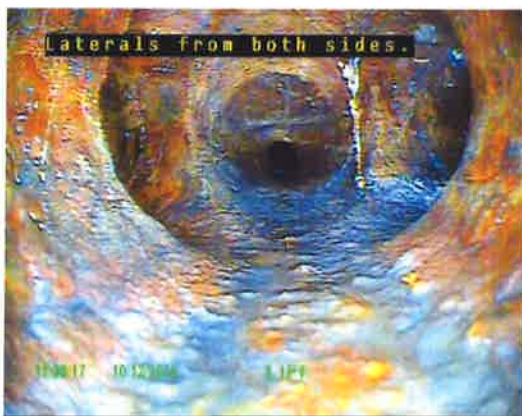
"Y" intersection at 2.10 ft.

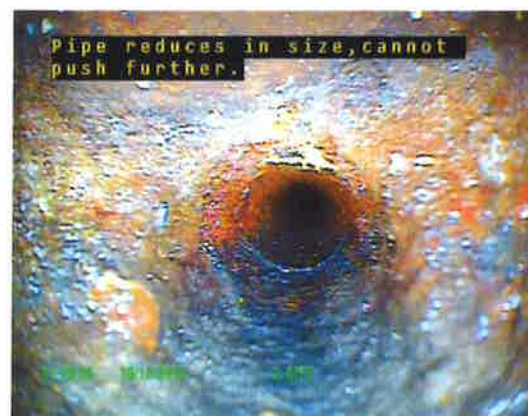
Line reduces in size unable to push further past 2.40 ft.

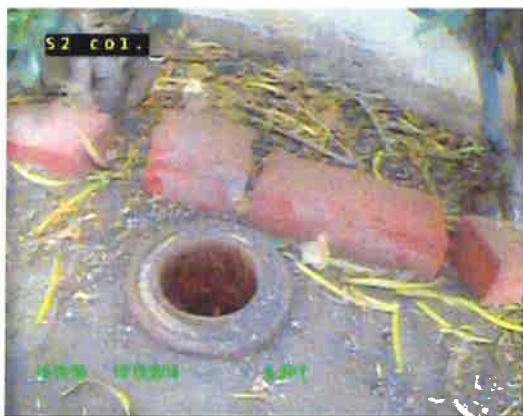
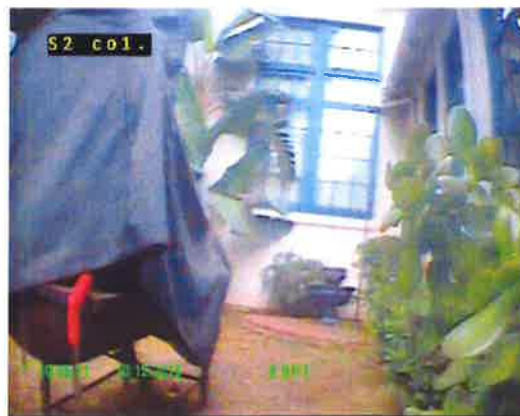
Entry point overview

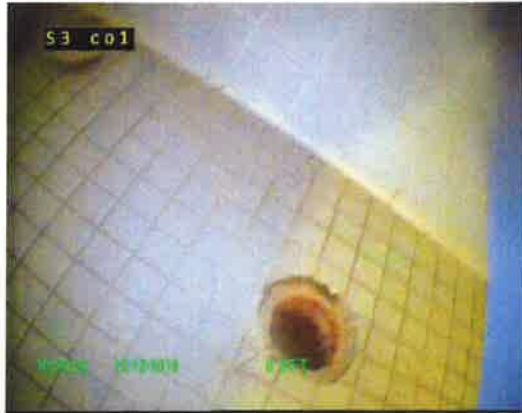
Entry point overview

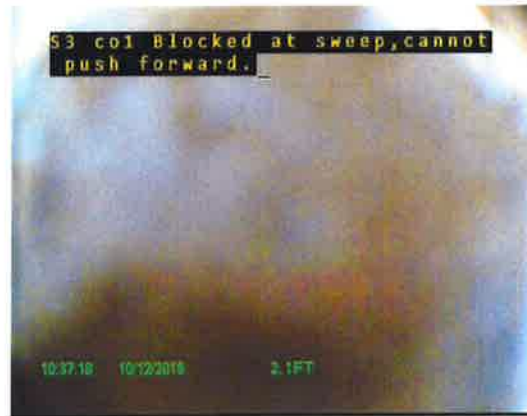
Unable to push past sweep.

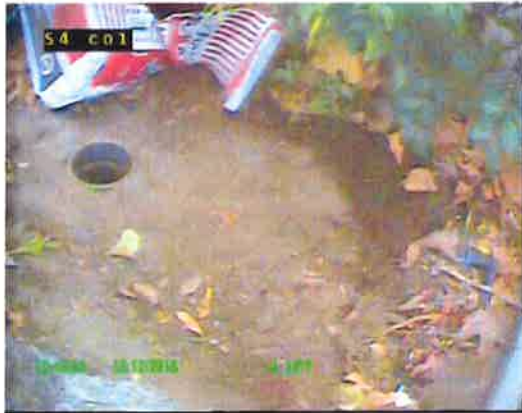
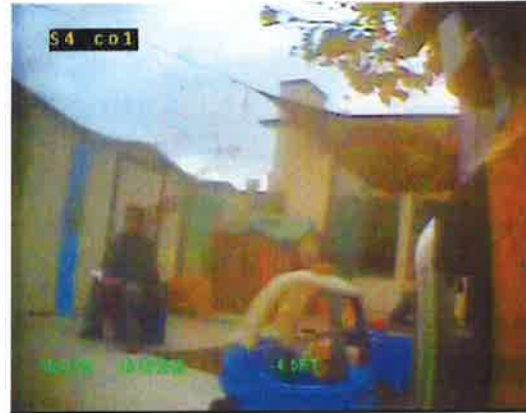
Entry point overview

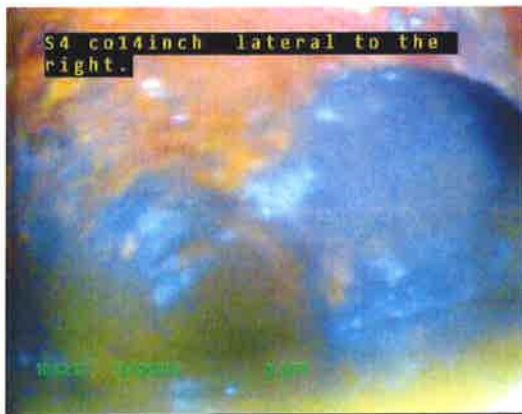
Lateral on right at entry point.

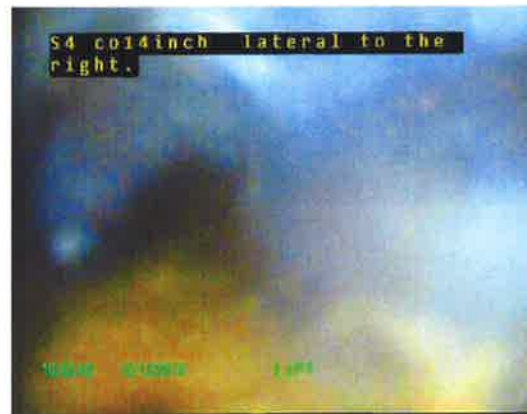
Lateral on the right at 2.40 ft.

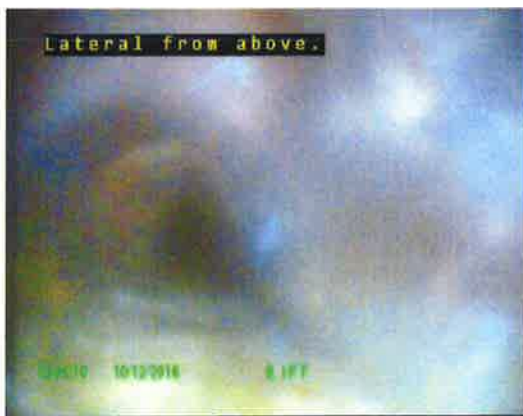
Lateral from above at 5.10 ft.

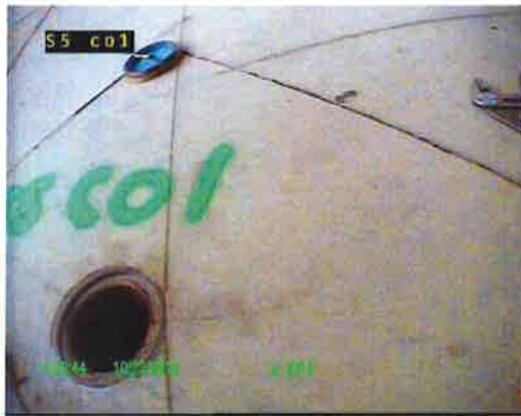
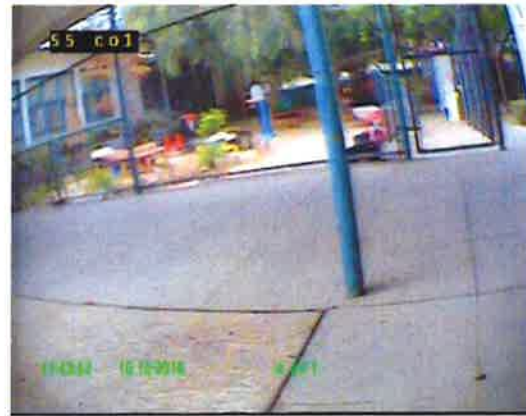
Entry point overview

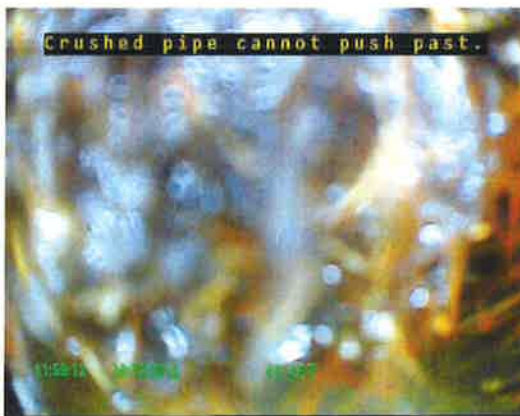
Unable to push past 45.40 ft.

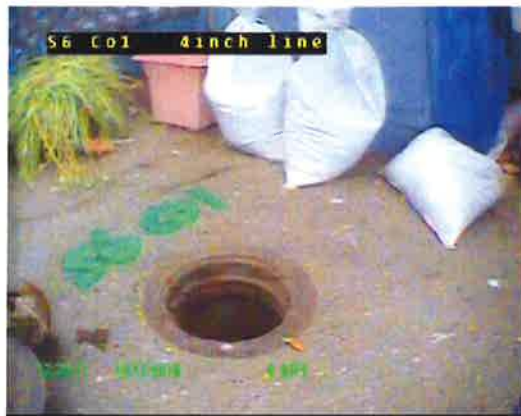
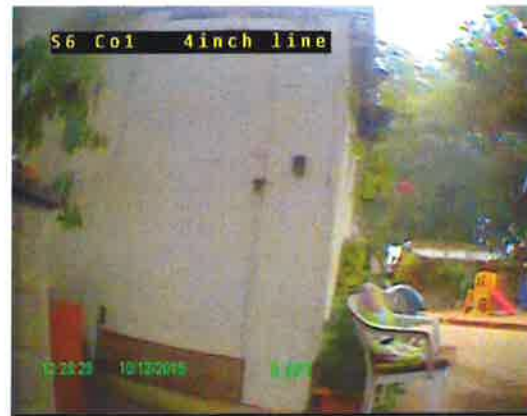
Entry point overview

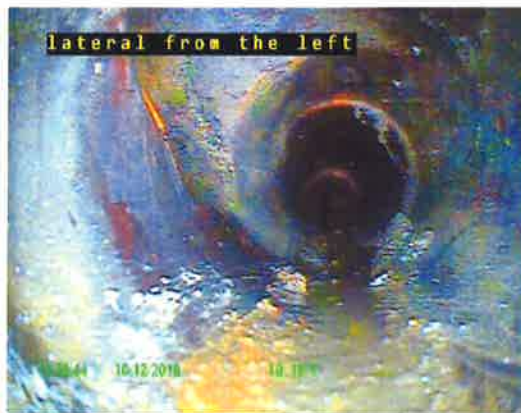
Typical line condition

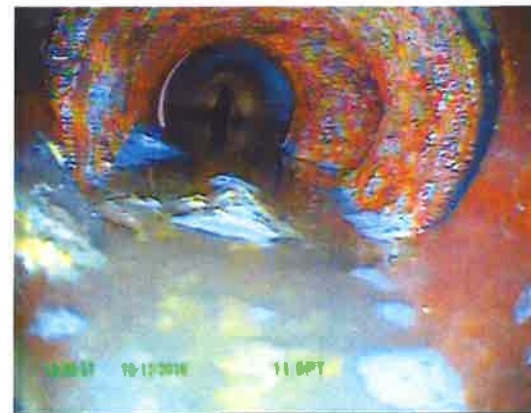
Typical line condition

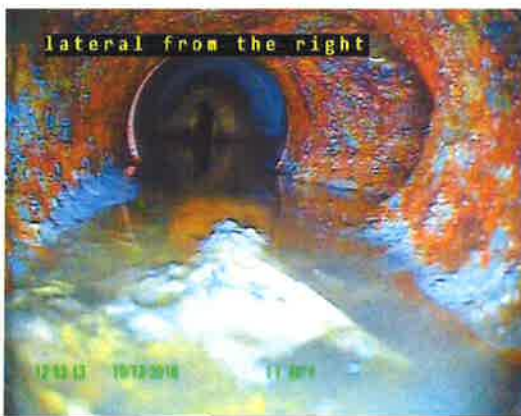
Typical line condition

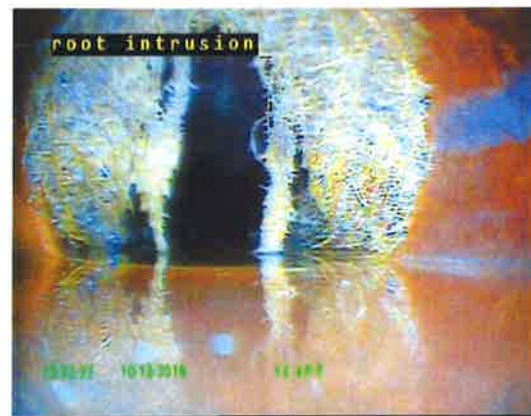
Typical line condition

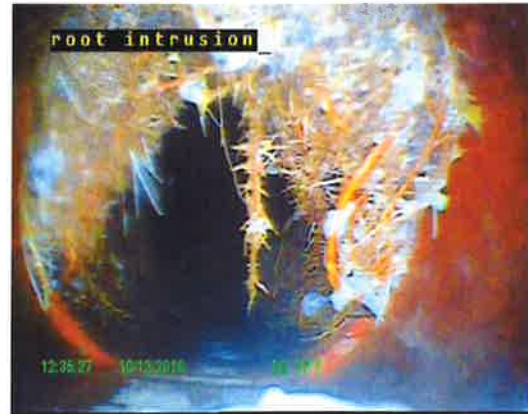
Root intrusion at 23.00 ft.

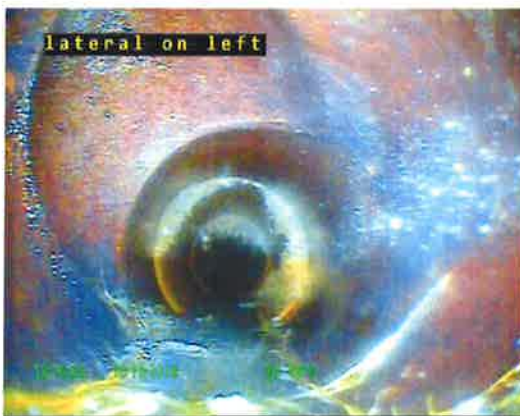
Root intrusion at 35.70 ft.

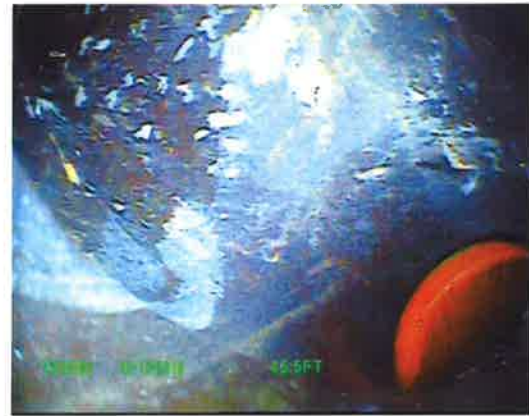
Line turns right at 42.40 ft. with root intrusion.

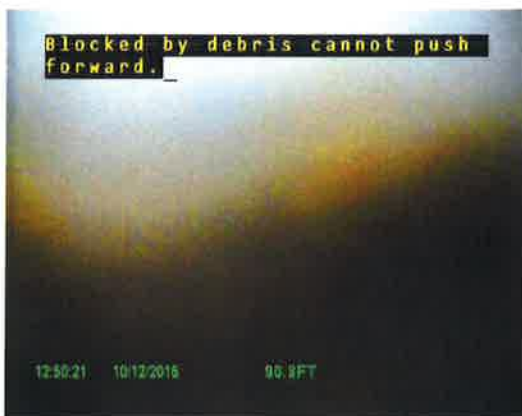
Camera under water at 89.50 ft.
